Haldimand County Lake Erie Hazard Mapping and Risk Assessment

Technical Report

March 19, 2020 | 12969.101.R2.Rev3

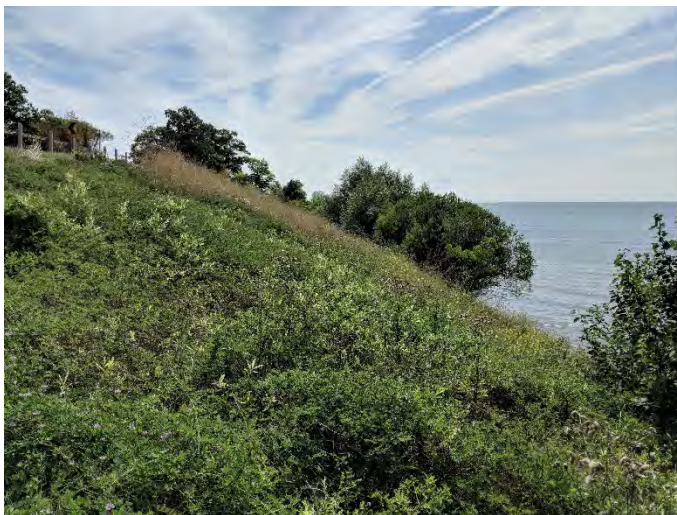
Location: Toe of slope around Section 1
Viewing: East
Description: The slope face is forested, the toe of slope is bare. Clayey silt soil is visible. There is a limestone shelf at the toe.

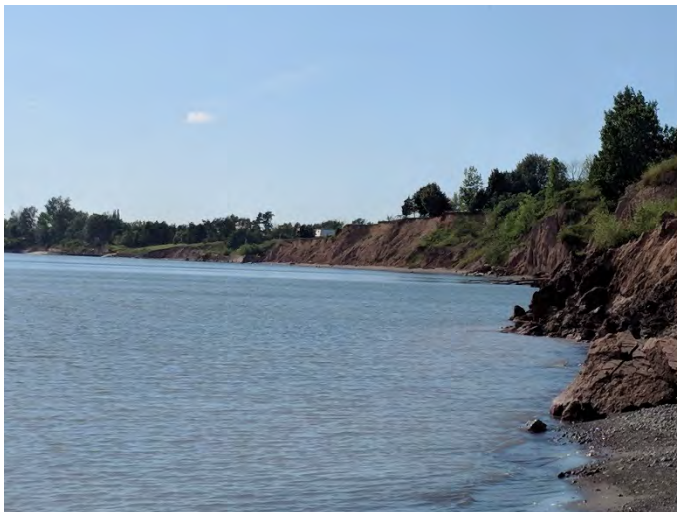
Photograph 12

Location: Slope around Section 40
Viewing: West
Description: There is a sand beach around Section 40.
