**FULL AUTHORITY MEETING**  
**Wednesday October 21, 2015 9:30 am**  
**Ball's Falls Centre for Conservation – Glen Elgin**  
**3292 Sixth Avenue; Jordan, ON**

**A G E N D A (Revised)**

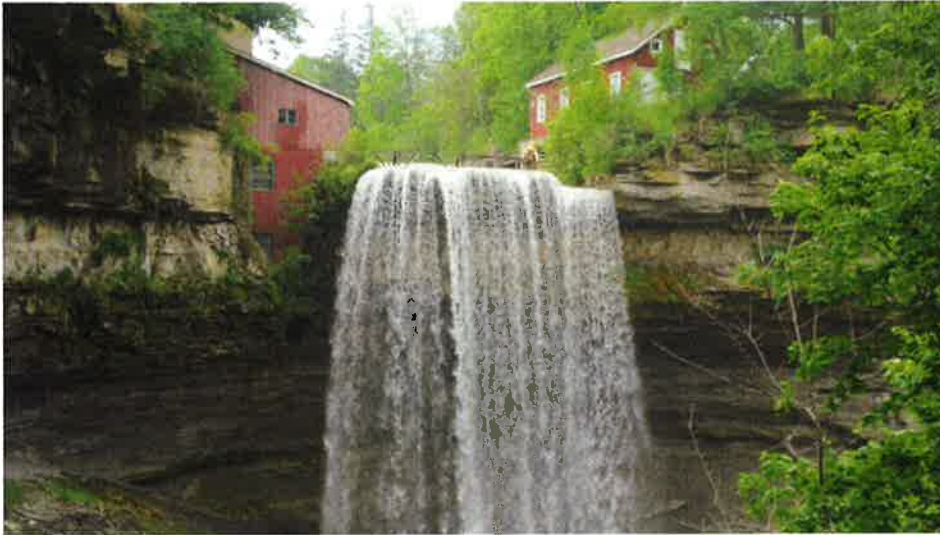
Rock faces next to the water fall area;  
Morningstar Mill buildings in the back

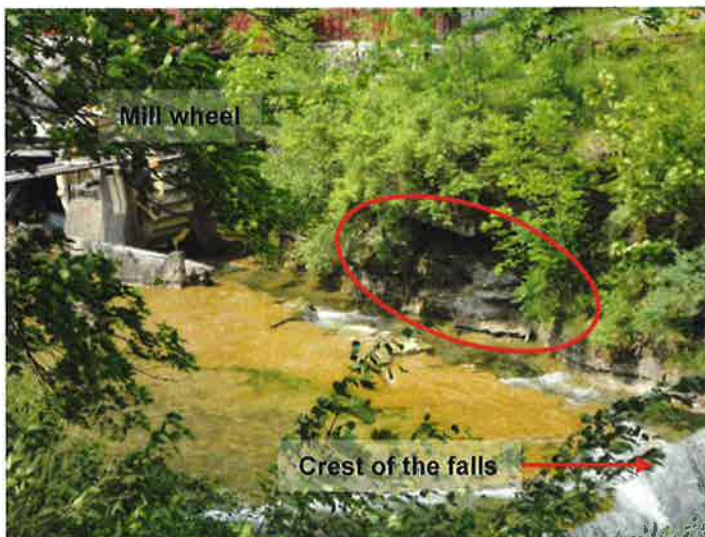
Some undercutting observed on the rock face (left bank  
downstream of the mill wheel)

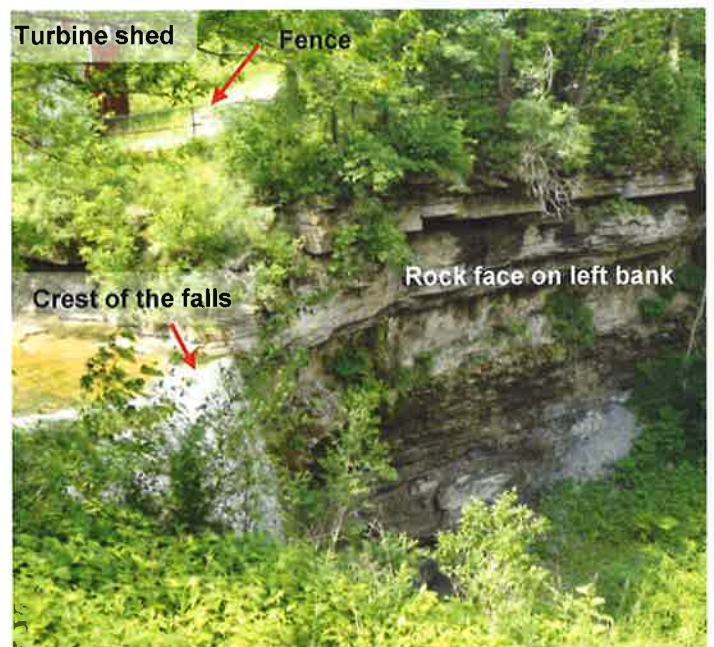
Top of waterfall: view from the right bank towards left bank;  
mill building in safe distance from the rock face; access to  
face prevented by fence

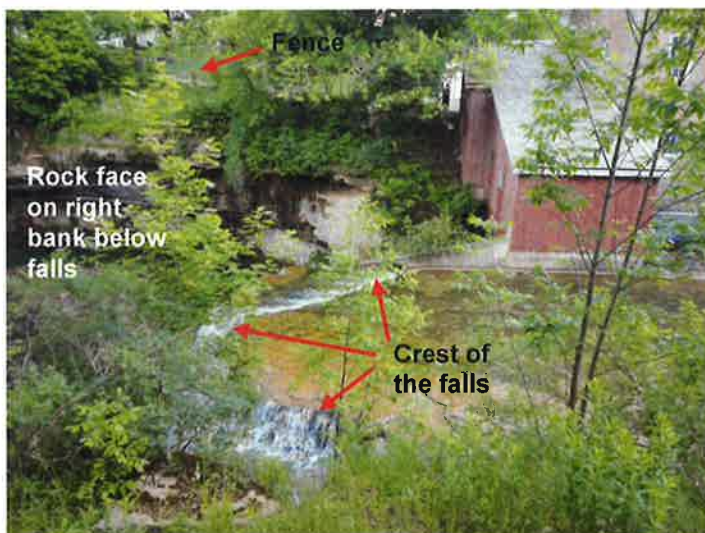
Top of water fall: view from the left bank towards right  
bank; access to face prevented by fence

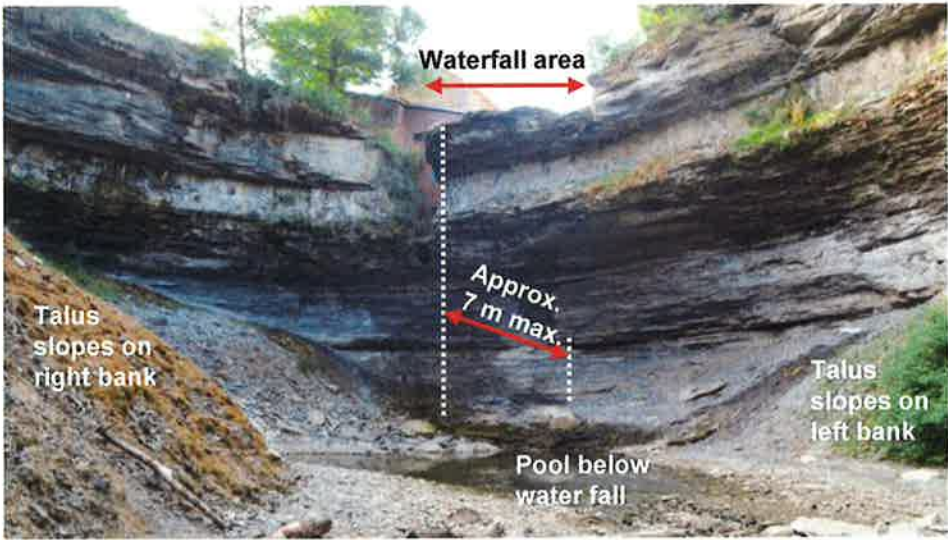
Rock face below the water fall with massive dolostone at the top and underlying shale (during water shut down in May 2015); large overhangs noted at the crest of the rock faces; large talus slopes consisting of small rock debris have formed around the pool below the falls

The Rock Slope Assessment states, *“All buildings at the Morningstar site are currently located well back from the rock faces and the overhangs are presently no cause for concern in terms of the stability of the structures above.”* Further, the City is waiting to see the results of the dam assessment in order to determine where to best invest its \$780,000 of approved capital dollars for the site.

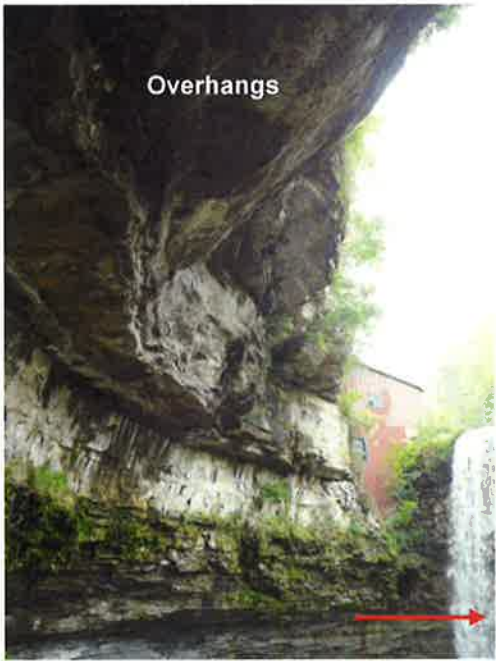
Rock face with large overhangs along the right bank below the falls

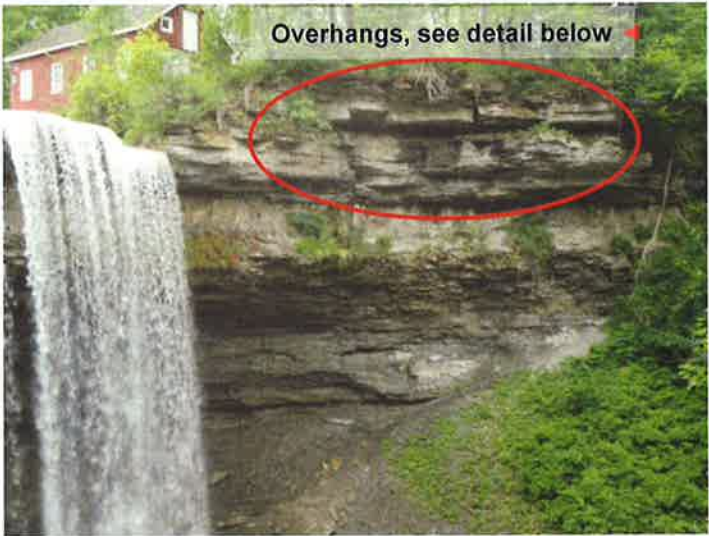
Rock face along left bank below the falls with overhangs at the crest

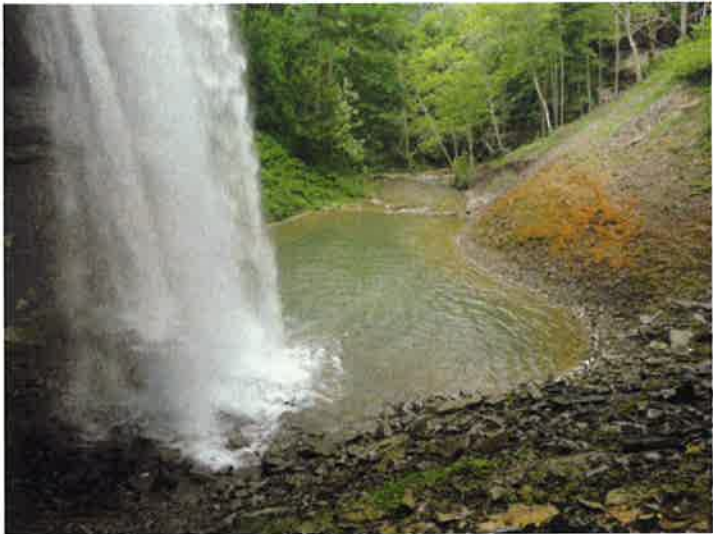
Pool formed below the falls, encircled by talus slopes

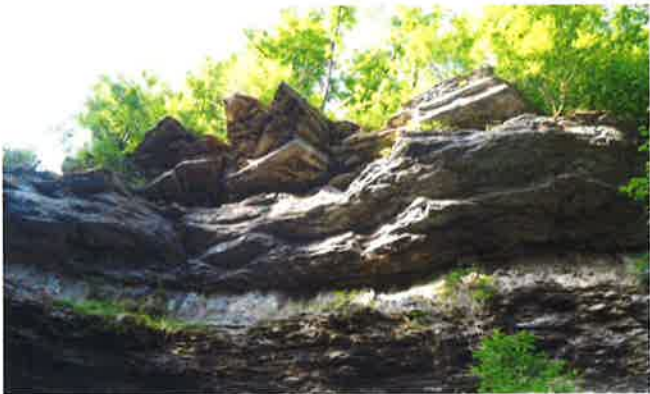
Details of the overhangs along the left bank of the ravine

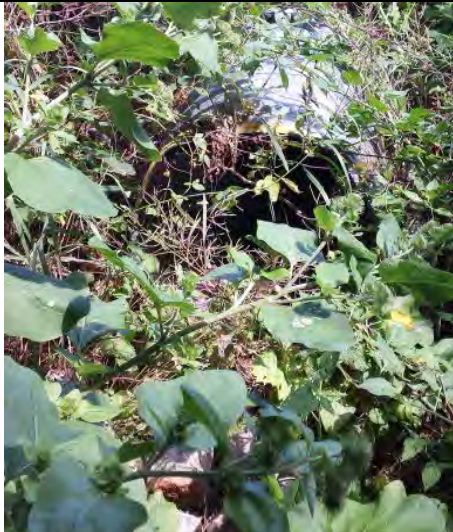
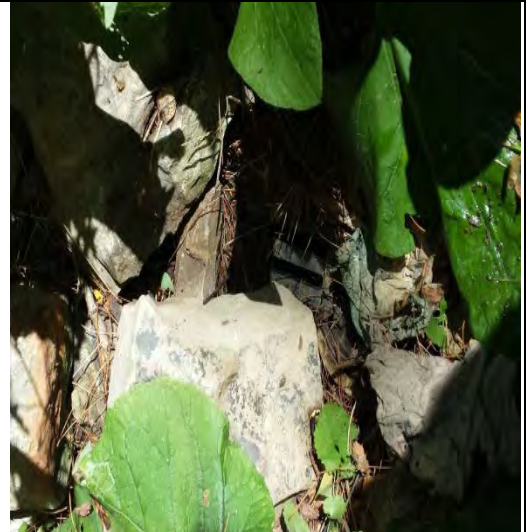
| No. | Item | Description | Image |
|---|--|--|---|
| 2 | <b>Drain pipes under trail</b> | <ul style="list-style-type: none"> <li>- Drain pipe grates must be cleaned out regularly in spring and fall seasons</li> </ul> | |

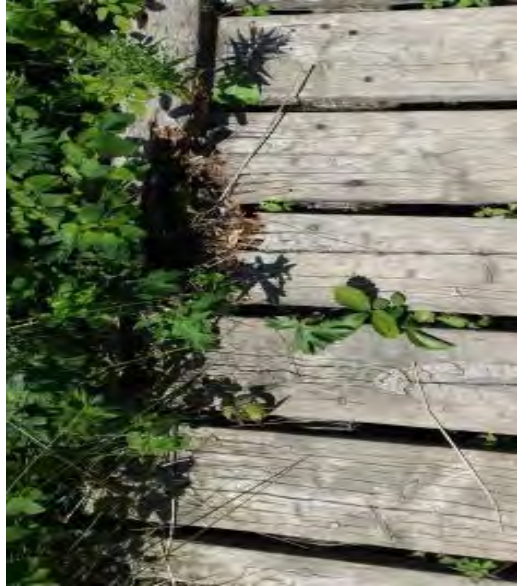
| 3 | Boardwalk repair | <ul style="list-style-type: none"><li>- 2 boards or more to be replaced</li></ul> | |

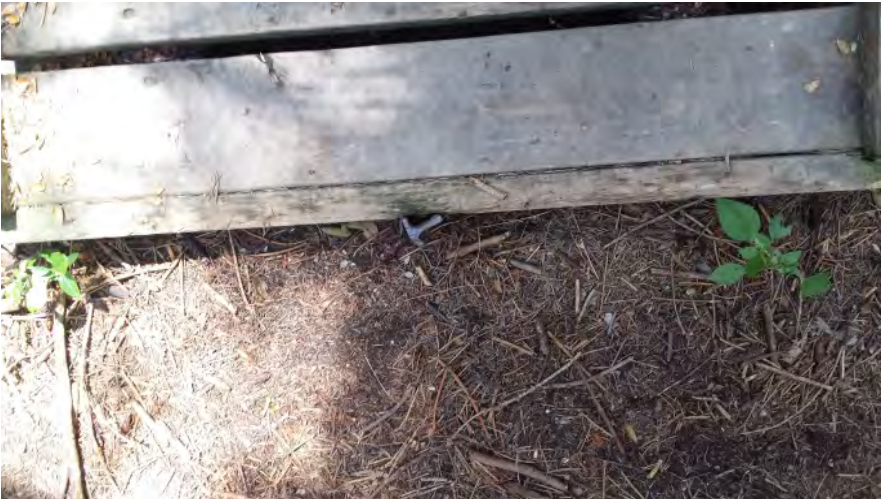
| 8 | <b>Boardwalk Repair</b> | <ul style="list-style-type: none"><li>- Replace boards along the boardwalk bridge</li></ul> | |

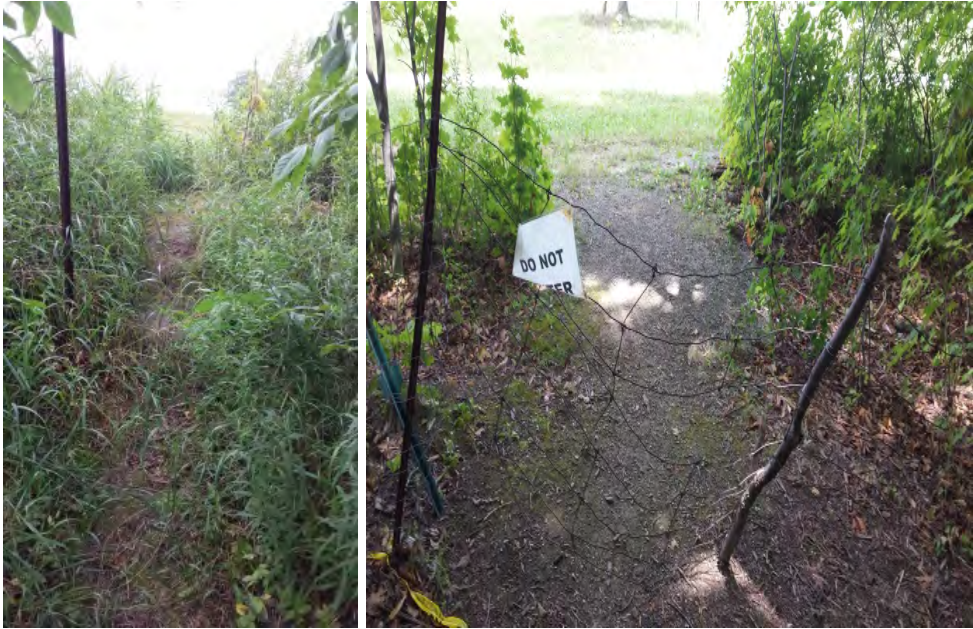
| 15 | Damaged NPCA fence | <ul style="list-style-type: none"> <li>- NPCA fence appears to be damaged and tampered with in numerous places along trail.</li> </ul> | |

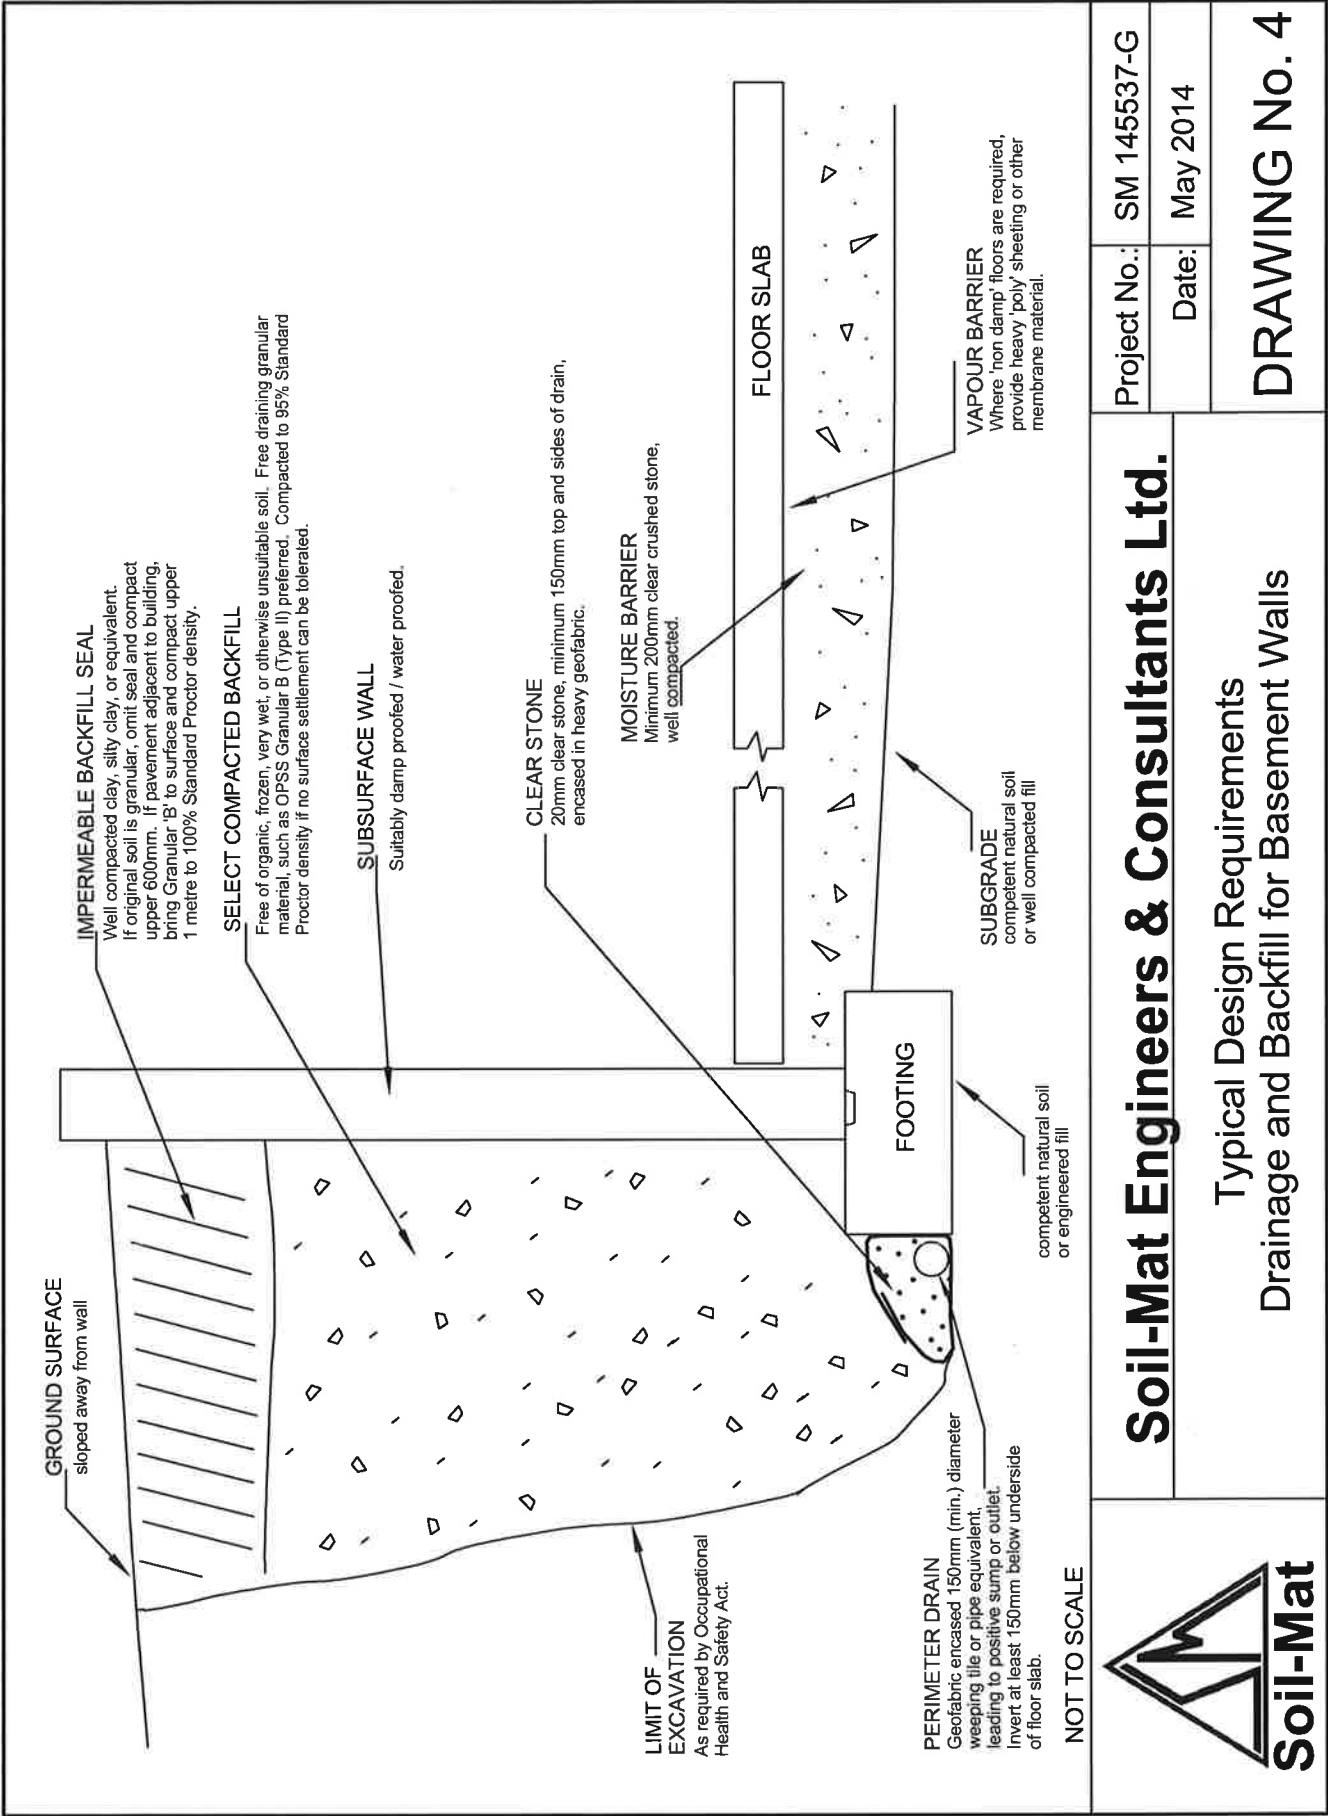
Typical Design Requirements  
Drainage and Backfill for Basement Walls
