**NPCA WATER QUALITY MONITORING PROGRAM:**

**SUMMARY REPORT OF THE YEAR 2018**

**JUNE 2019**

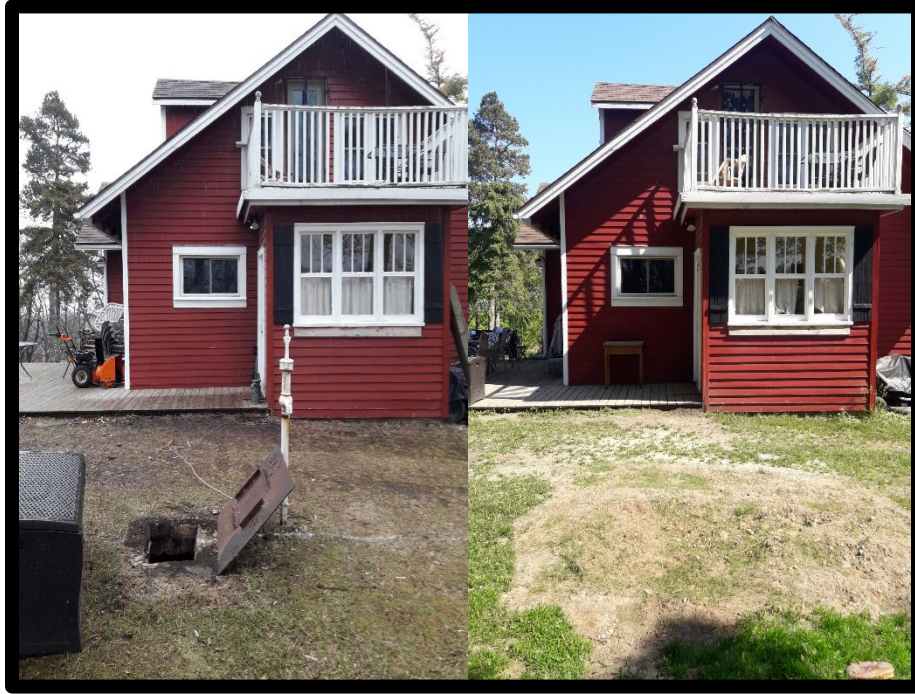
**Figure 12:** An example of a NPCA Water Well Decommissioning Project. Left photo shows an abandoned dug well in need of decommissioning and the right photo shows same dug well after decommissioning had been completed by a licensed well contractor.

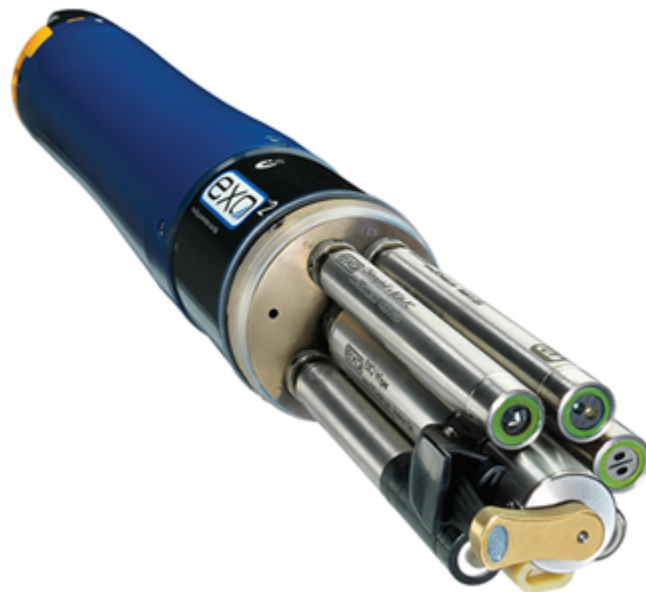
**Figure 13.** YSI EXO Sensor used at Lake Niapenco

The NPCA continued to monitor DO concentrations during the 2019 winter season. To assess wintertime, DO concentrations NPCA staff installed YSI EXO Water Quality Sondes (**Figure 13**) in Lake Niapenco (**Figure 14**). Before deployment the logger was lab calibrated for use. The logger was deployed to a depth of 1.5m and 4.5m from surface of Lake Niapenco. The logger was suspended with buoys on a steel aircraft cable that was anchored with an anchor. The logger was programed to take DO readings every 15 minutes. The YSI loggers was taken to the NPCA main office and the data downloaded to a computer. All data was analyzed with Excel.

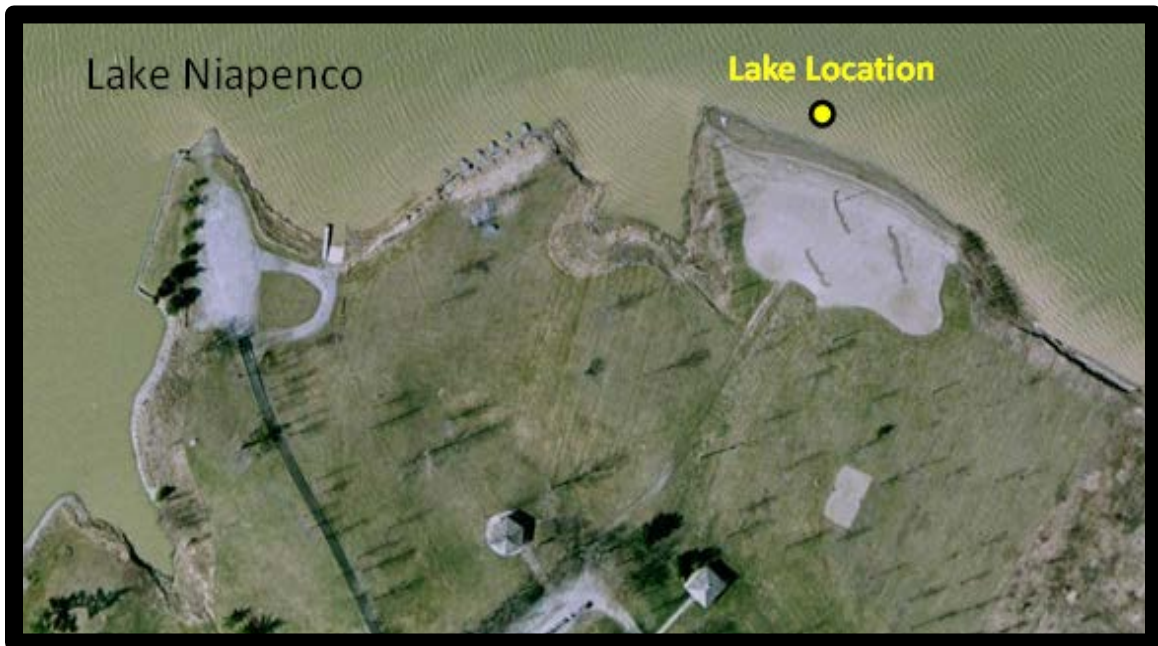
**Figure 16:** Sample Location at Lake Niapenco

NPCA collected a water sample at Lake Niapenco on June 21, 2018. A raw water sample could not be collected from the water supply well because of the new water treatment infrastructure prevented access. **Figure 16** shows the sample location in the Conservation Area. Water samples were collected following the same protocol used by the NPCA's Operation Department. This protocol was as follows: 1) Lake Niapenco samples were collected in waist-deep water at the beach (**Figure 17**); and 2) Samples were collected and placed in a cooler with ice and shipped the next day for PFC analysis.

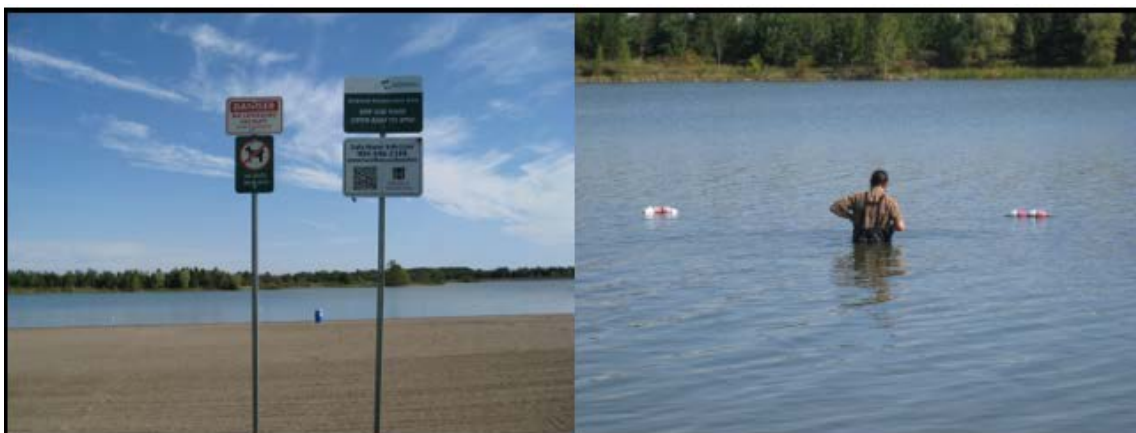
**Figure 17:** Sample location at the beach Lake Niapenco

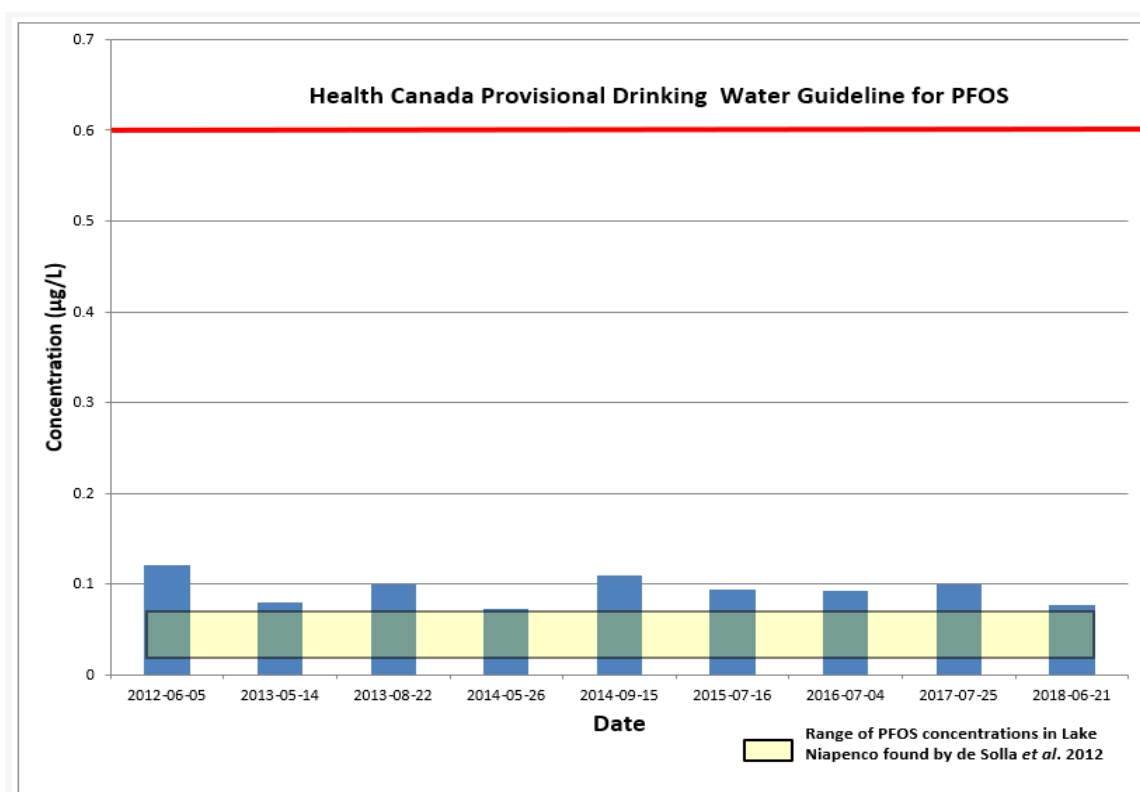
**Figure 18.** PFOS concentrations found in Lake Niapenco by NPCA monitoring

Lake Niapenco was contaminated by historic PFC usage from John C. Munro International Airport in Hamilton (de Solla 2012 and Fowler 2011). The NPCA's monitoring at Binbrook Conservation Area continues to support the evidence that PFCs and specifically PFOS are present in Lake Niapenco but not at concentrations above Health Canada drinking water guidelines. It is expected that PFCs will continue to be present in Lake Niapenco due the persistence of PFCs in the environment and due to the delay to contain upstream sources. It should be noted that Hamilton Public Health has evaluated previous PFC water quality data at Binbrook Conservation Authority and determined that the PFC concentrations detected would not adversely affect the park users.
