Lake Ontario Shoreline Management Plan Update

Niagara Peninsula Conservation Authority

November 2009

W.F. Baird & Associates Coastal Engineers Ltd.

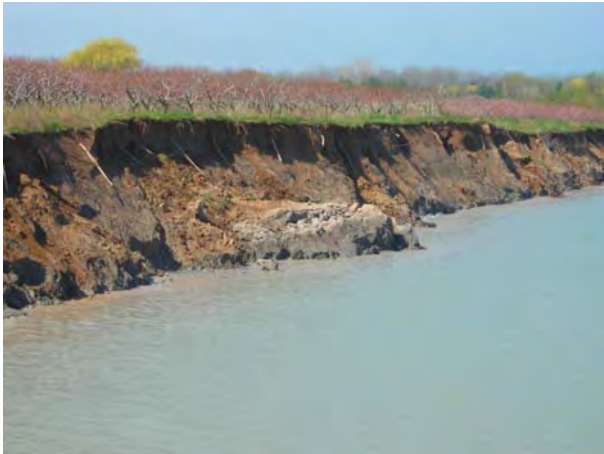
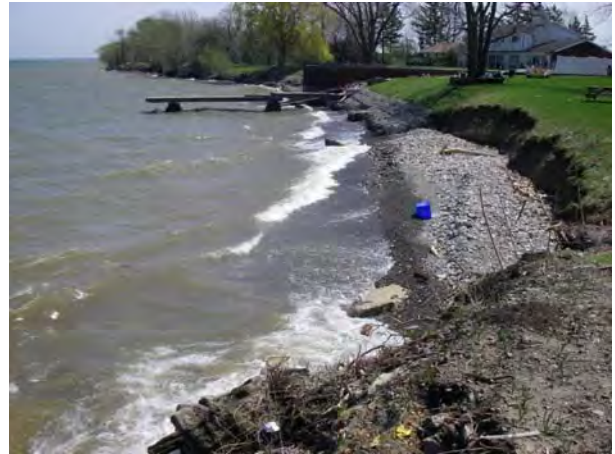
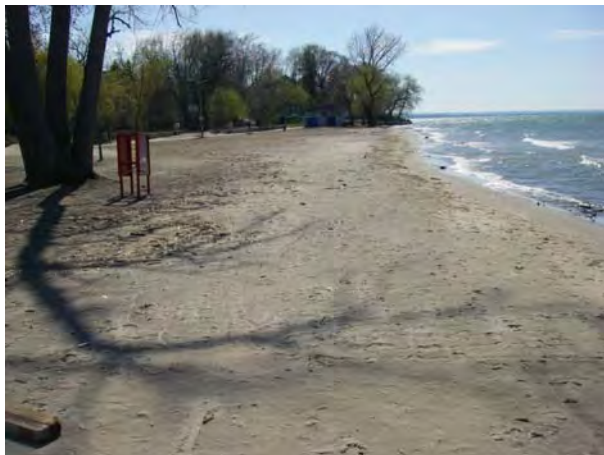
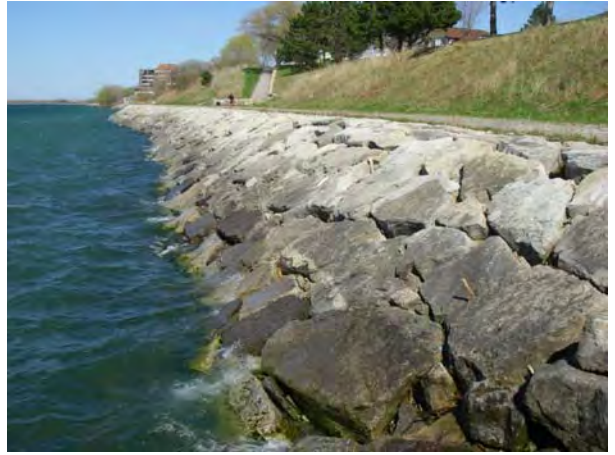
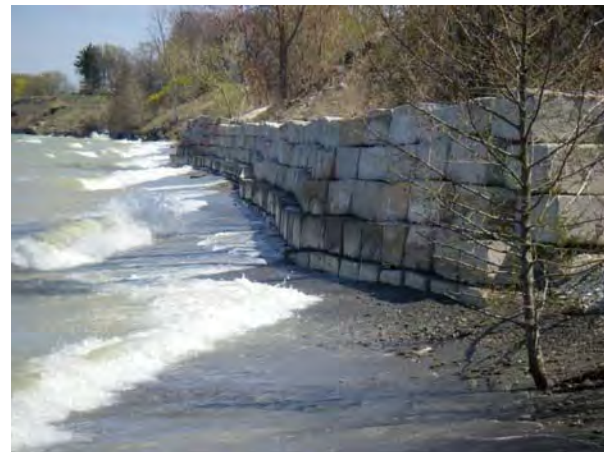
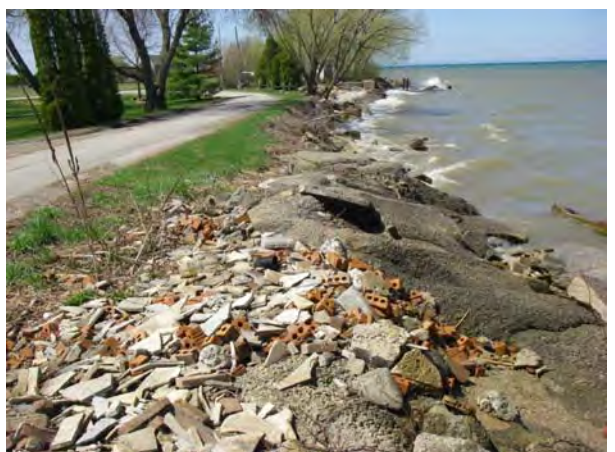
Figure 2.2 Examples of Site Visit Photographs April-May 2009

Eroding Bluff - Site 29 Reach 40

Low Shore - Site 14 Reach 13

Beach - Site 25 Reach 28

Armour Stone Revetment - Site 26 Reach 32

Stacked Concrete Block Wall – Site 29 Reach 40

Ad Hoc Protection - Site 15 Reach 15

A standardized form was used for note taking at each site, including water level and wind information at the time of the visit. The forms and photographic records for each site visit are provided in Appendix A.

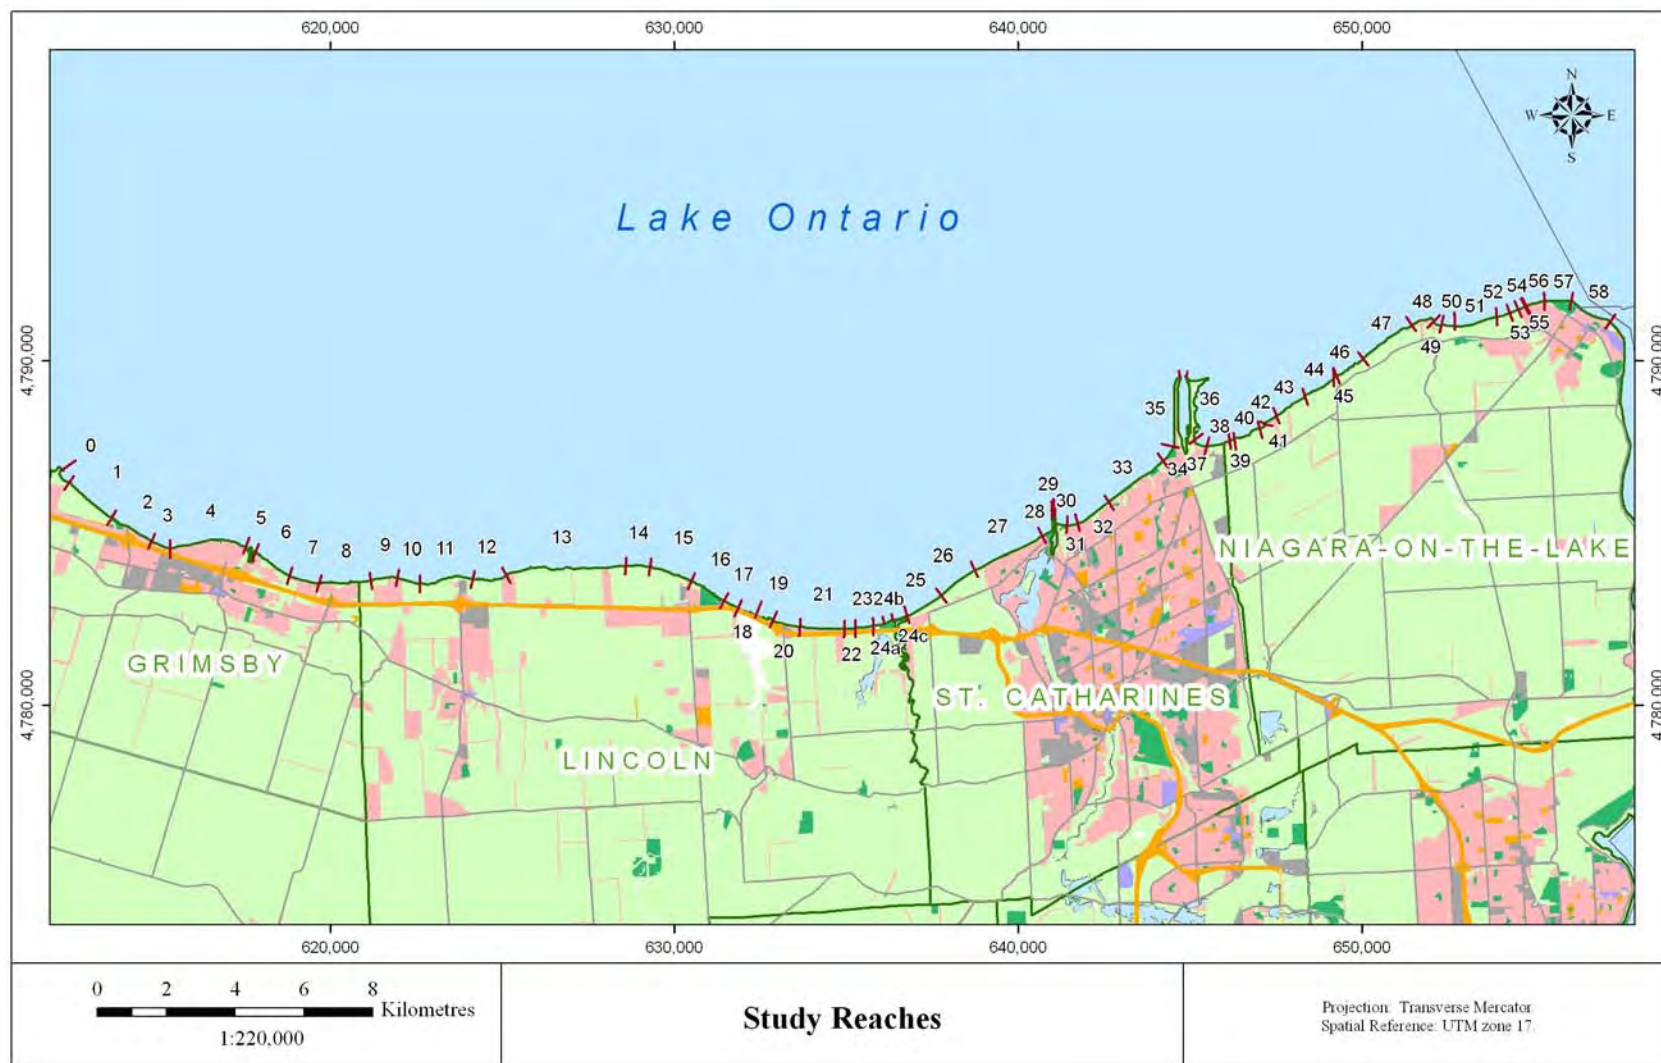
Figure 3.1 Shoreline Reach Boundaries

The 1994 LOSMP reaches were reviewed for this study and it was concluded that the reach delineation was appropriate and suitable for the SMP update. The 1994 LOSMP reach numbering system with some modifications was retained for this study for consistency. Figure 3.1 shows the modified shoreline reaches. A larger map is presented in Appendix C. The geographic boundaries of the reaches are presented in Table 3.1.

The reach numbering extended from Reach 0, at the western limit of the study area to Reach 58 at the eastern limit. The full extent of Reaches 0 and 58 were not shown in the 1994 LOSMP because the mapping at that time did not provide coverage for the entire study area.

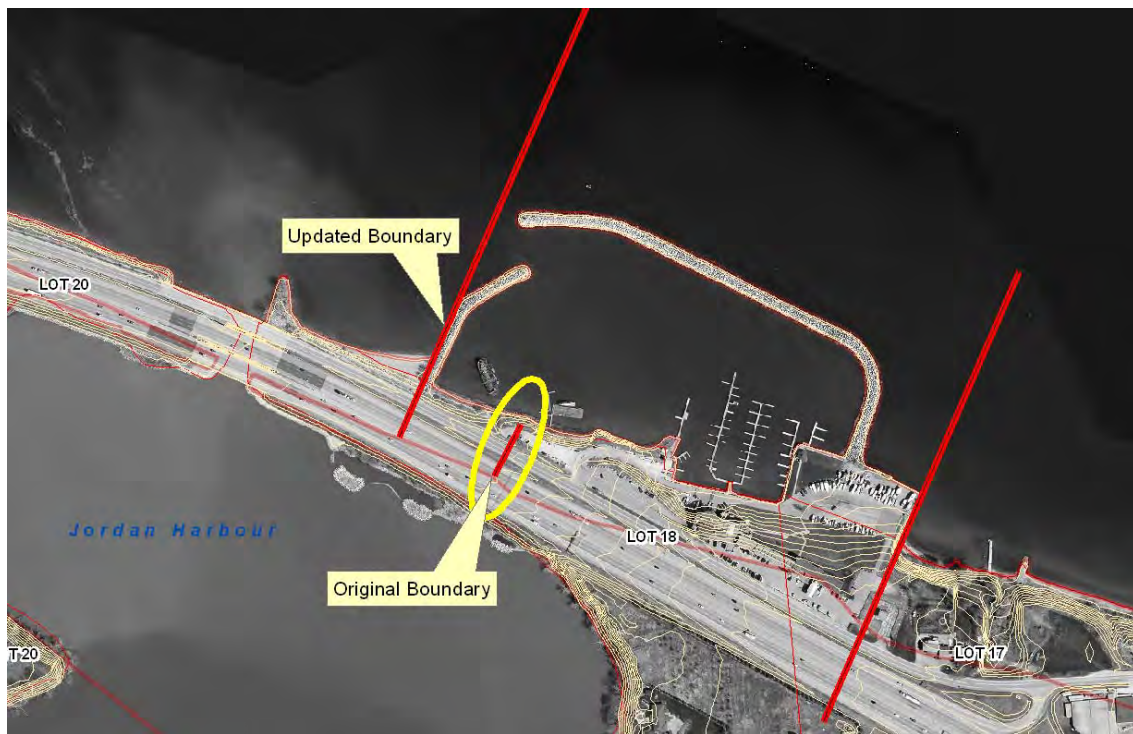
Figure 3.2 Updating Boundary Between Reaches 18 and 19

- Some boundary lines shifted slightly to better match with the newer, more detailed mapping. For example, the boundary between Reaches 7 and 8 was shifted west by less than 10 m to align with the centre of Betts Avenue.
- Slight adjustments to reach boundaries shown on 1994 LOSMP mapping to match the boundaries originally delineated on more detailed 1994 working draft mapping.
- Boundary between Reaches 18 and 19 was shifted approximately 100 m to match the limits of the marina breakwater, which did not exist in the 1994 mapping (see Figure 3.2).
- Reach 24 was further subdivided into 3 sub-reaches (24a, 24b and 24c) to better delineate the beach areas. The change does not affect the numbering on the other reaches.

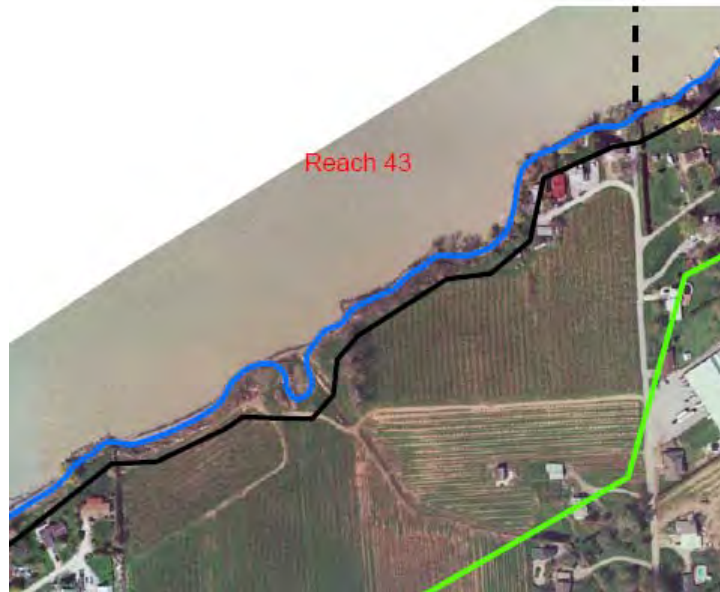
Boundary delineated by HCCL (2006) shifted the line to match Irvine Road.

For Reaches 37 to 58 within Niagara-on-the-Lake, HCCL (2006) reported that they accepted the reach definitions used in the 1994 LOSMP and maintained them for the sake of consistency. As part of the present study, the boundaries of Reaches 37 to 58 in Niagara-on-the-Lake, as presented by HCCL (2006), were compared with the original 1994 boundaries. The HCCL boundary lines generally matched the 1994 limits with some noteworthy exceptions; these exceptions are described in Appendix C. For the present study, the HCCL boundaries were revised to match the original 1994 boundaries as intended. Figure 3.3 shows an example of a revised reach boundary. In addition, the reach boundary lines shown in the HCCL (2006) mapping were illustrative in nature and all were drawn with an arbitrary due-north orientation, not shore perpendicular, as is standard practice. The HCCL boundaries were therefore revised to a shore perpendicular orientation and were also created as larger 500 m line segments so they could be used for geoprocessing with other datasets.

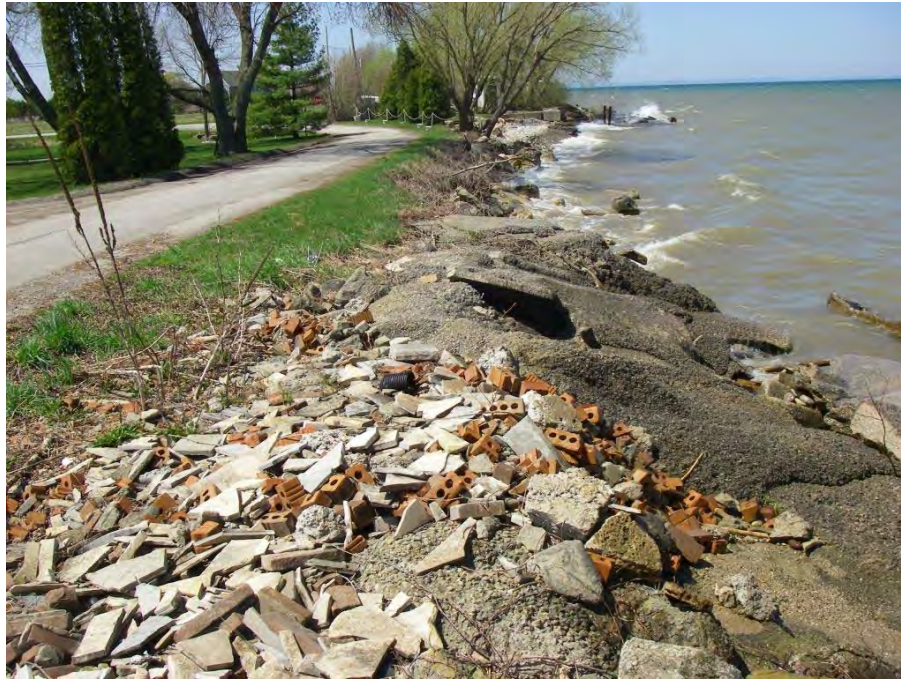
Figure 4.5 Low Shoreline East of Martin Road (Reach 15)

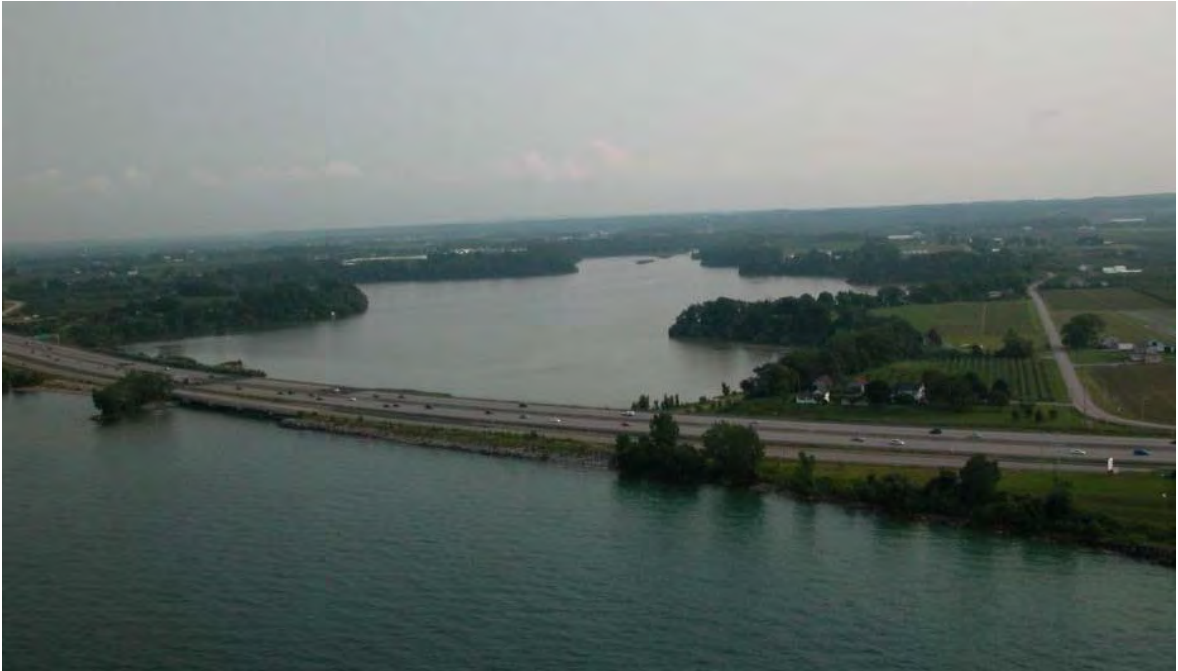
Figure 4.13 Jordan Harbour, Reach 18

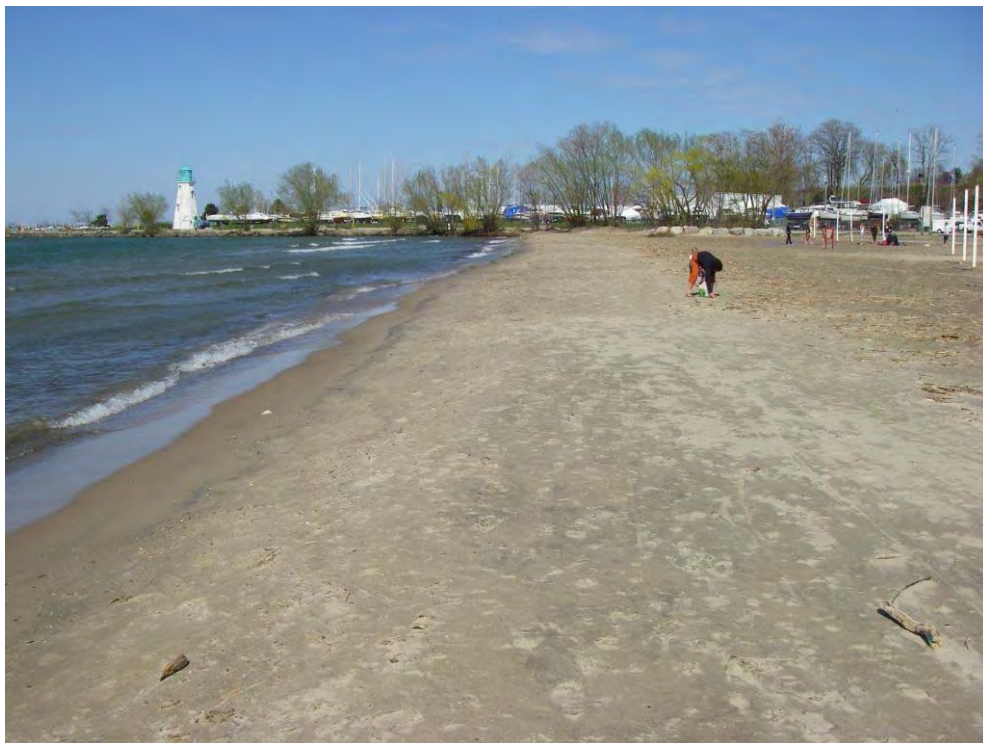
Figure 4.14 Lakeside Park Dynamic Beach, Reach 28

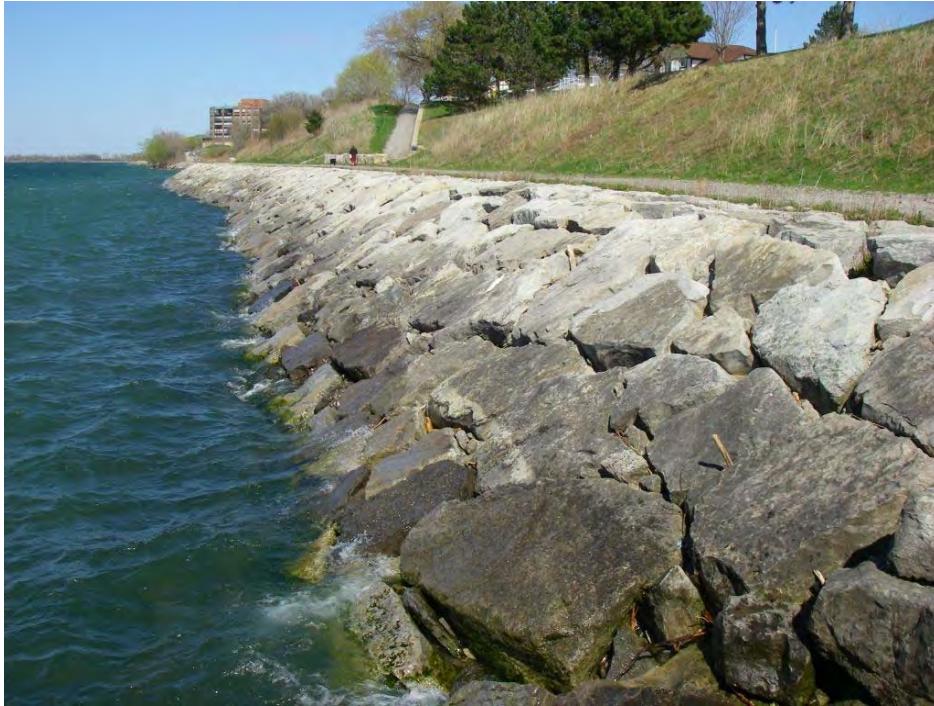
Figure 6.1 Armour Stone Revetment (Belmont Park at Beachview Drive; Site 26, Reach 22)

The 1994 LOSMP provided a discussion of alternative protection measures and recommended the armour stone revetment as the preferred structure where shoreline protection is necessary at individual properties. Representative shoreline protection structures were reviewed during this study and armour stone revetments are shown in Figures 6.1 and 6.2.

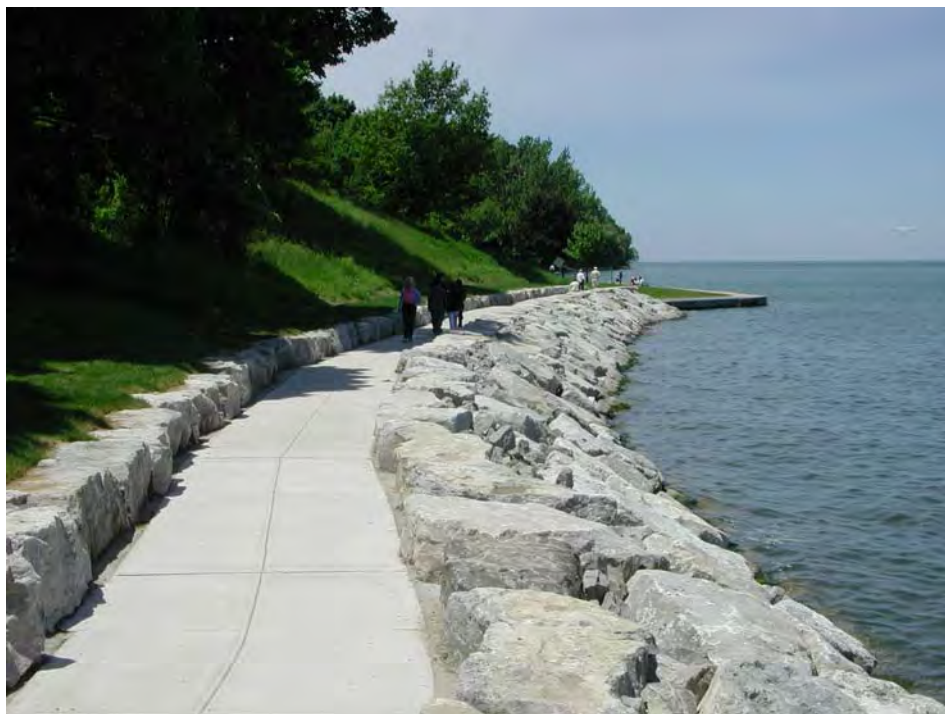
Figure 6.2 Armour Stone Revetment (Queens Royal Park, NOTL, Reach 5, constructed 2004)

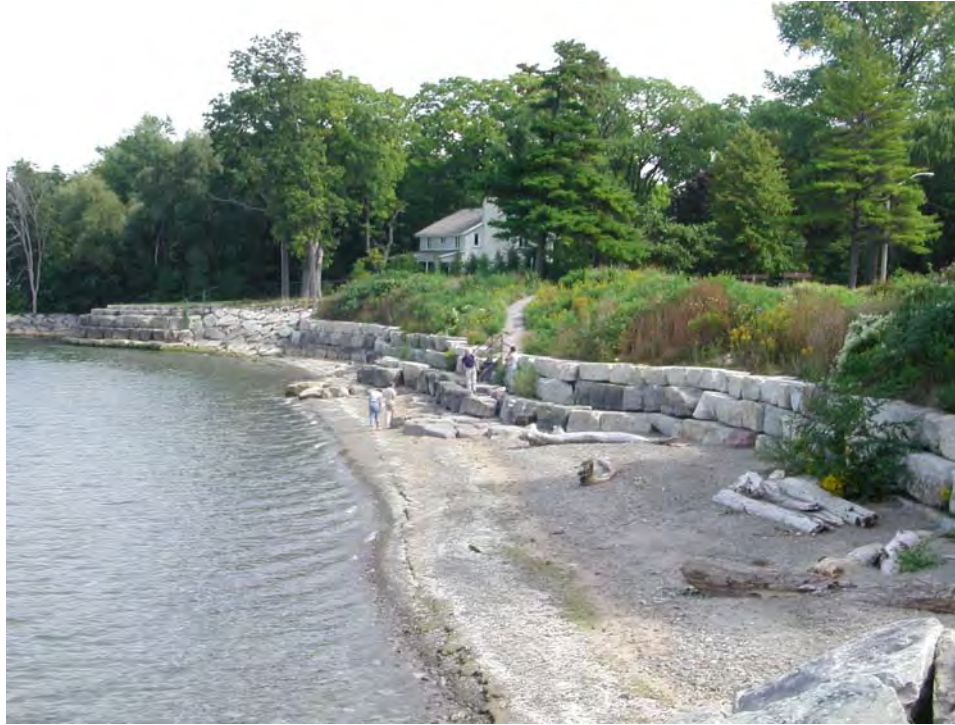
Figure 6.10 Stacked Armour Stone Wall (Ryerson Park, NOTL, Reach 54; constructed 1997)

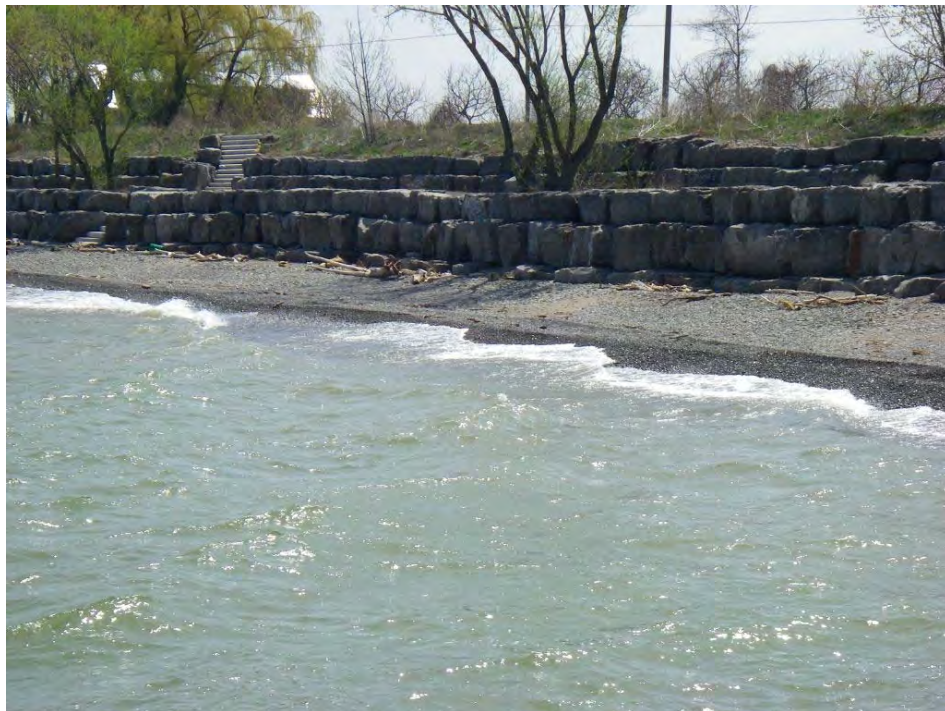
Figure 6.11 Stacked Armour Stone Wall (Site 11 east of Bartlett Ave; Reach 12; constructed since 2006)

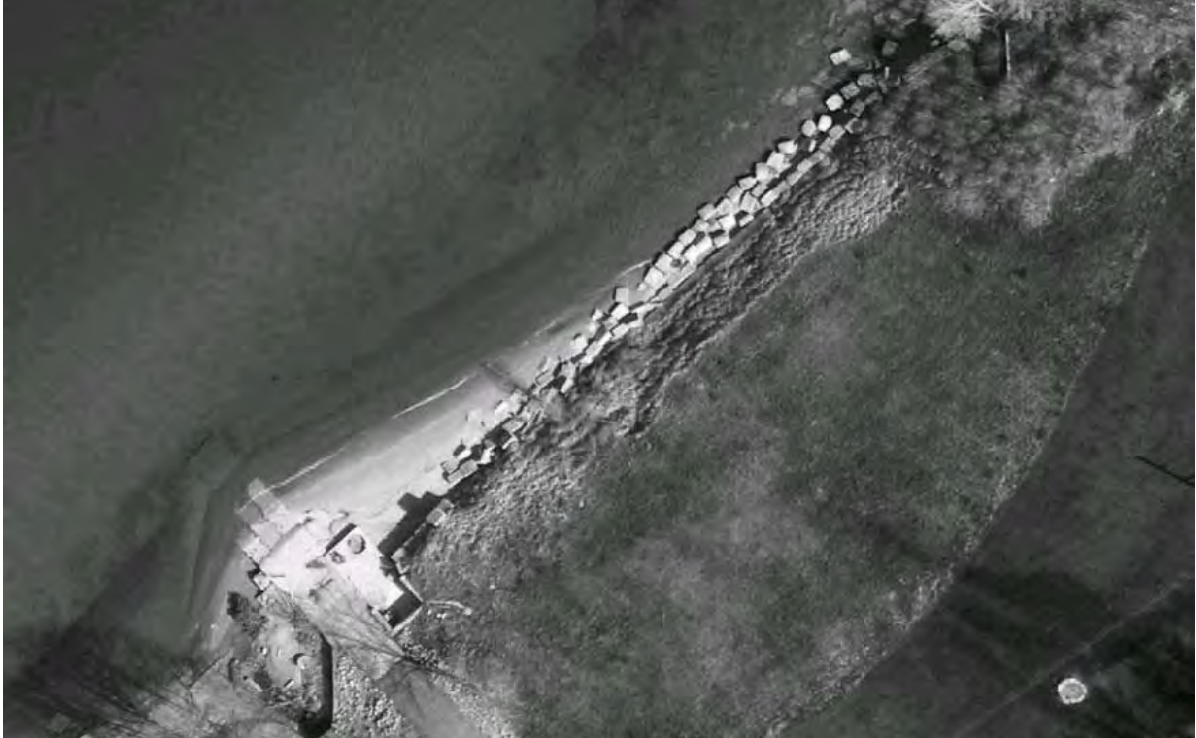
Figure 6.12 Concrete Blocks Appear to Be Toppled (Reach 26, 2006 aerial)

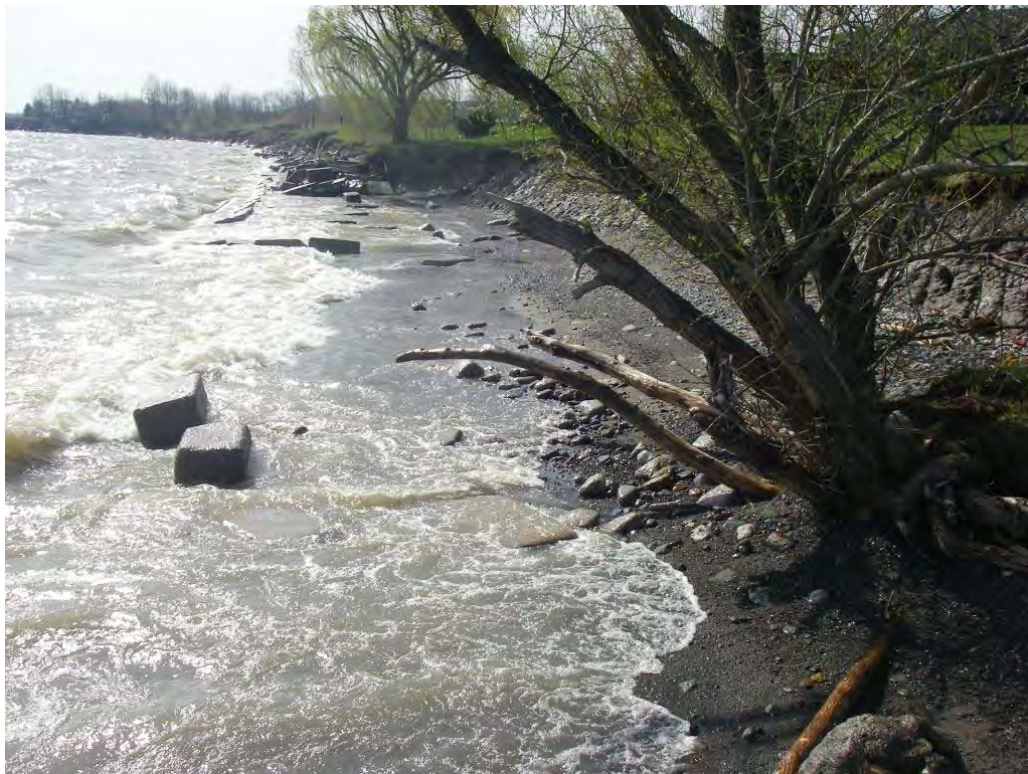
Figure 6.13 Ineffective Concrete Blocks (east of Hunter Road at boundary Reaches 1 and 2)

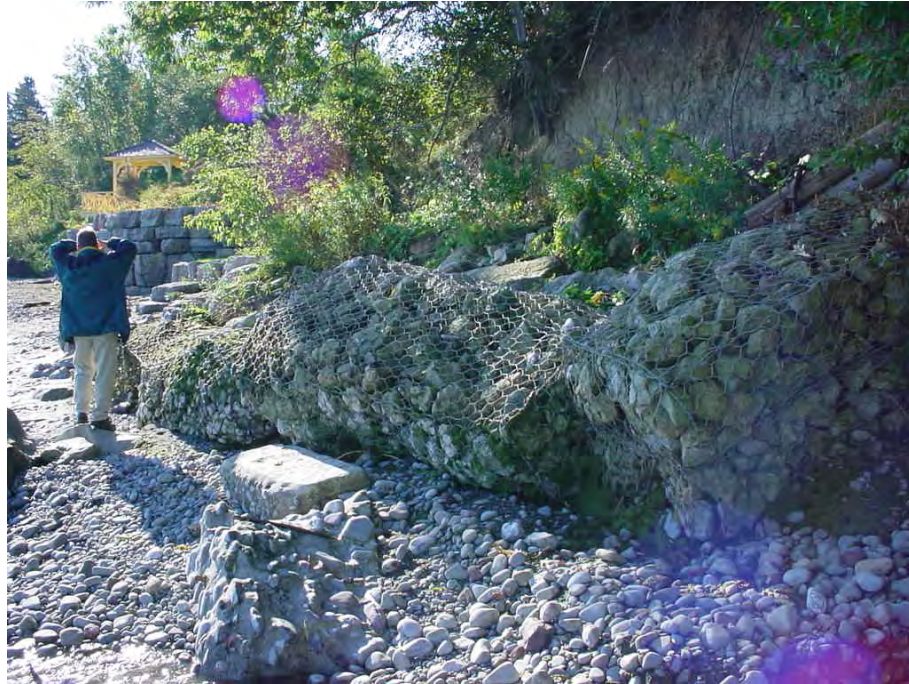
Figure 6.14 Collapsed Gabion Basket Wall

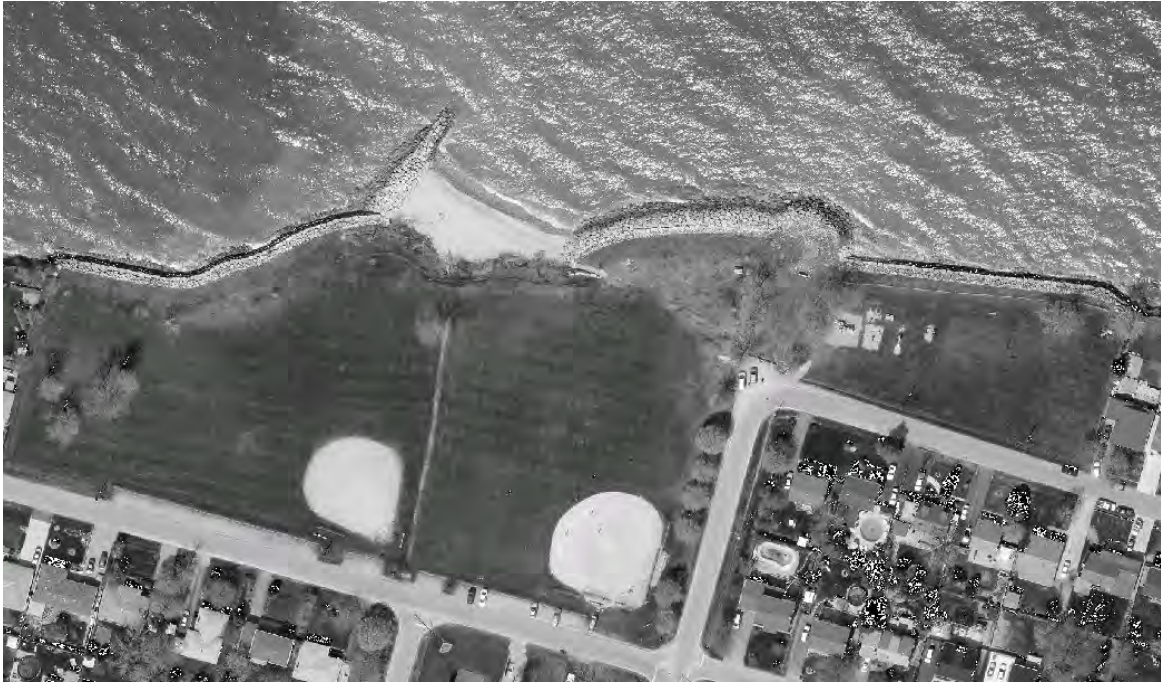
Figure 6.16 Anchored Beach, Grimsby (Reach 4)

As described in the 1994 LOSMP, groynes and headlands (see Figure 6.15) can provide effective protection in certain circumstances. Figures 6.16, 6.17 and 6.18 show examples of anchored beaches that appear to be effective although no evaluation of potential adverse effects, if any, was carried out for this study. Groyne/headland anchored beaches are generally more complex approaches that require analysis and design by qualified coastal engineers. Potential impacts are discussed in the 1994 LOSMP and Section 6.2.9.

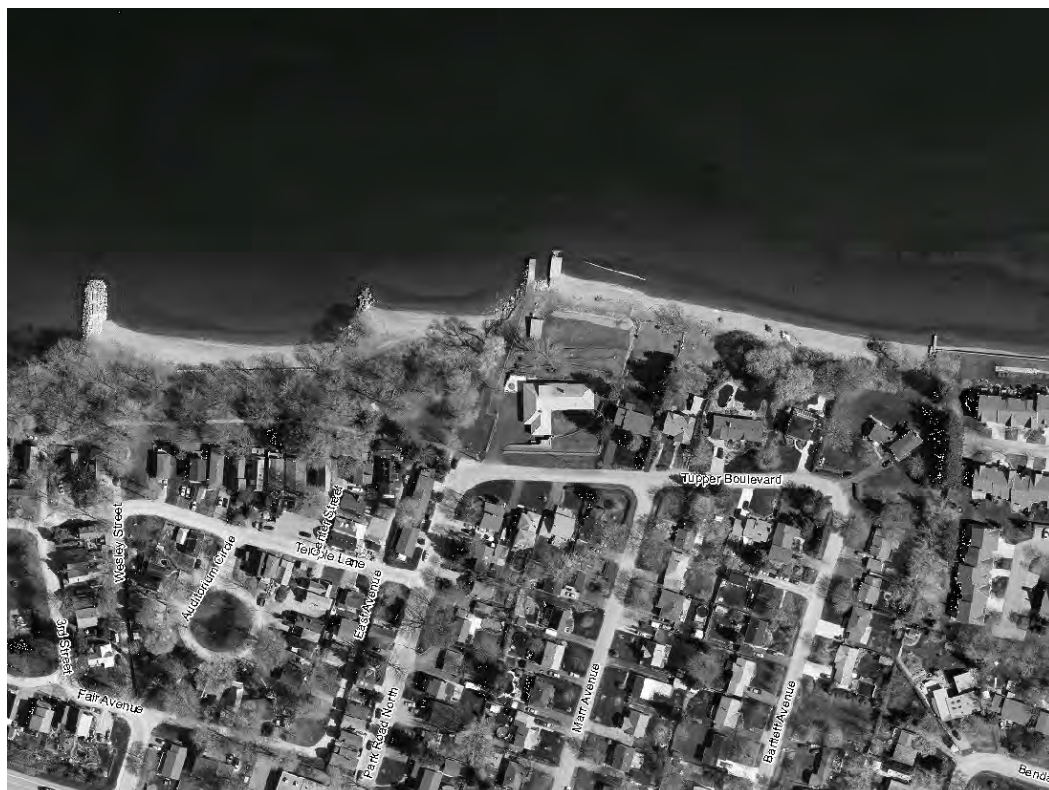
Figure 6.17 Groynes at Westerly End of Tupper Road (Reach 8)

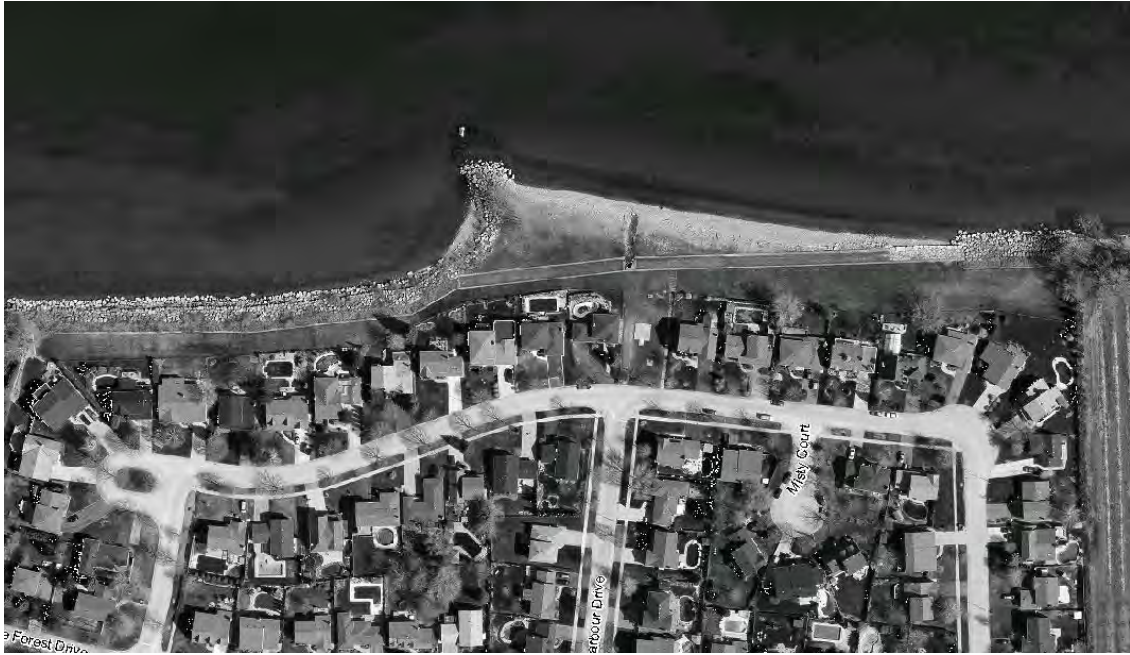
Figure 6.18 Headland Anchored Beach and Revetment (Bal Harbour, Reach 8)

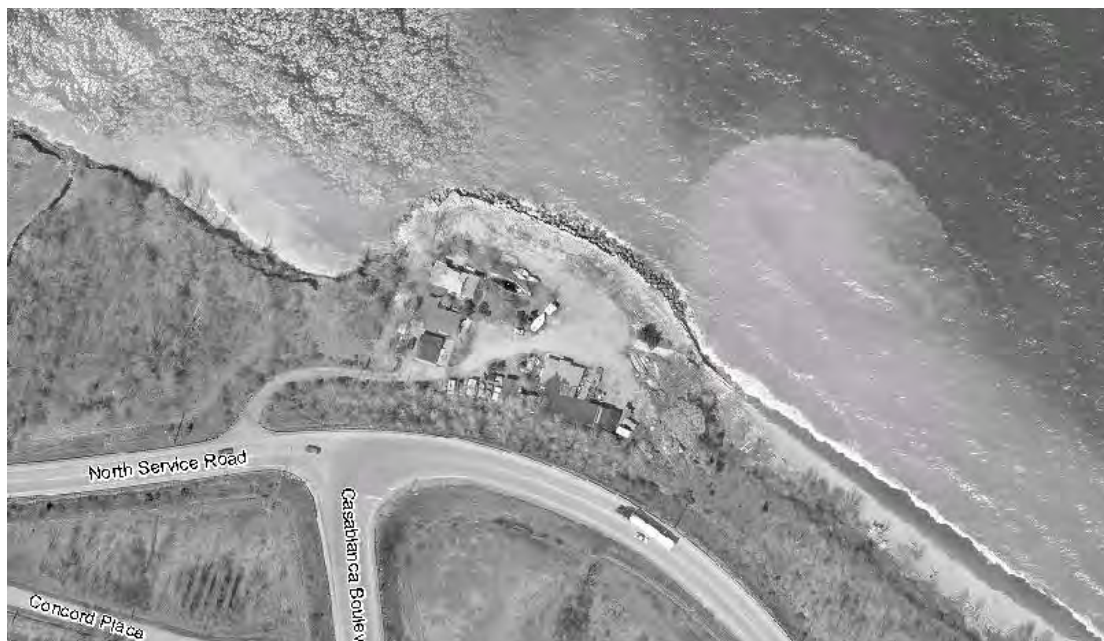
Figure 6.23 Outflanking of Shoreline Protection (left hand side; Reach 2 at Casablanca Blvd.)

The importance of coordinated, cooperative protection (see Figure 6. 22) was described in the 1994 LOSMP; individual efforts are often outflanked, reducing the effectiveness and design life of the protection. Figures 6.23 and 6.24 provide examples of shoreline protection being outflanked, with recession continuing at the adjacent shoreline.

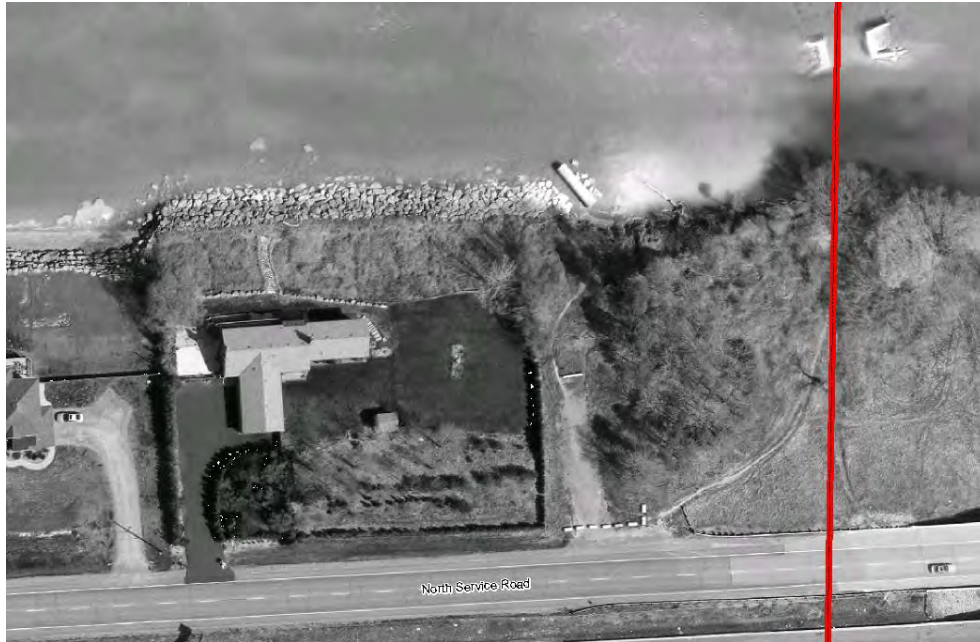
Figure 6.24 Outflanking of Shoreline Protection (right hand side; 13th Street Road Allowance)
