LAKE ERIE NORTH SHORE WATERSHED PLAN

NOVEMBER 2010

NIAGARA PENINSULA CONSERVATION AUTHORITY
250 THOROLD ROAD WEST, 3RD FLOOR
WELLAND, ONTARIO L3C 3W2
(905) 788-3135
www.nPCA.ca

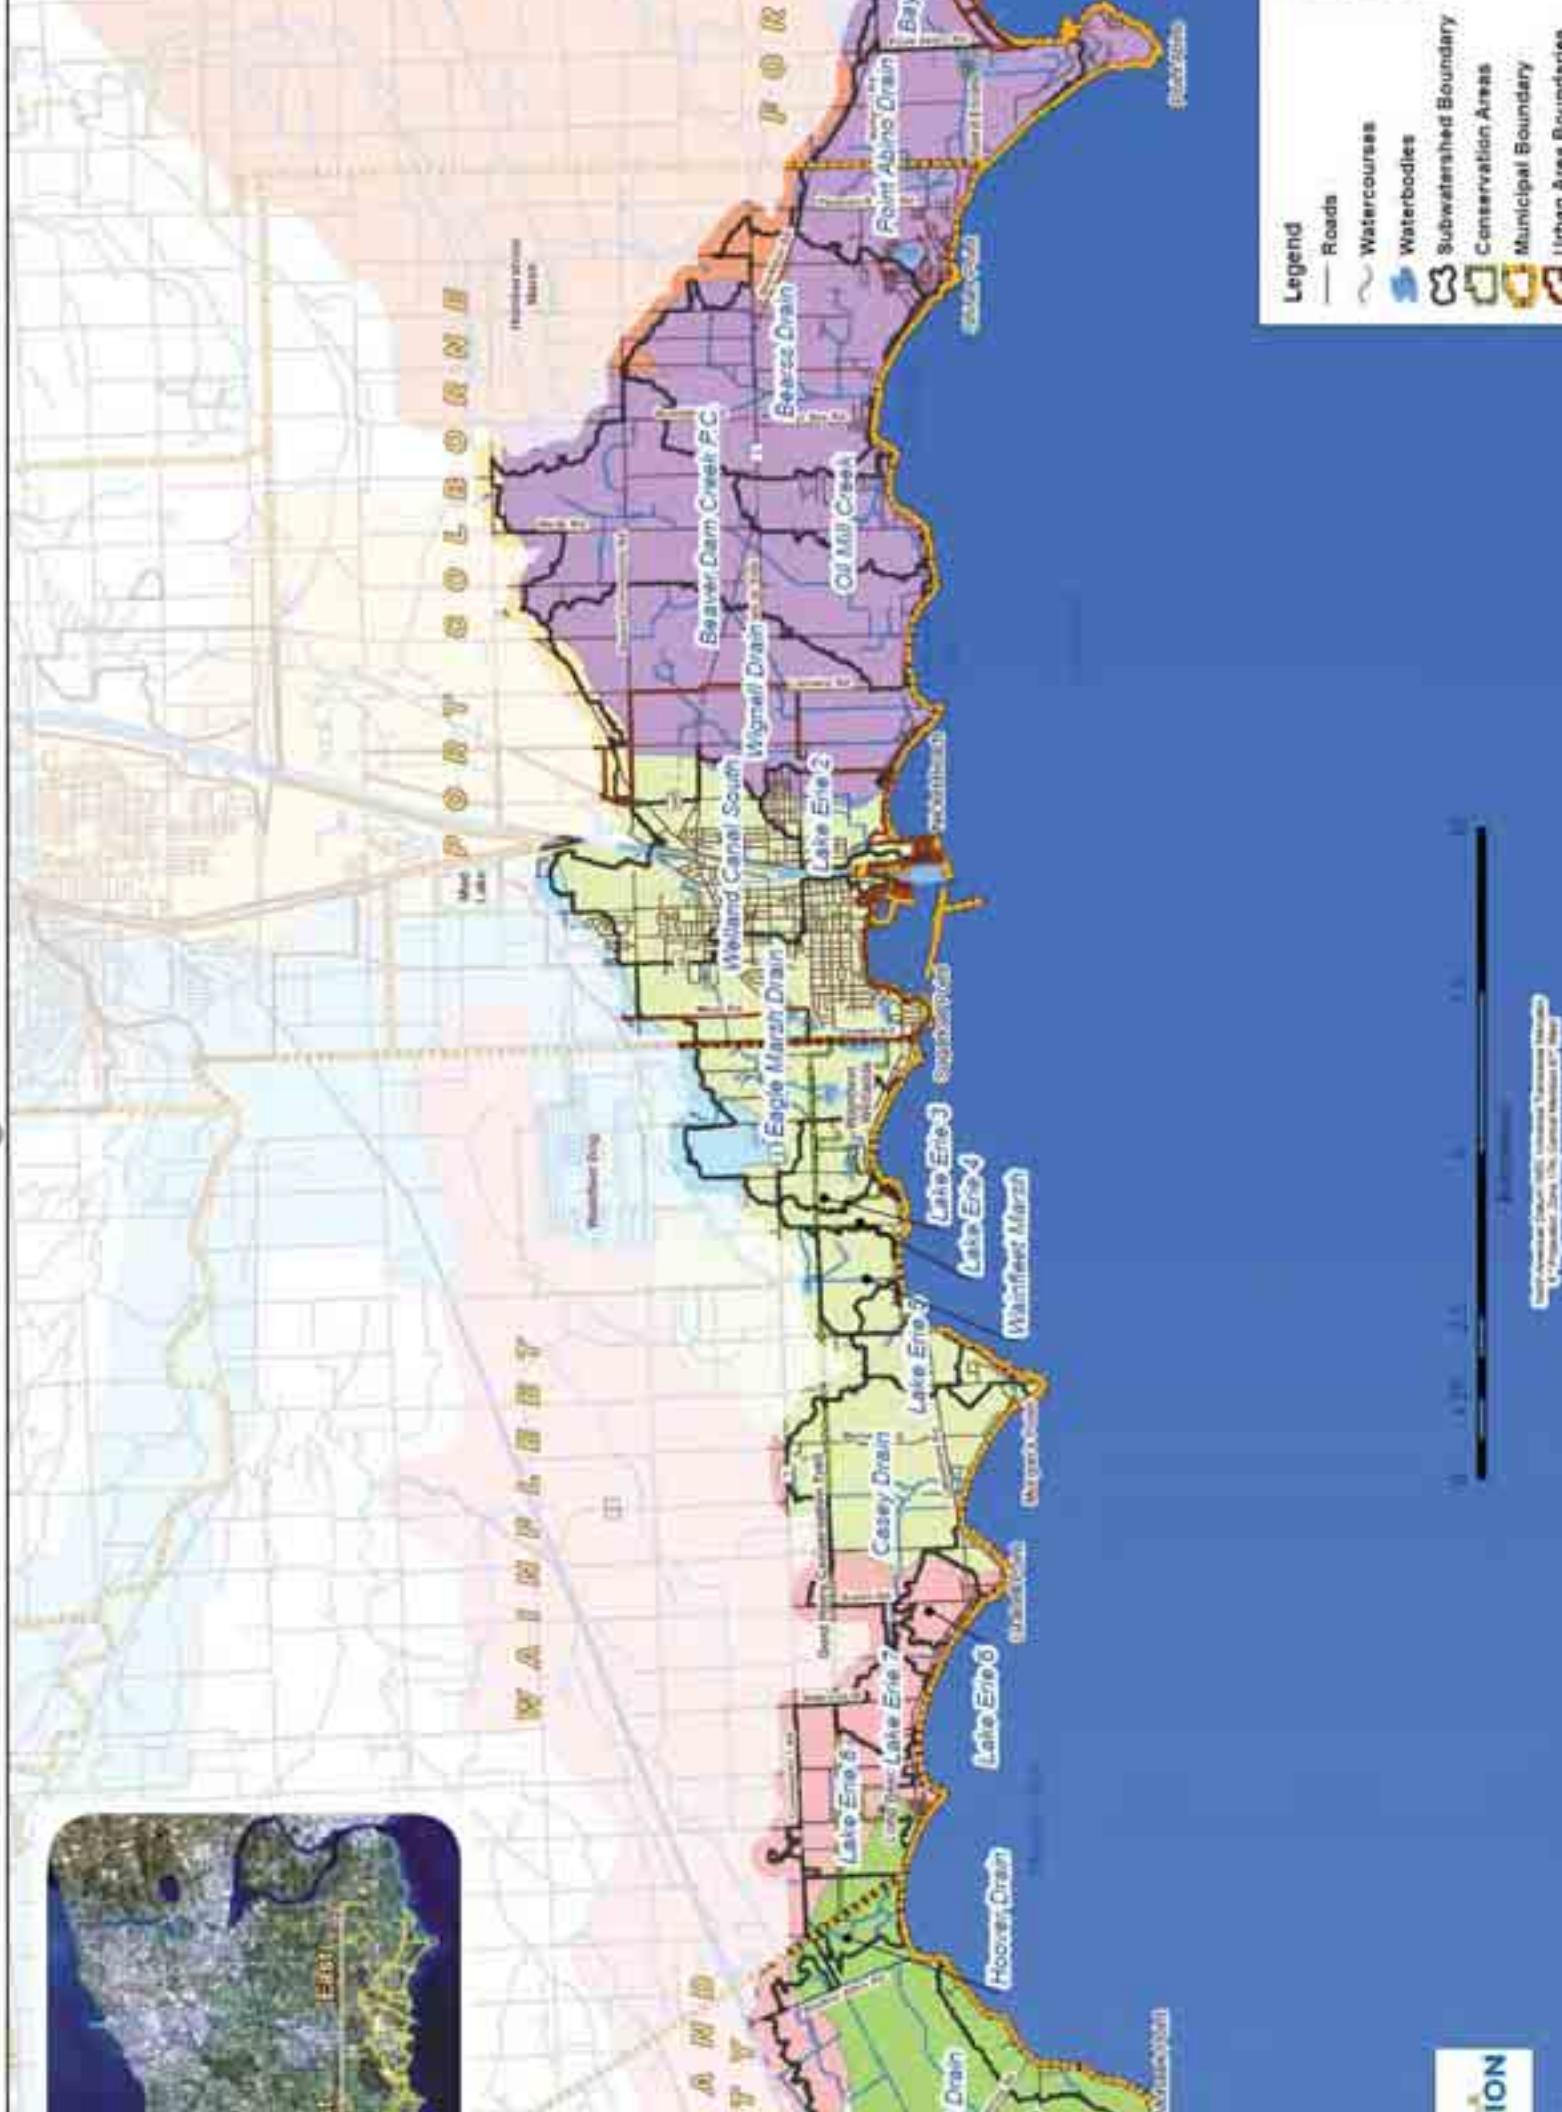
Local Management Areas

Local Management Area 3.1 extends along the shoreline from Low Banks in Haldimand County to Rock Island Point in Wainfleet and includes the subwatersheds Low Banks

The small portion of Local Management Area 2.9 that is included in the Lake Erie North Shore study area is nestled between LMA 3.1 and LMA 3.2 (Figure 3). It extends along the shoreline from Rock Island to Grabell Point in Wainfleet and includes Lake Erie 6 and Lake Erie 7 subwatersheds. The watercourses in this portion of the study area have not been evaluated in terms of importance for fish habitat.

Local Management Area 3.2 extends from Grabell Point in Wainfleet, eastward to the eastern side of the Welland Canal at Nickel Beach in Port Colborne (Figure 3). Subwatersheds included in this portion of the study area are Casey Drain, Wainfleet Marsh, Eagle Marsh Drain, Welland Canal South and Lake Erie 2, 3, 4, and 5. Casey Drain, Eagle Marsh Drain, Lake Erie 3 and a portion of the Welland Canal (old route) have all been identified as important fish habitat. A portion of Eagle Marsh Drain has been designated as critical fish habitat and the Welland Canal has been designated as marginal fish habitat; the remaining watercourses in this area have not been evaluated in

Local Management Area 3.3 extends from the eastern side of the Welland Canal at Nickel Beach in Port Colborne to the eastern side of Crystal Beach in Fort Erie; the eastern extent of the Lake Erie North Shore watershed study area (Figure 3). Subwatersheds in this portion of the study area include Wignell Drain, Beaver Dam Creek P.C., Oil Mill Creek, Bearss Drain, Point Abino Drain and Bay Beach Area Drain. Wignell Drain and most of Bearss Drain and Point Abino Drain have been identified as important fish habitat. In addition, a portion of Point Abino Drain and the shoreline area at Nickel Beach, Shisler Point and Crystal Beach have been designated as critical fish spawning habitat; the remaining watercourses in this area have not been evaluated in terms of importance for fish habitat. Aside from a couple of small tributaries, all of the watercourses in this portion of the study area are designated municipal drains.

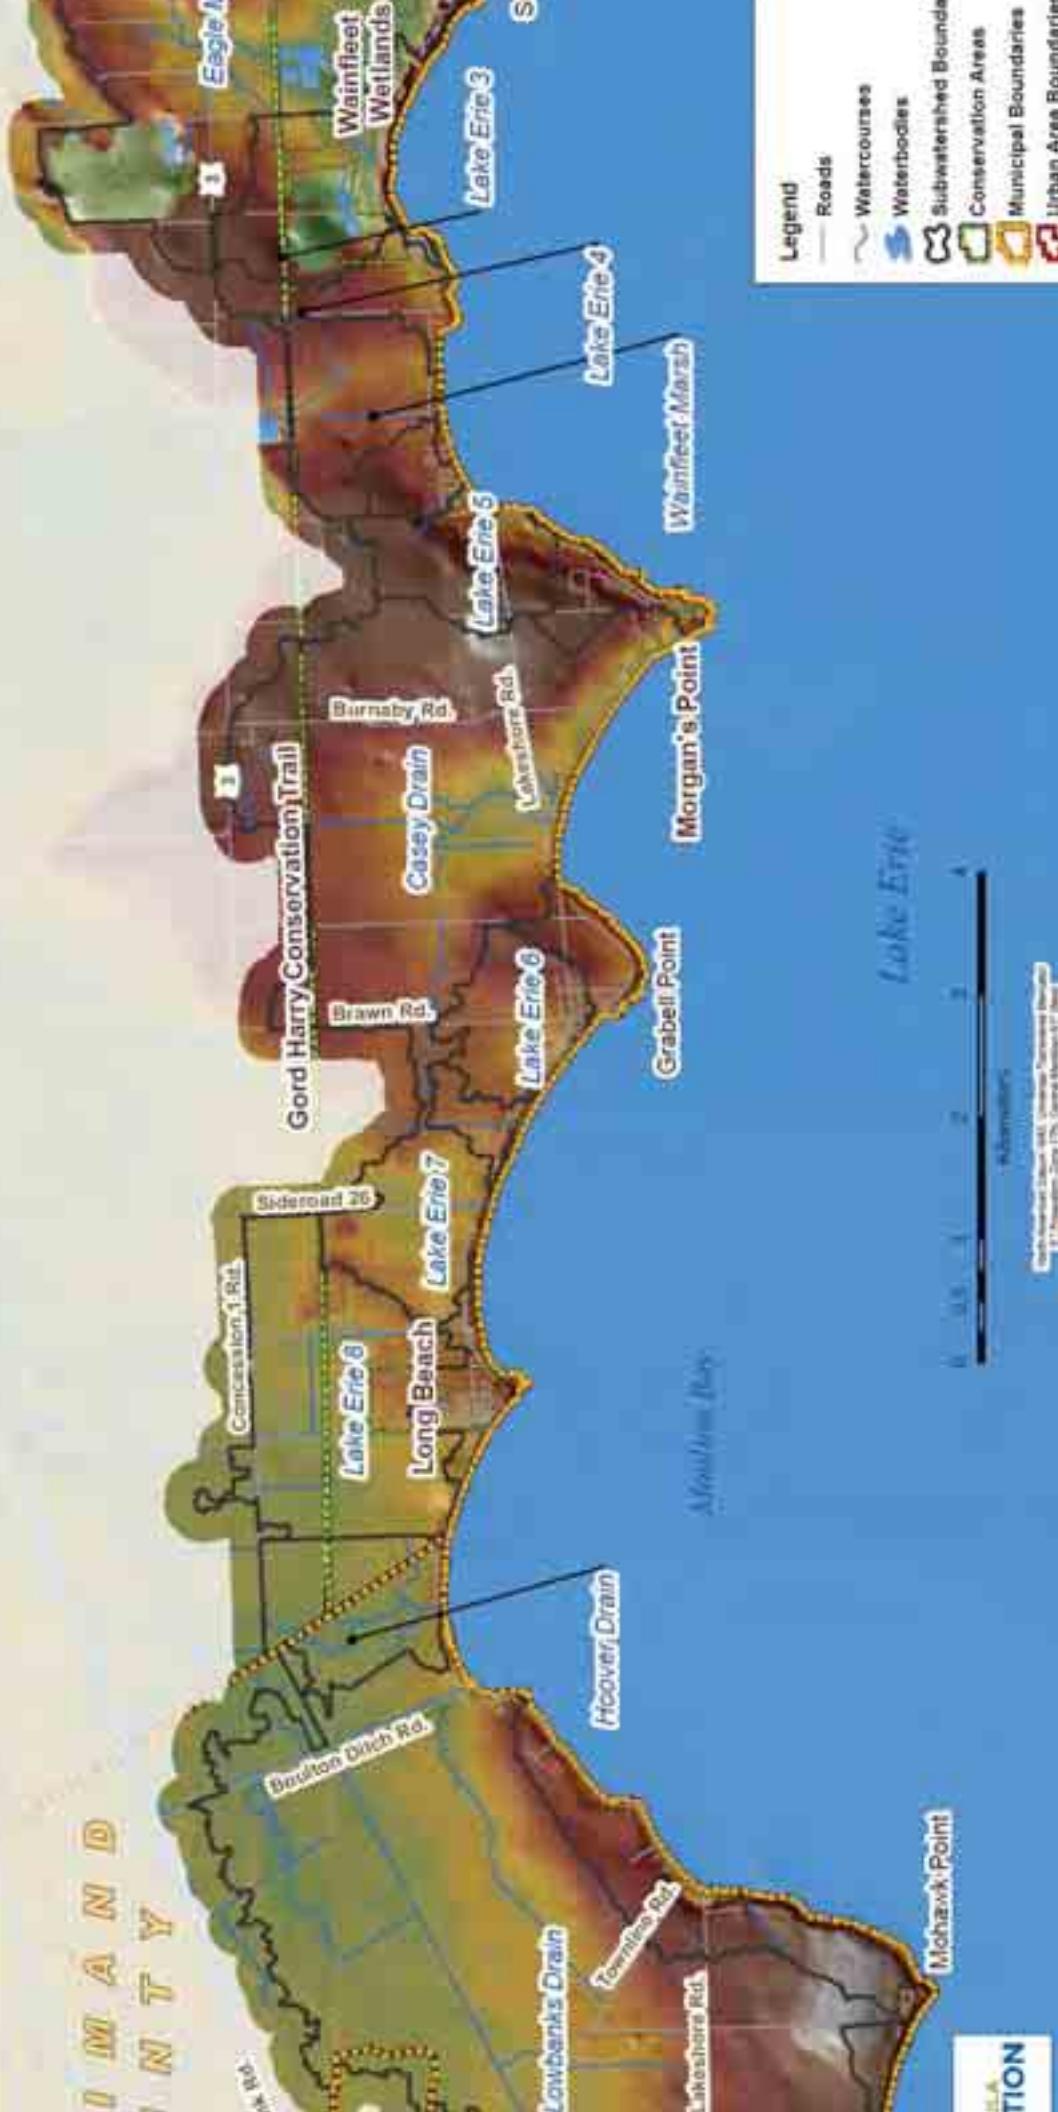
Topography

The low-lying, north-facing Onondaga Escarpment, which rarely reaches heights of more than a few meters, is the most prominent feature in the Lake Erie North Shore watershed. Aside from a few openings, the ridge of the Onondaga prevents drainage south towards Lake Erie, resulting in a wet and swampy landscape north of the Onondaga Escarpment. The shoreline of Lake Erie consists of a series of rocky headlands combined with bayhead beaches that exhibit broad sandy bays or rocky interfaces. The sandy bays and beaches are consistently found west of the headlands, while the rocky, more rugged coastal features are found at the tip or to the east of the headlands (Jackson 1967). The topography of the Lake Erie North Shore watershed is illustrated on Figures 4a and 4b.

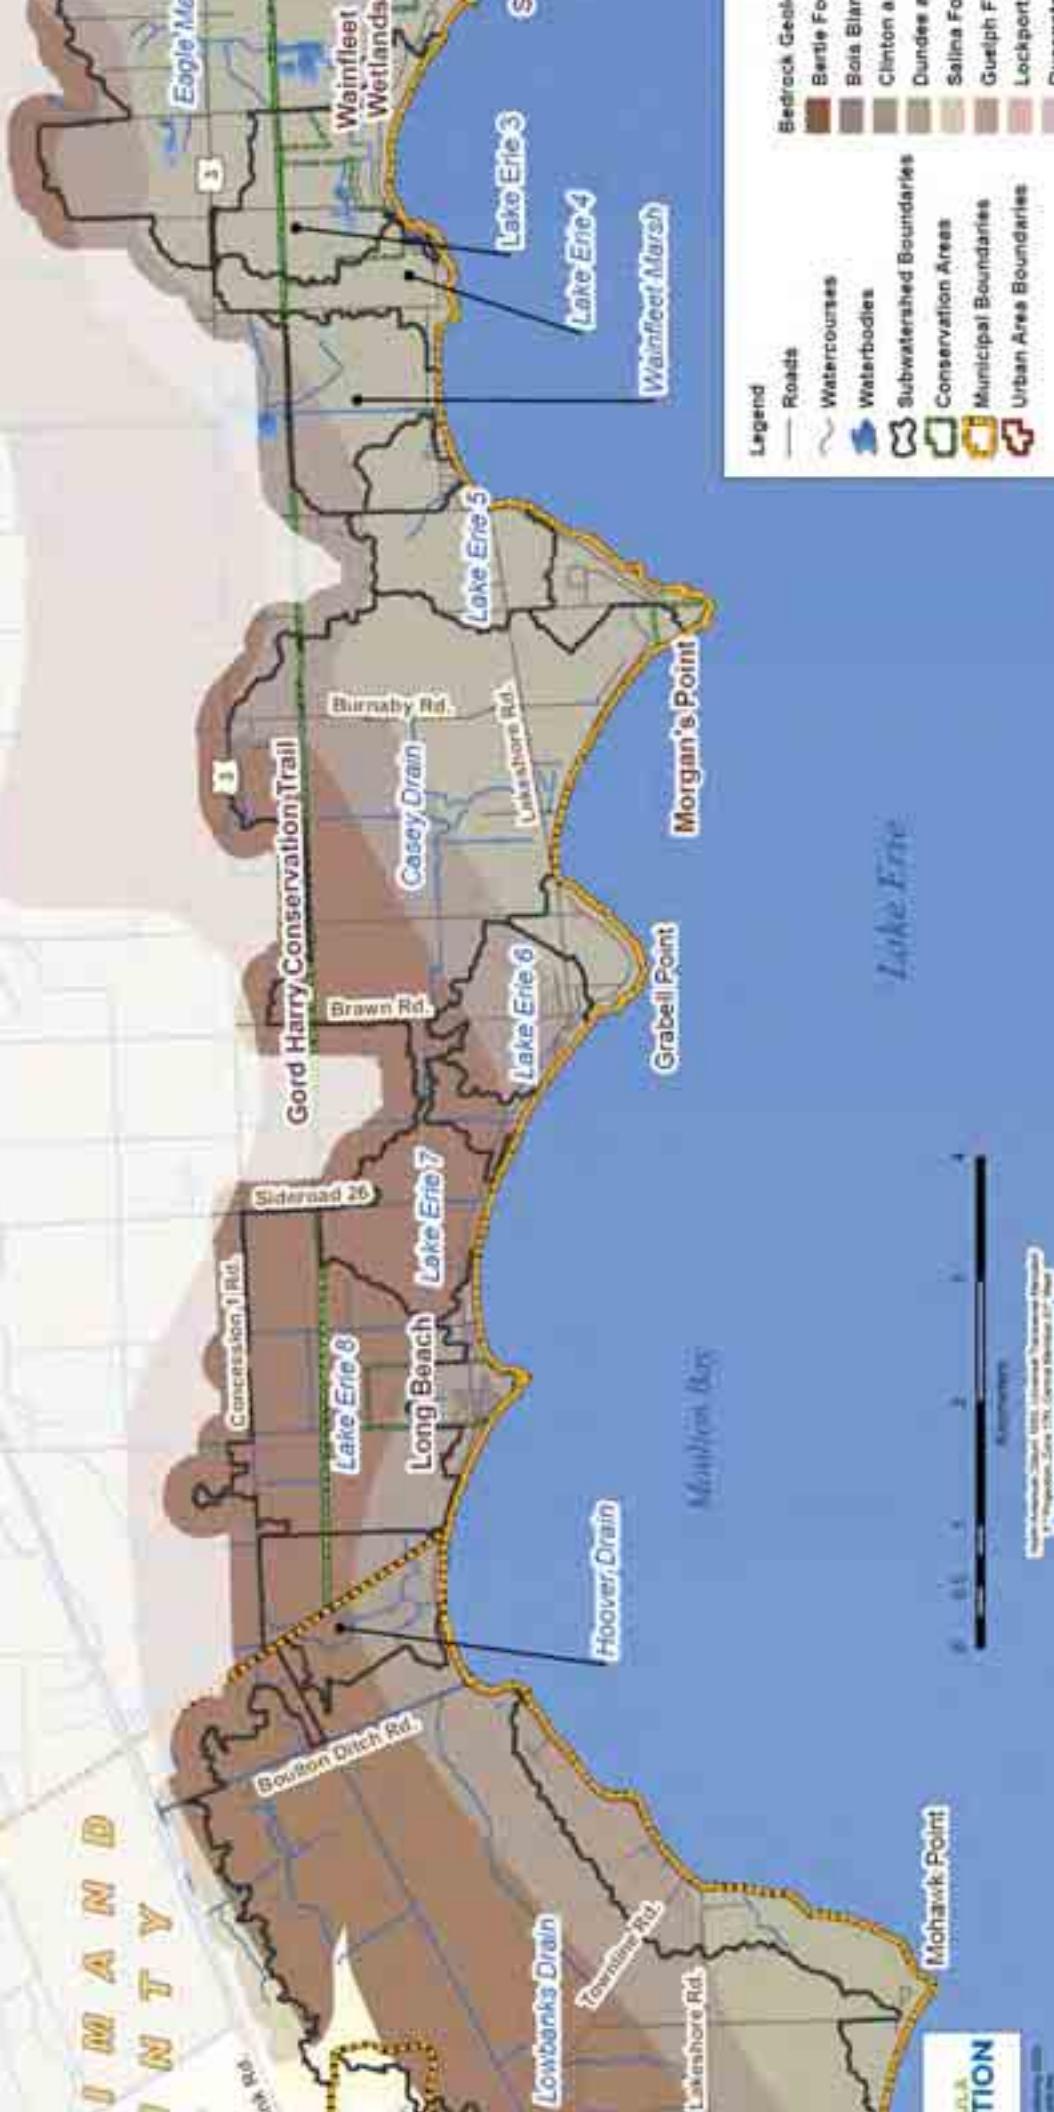
Bedrock Geology

The Lake Erie North Shore watershed study area is predominately overlain with bedrock from the Devonian period of roughly 350 million years ago; Onondaga Formation and Bois Blanc Formation. Although a small portion is overlain with bedrock from the end of the Silurian period roughly 410 million years ago; the Bertie Formation from which formed “*the main face of the erroneously named, Onondaga Escarpment*” (Armstrong 2007). The dolostones and shales of the Bertie Formation were deposited in very shallow water as the sea gradually withdrew from the Niagara Peninsula.

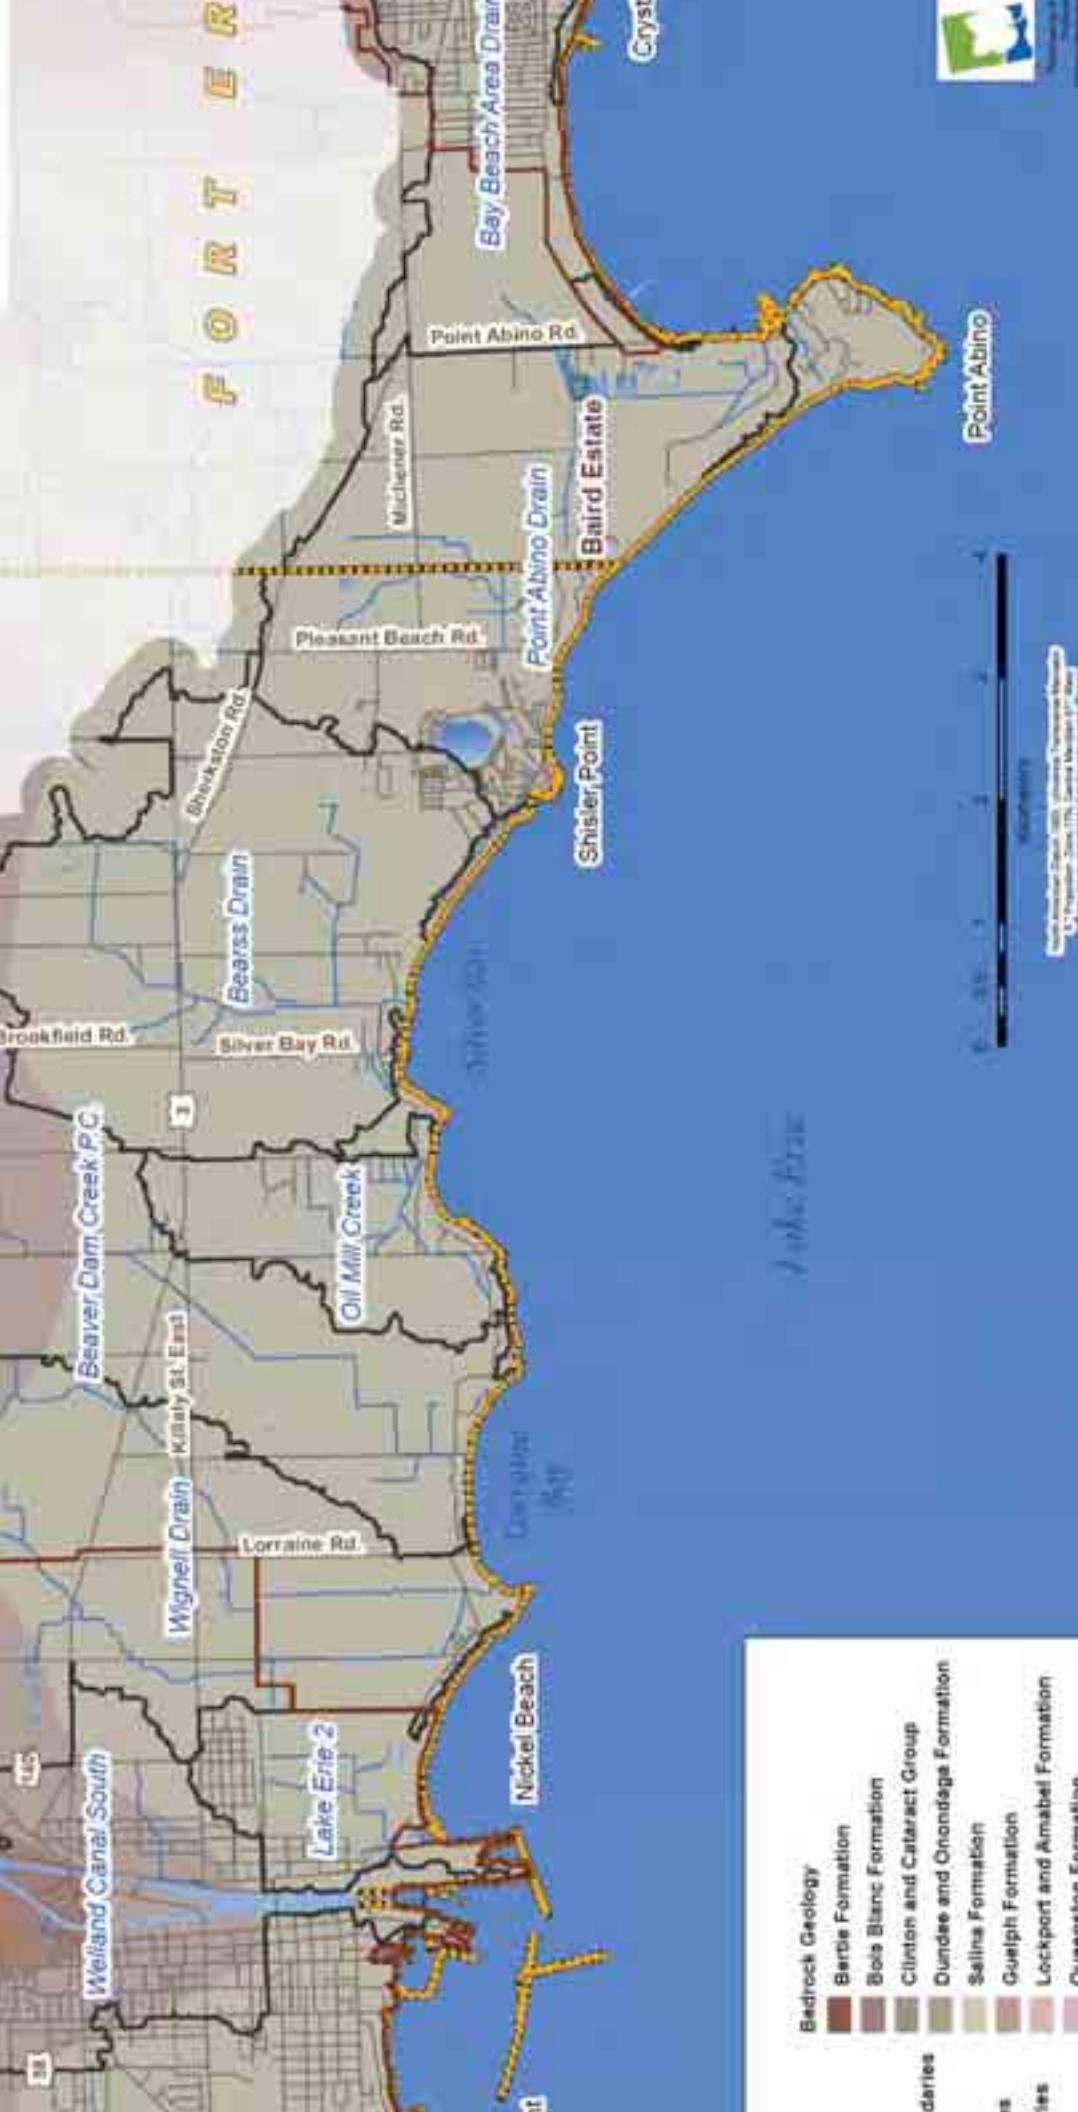
Physiography

Underlying rocks consist of a succession of Palaeozoic beds dipping slightly southward under Lake Erie (Chapman & Putnam 1984). Soft shales have been worn down in front of the hard limestone Onondaga Escarpment, forming a large depression. The overburden of soil materials increases southward from the Niagara Escarpment to a thickness depth nearing 45 meters over the wide buried bedrock valley called the Erigan Valley north of the Onondaga Escarpment. The Erigan Valley extends in a southwestwardly orientation from Fonthill towards Lake Erie cutting through the Onondaga Escarpment in the Moulton Bay area (Armstrong 2007). Southward of the Onondaga Escarpment, overburden remains relatively thin, ranging in thickness from 3 meters up to 15 meters near the shoreline.

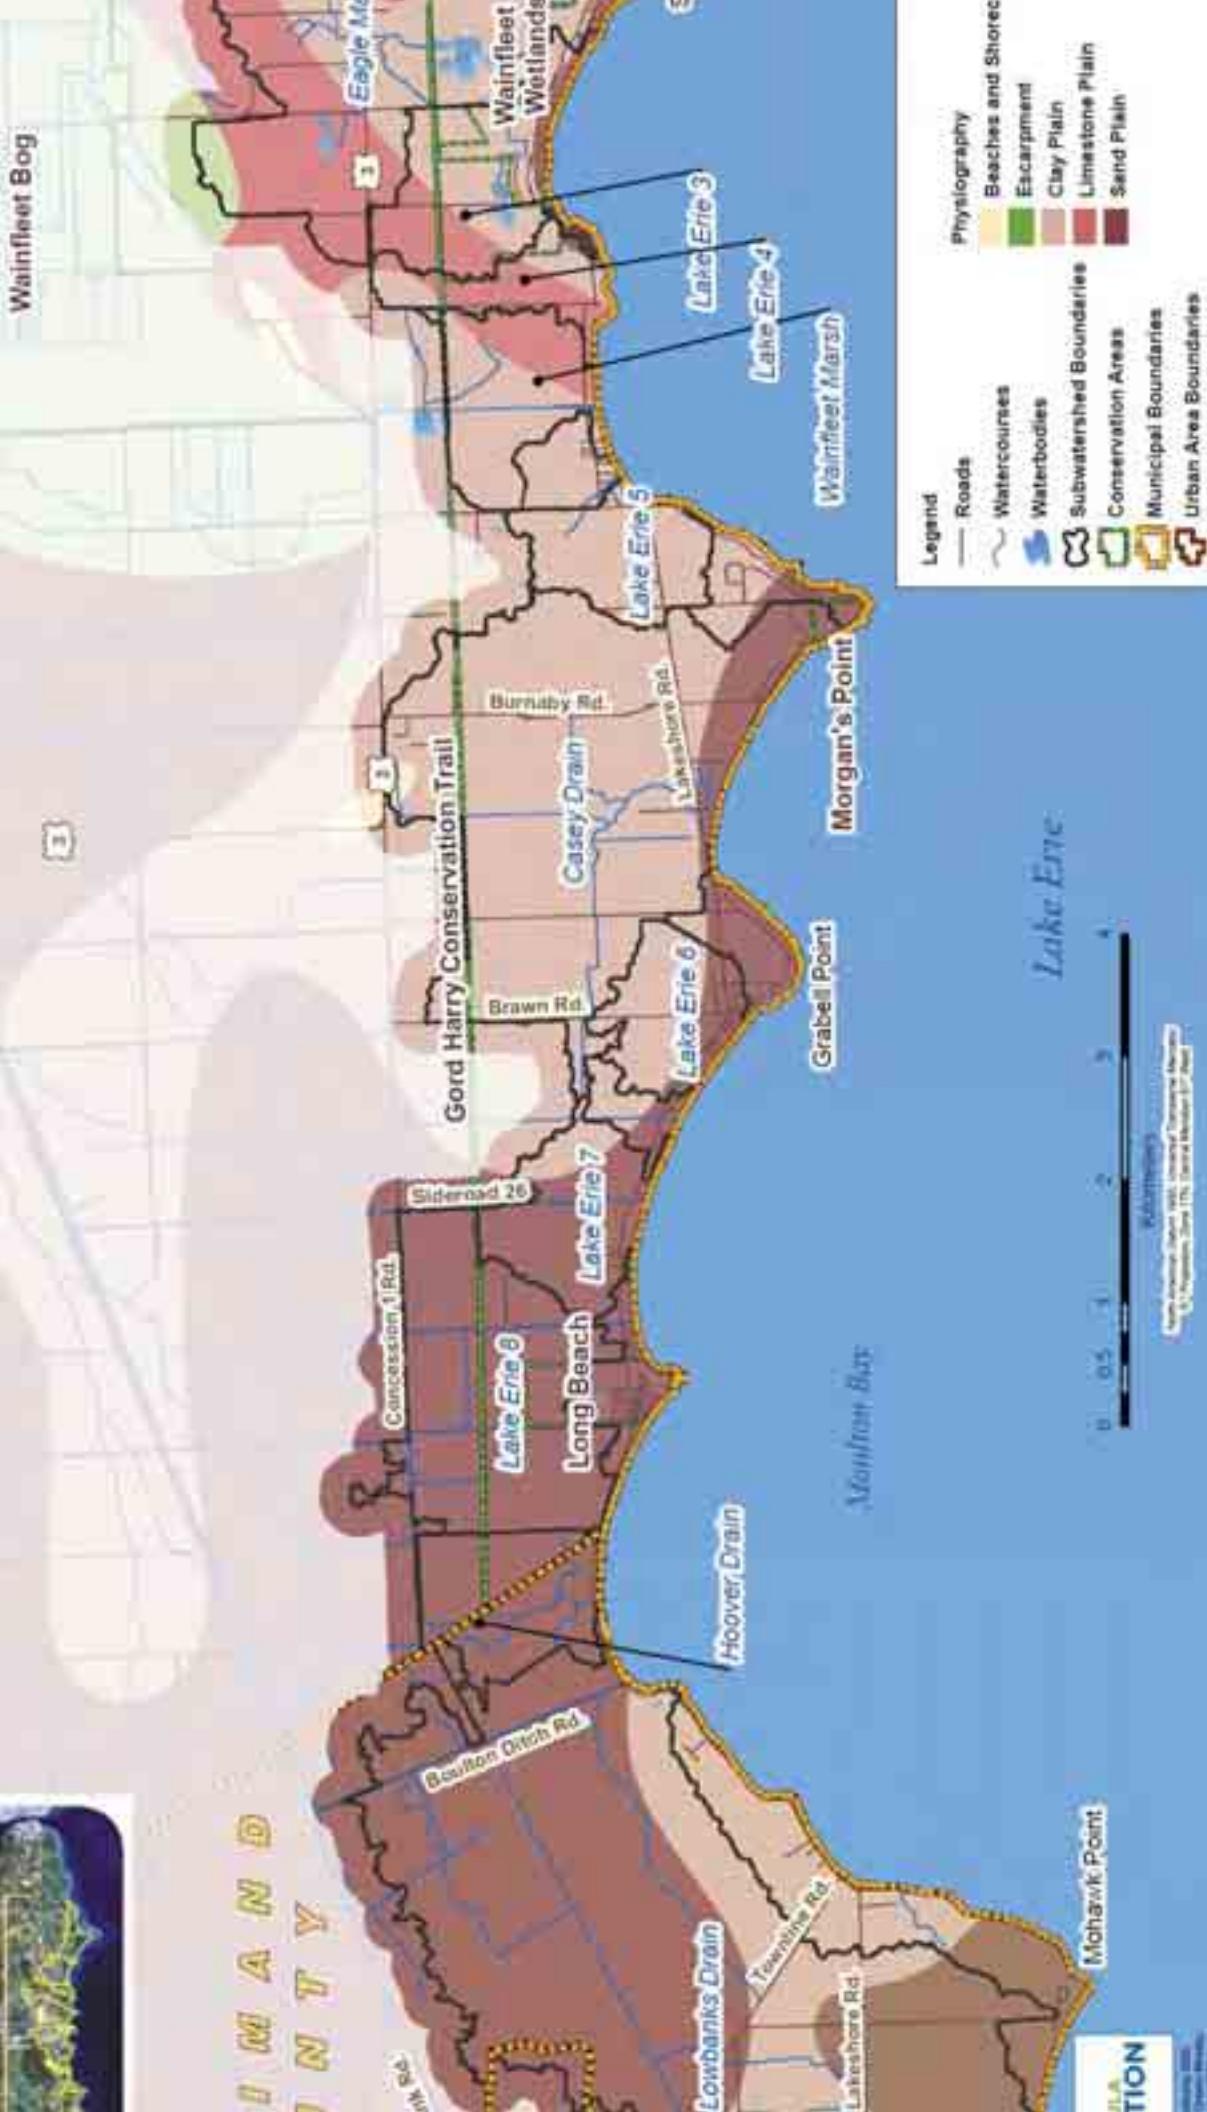
Physiography

The physiographic region of the Lake Erie North Shore watershed is the Haldimand Clay Plain which extends from the Niagara Escarpment to Lake Erie. The Haldimand Clay Plain was submerged by post-glacial Lake Warren and much of it is covered by lacustrine clay deposits; although not all till was covered such as the till moraine in Lowbanks.

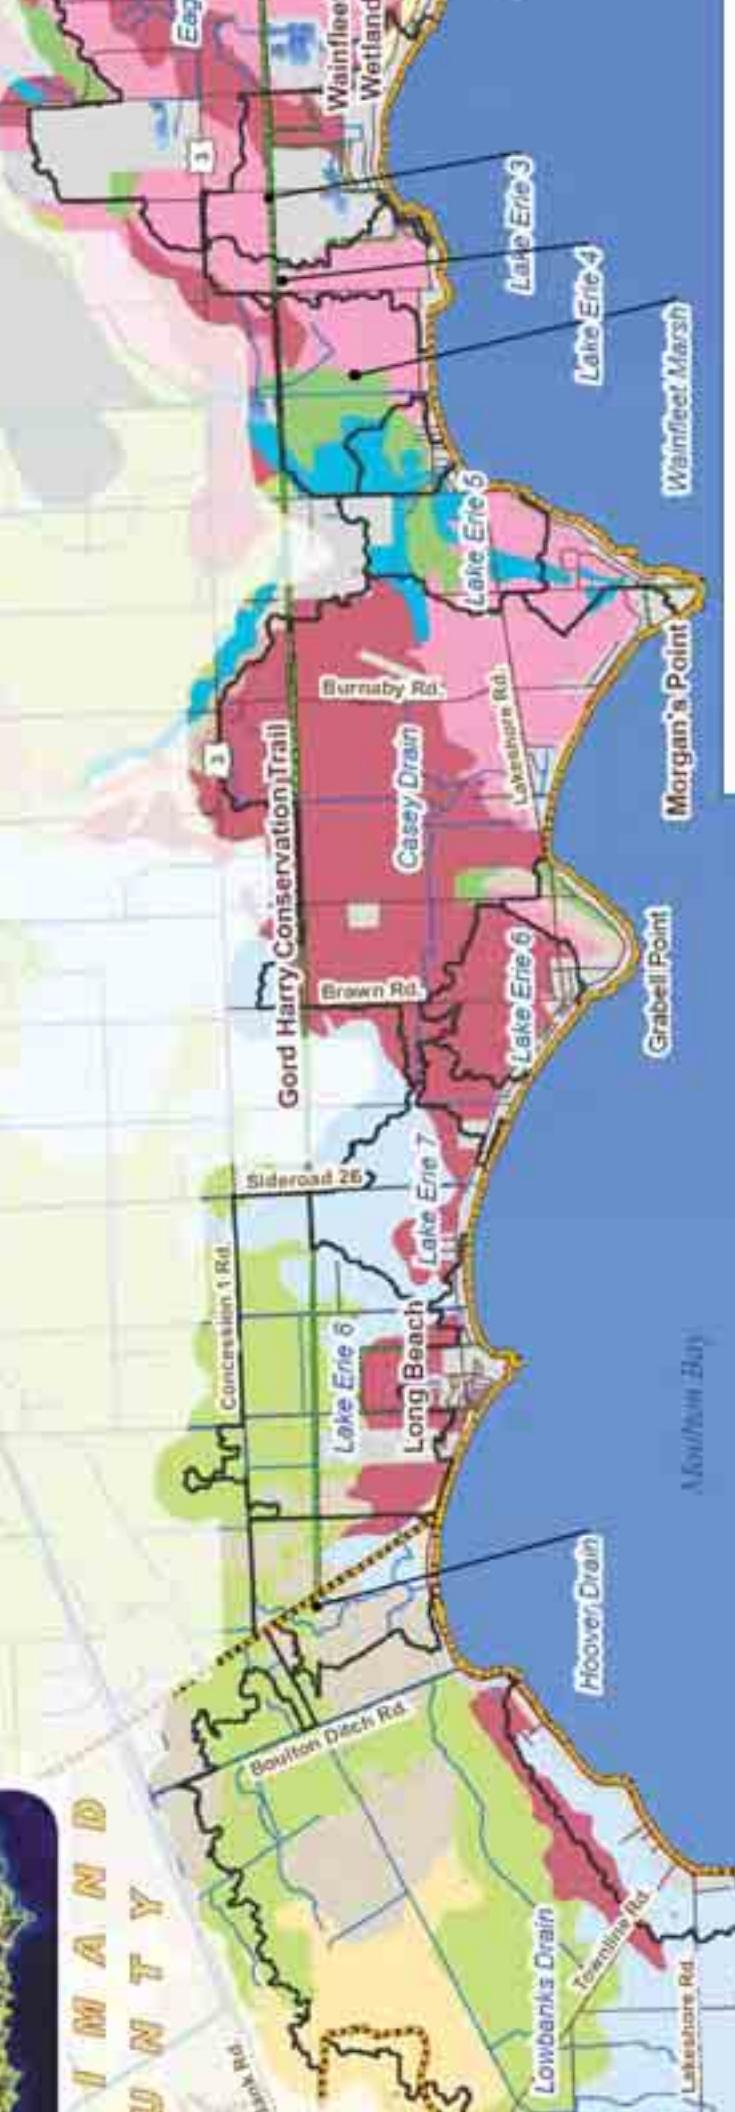
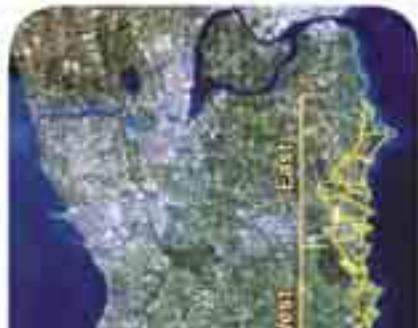
Lake Erie North Shore Watershed - East Soils

Numerous soil groups characterize the Lake Erie North Shore watershed; however, it is generally dominated by the poorly drained Welland and Brooke soil groups. Both soil groups have a high capacity to hold water and a slow to moderate rate of permeability, however, surface cracking increases the permeability of Welland soils during the summer months. Except for the drier period during the summer months, the groundwater level remains close to the surface in Welland soils, and although they have a high capacity to hold water, moisture availability for plants is limited at this time due to the soils high clay content. The combined problems associated with high clay contents and high water tables limit the use of this soil group for most agricultural crops. Welland soils are typically associated with Malton soils and Lincoln soils which like Welland soils, both groups have a high clayey texture, high water-holding capability and a perched water table. These soil groups are also generally limited to field crops if tile drained.

Soil Series	Geologic Deposits	Natural Drainage	Water Holding Capacity	Permeability	Surface Runoff	Class	Land use Comments
Mineral Soils							
Welland Soils (WLL)	Mainly reddish-hued deep water lacustrine heavy clay	Poor	Relatively High	Slow	Slow to Moderate	3WD, 4W, 5W	Range from unsuitable to poorly suitable for most fruit & vegetable crops
Malton Soils (MAT)	40-100cm clayey sediments over clay loam till	Poor	Relatively High	Slow	Slow	3W	Limited use for agriculture; artificial drainage recommended
Lincoln Soils (LIC)	Deep water lacustrine heavy clay	Poor	High	Slow	Slow to Rapid	3WD	Unsuitable for most horticultural crops
Brooke Soils (BOK)	Variable sediments 10-100cm over mainly limestone & dolostone bedrock	Poor	Fairly High	Moderate to Slow	Moderate	4W, 5W	Not suited for most agricultural uses due to shallowness to bedrock & poor drainage
Chinguacousy Soils (CGU)	Clay loam till	Imperfect	Relatively High	Moderate to Slow	Moderate to Rapid	2D	Widely used for growing common field crops

Jeddo Soils (JDD)	Clay loam till	Poor	Relatively High	Slow	Moderate to Rapid	3W	Over compaction is a serious management concern
Farmingtown Soils (FRM)	Variable sediments 10-100cm over mainly limestone & dolostone bedrock	Well	Variable	Good	Variable	3R, 4R	Little agricultural value due to shallow bedrock & droughtiness conditions
Plainfield Soils (PFD)	Eolian dunes, sand dunes	Rapid	Low	Rapid	Slow	3F	Limitations due to seasonal droughtiness, low fertility & pH problems
Organic Soils							
Quarry Soils (QRY)	Organic swamp sediments 40-160cm over loamy sediments	Very Poor	High	Rapid	Very Slow	2HL-3H	Extensive clearing & drainage necessary before suitable for agriculture
Lorraine Soils (LRR)	Organic fen sediments 40-160cm over clayey sediments	Very Poor	High	Rapid	Very Slow	2FHL-3FH	Extensive clearing & drainage necessary before suitable for agriculture
Portsmouth Soils (PUH)	Organic swamp sediments >160cm	Very Poor	High	Rapid	Very Slow	2FL-3F	Extensive clearing & drainage necessary before suitable for agriculture

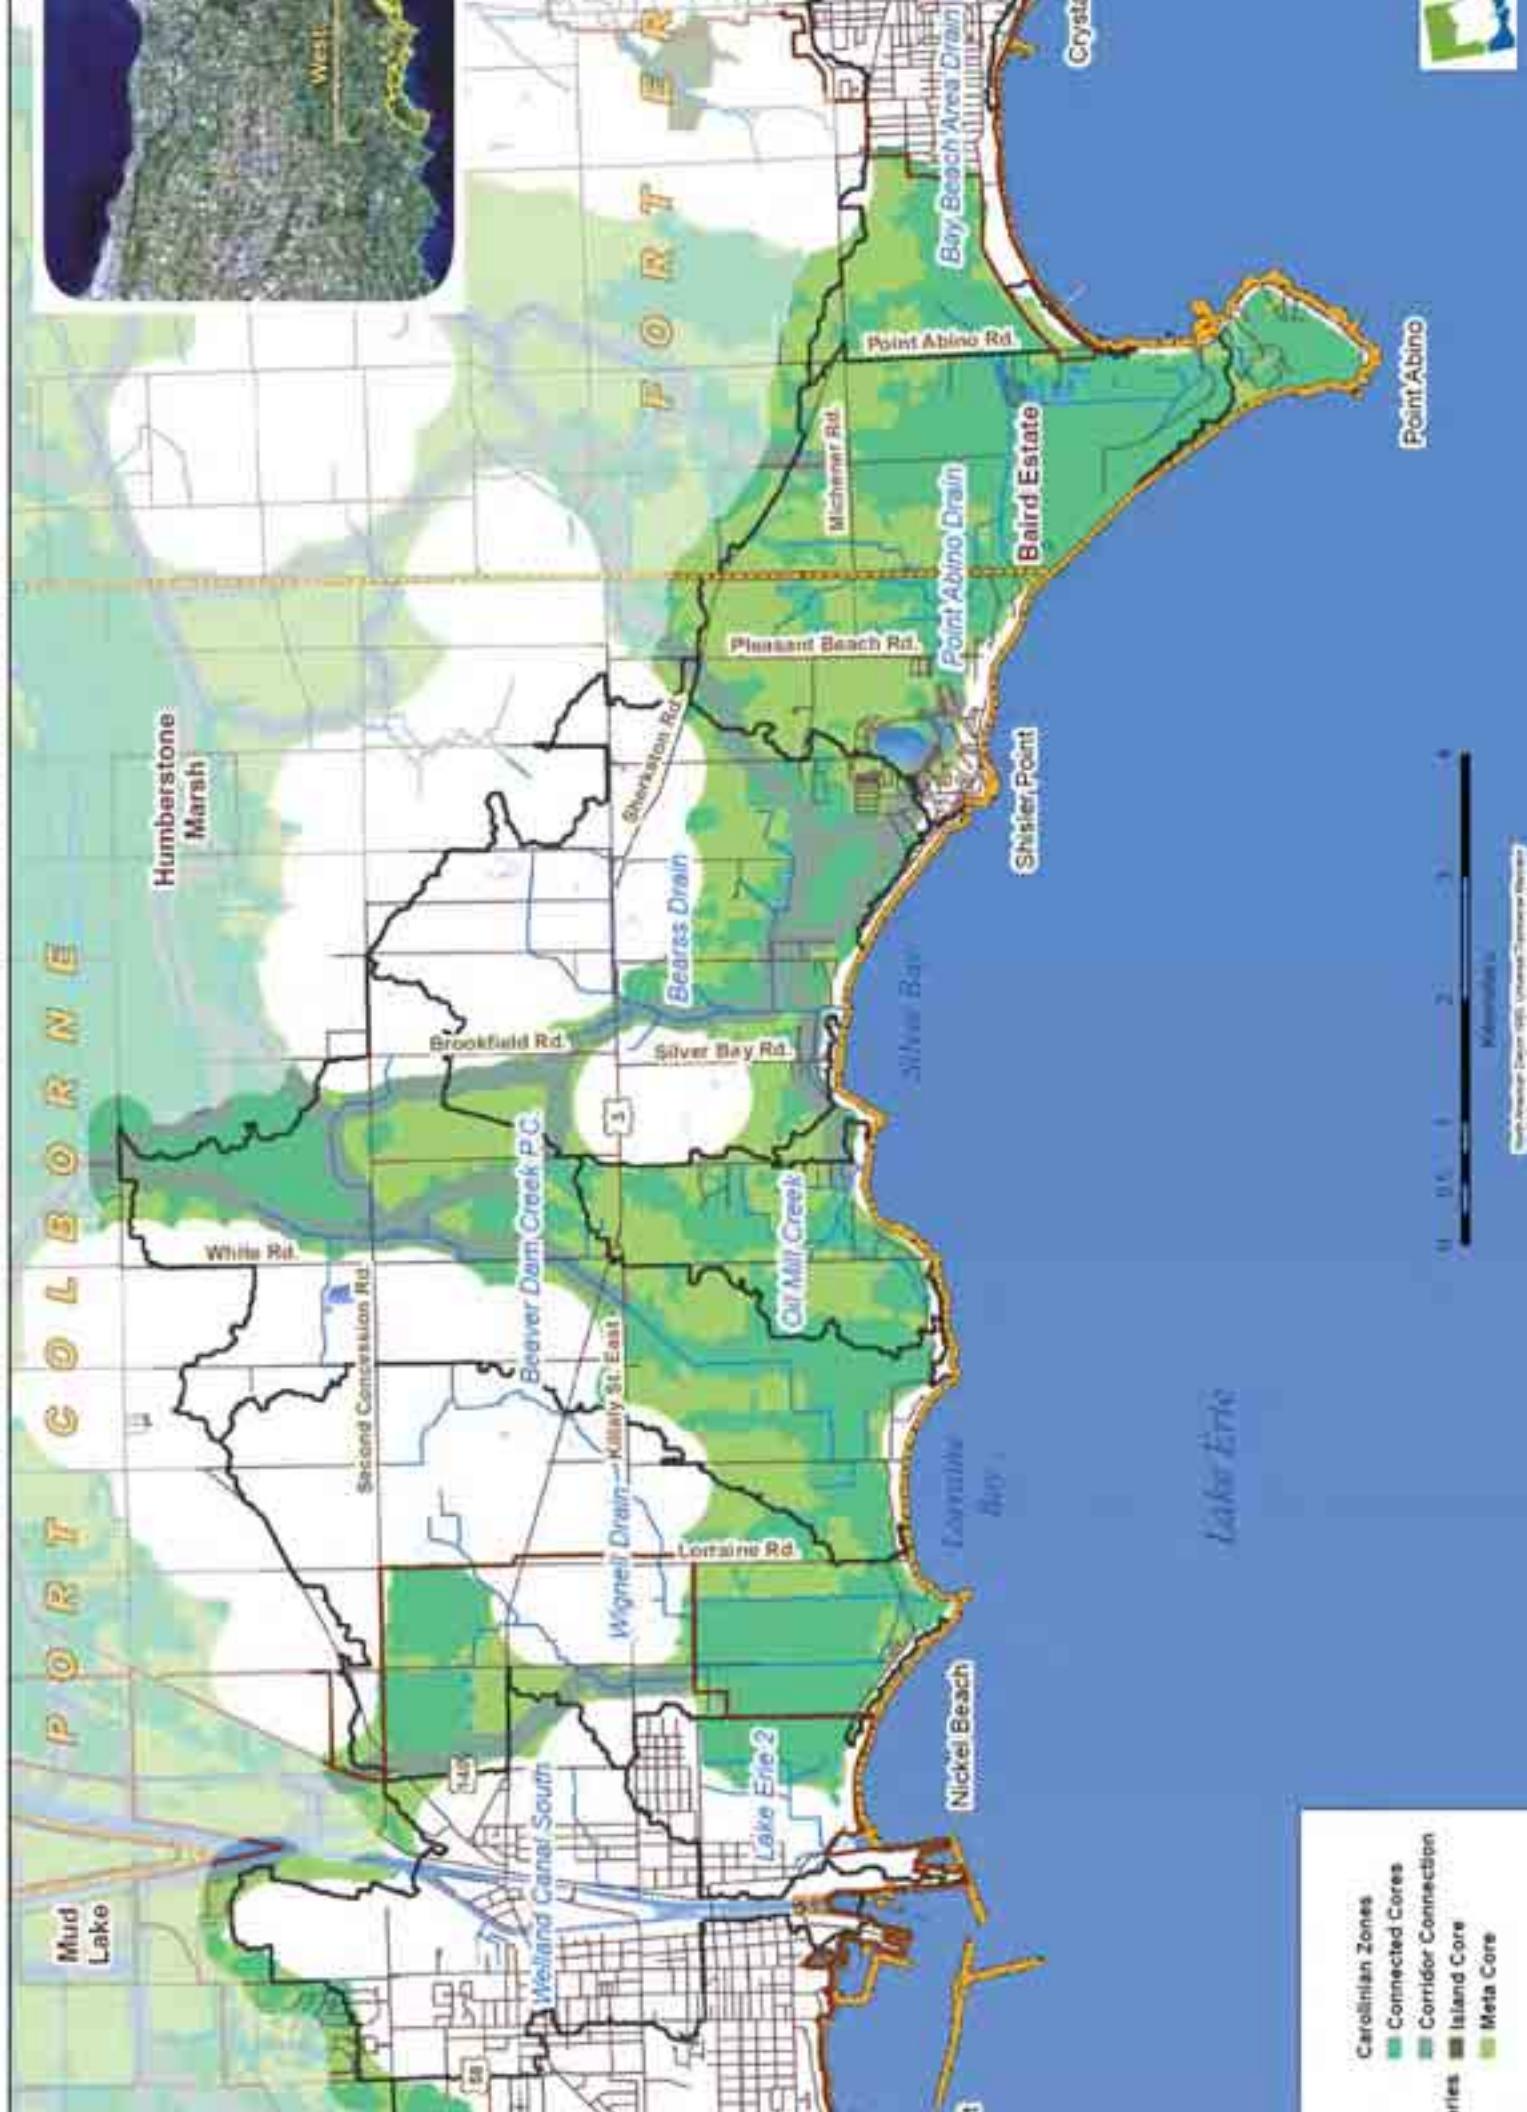
Cores and Connections of the Carolinian Zone

In southwestern Ontario, the Carolinian Life Zone is a rich and diverse network of cores and corridors that stretches from Toronto to Grand Bend extending southward to Lake Erie. Also known as the Eastern Deciduous Forest Region, this unique ecosystem boasts roughly one-third of Canada's rare and endangered species. Even though the Carolinian Life Zone makes up less than one percent of Canada's total land area, it contains a greater number of species than any other ecosystem in Canada and many of these species are not found anywhere else in the country (Johnson 2005). As part of its *Big Picture* project, Carolinian Canada identified considerable lands within the Lake Erie North Shore watershed as a „Carolinian Core Natural Area" (Figures 10a and 10b).

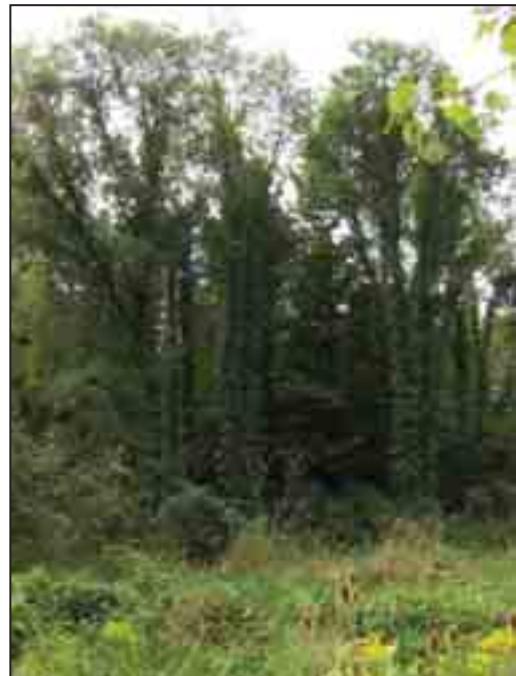
Humberstone Quarry (Port Colborne Quarry) Earth Science ANSI

The Humberstone Quarry has been designated as a provincially significant Area of Natural and Scientific Interest due to its excellent representation of the Bertie Formation. The bedrock in the quarry exhibits the contact between the Devonian (Bois Blanc Formation) and the Silurian (Bertie Formation) Palaeozoic periods. Present in the quarry, is an exposed sequence of Bertie dolostone and the presence of a major disconformity which can be traced throughout the Niagara Peninsula (MNR 1983).
