LAKE ERIE NORTH SHORE WATERSHED PLAN

NOVEMBER 2010

NIAGARA PENINSULA CONSERVATION AUTHORITY
250 THOROLD ROAD WEST, 3RD FLOOR
WELLAND, ONTARIO L3C 3W2
(905) 788-3135
www.nPCA.ca

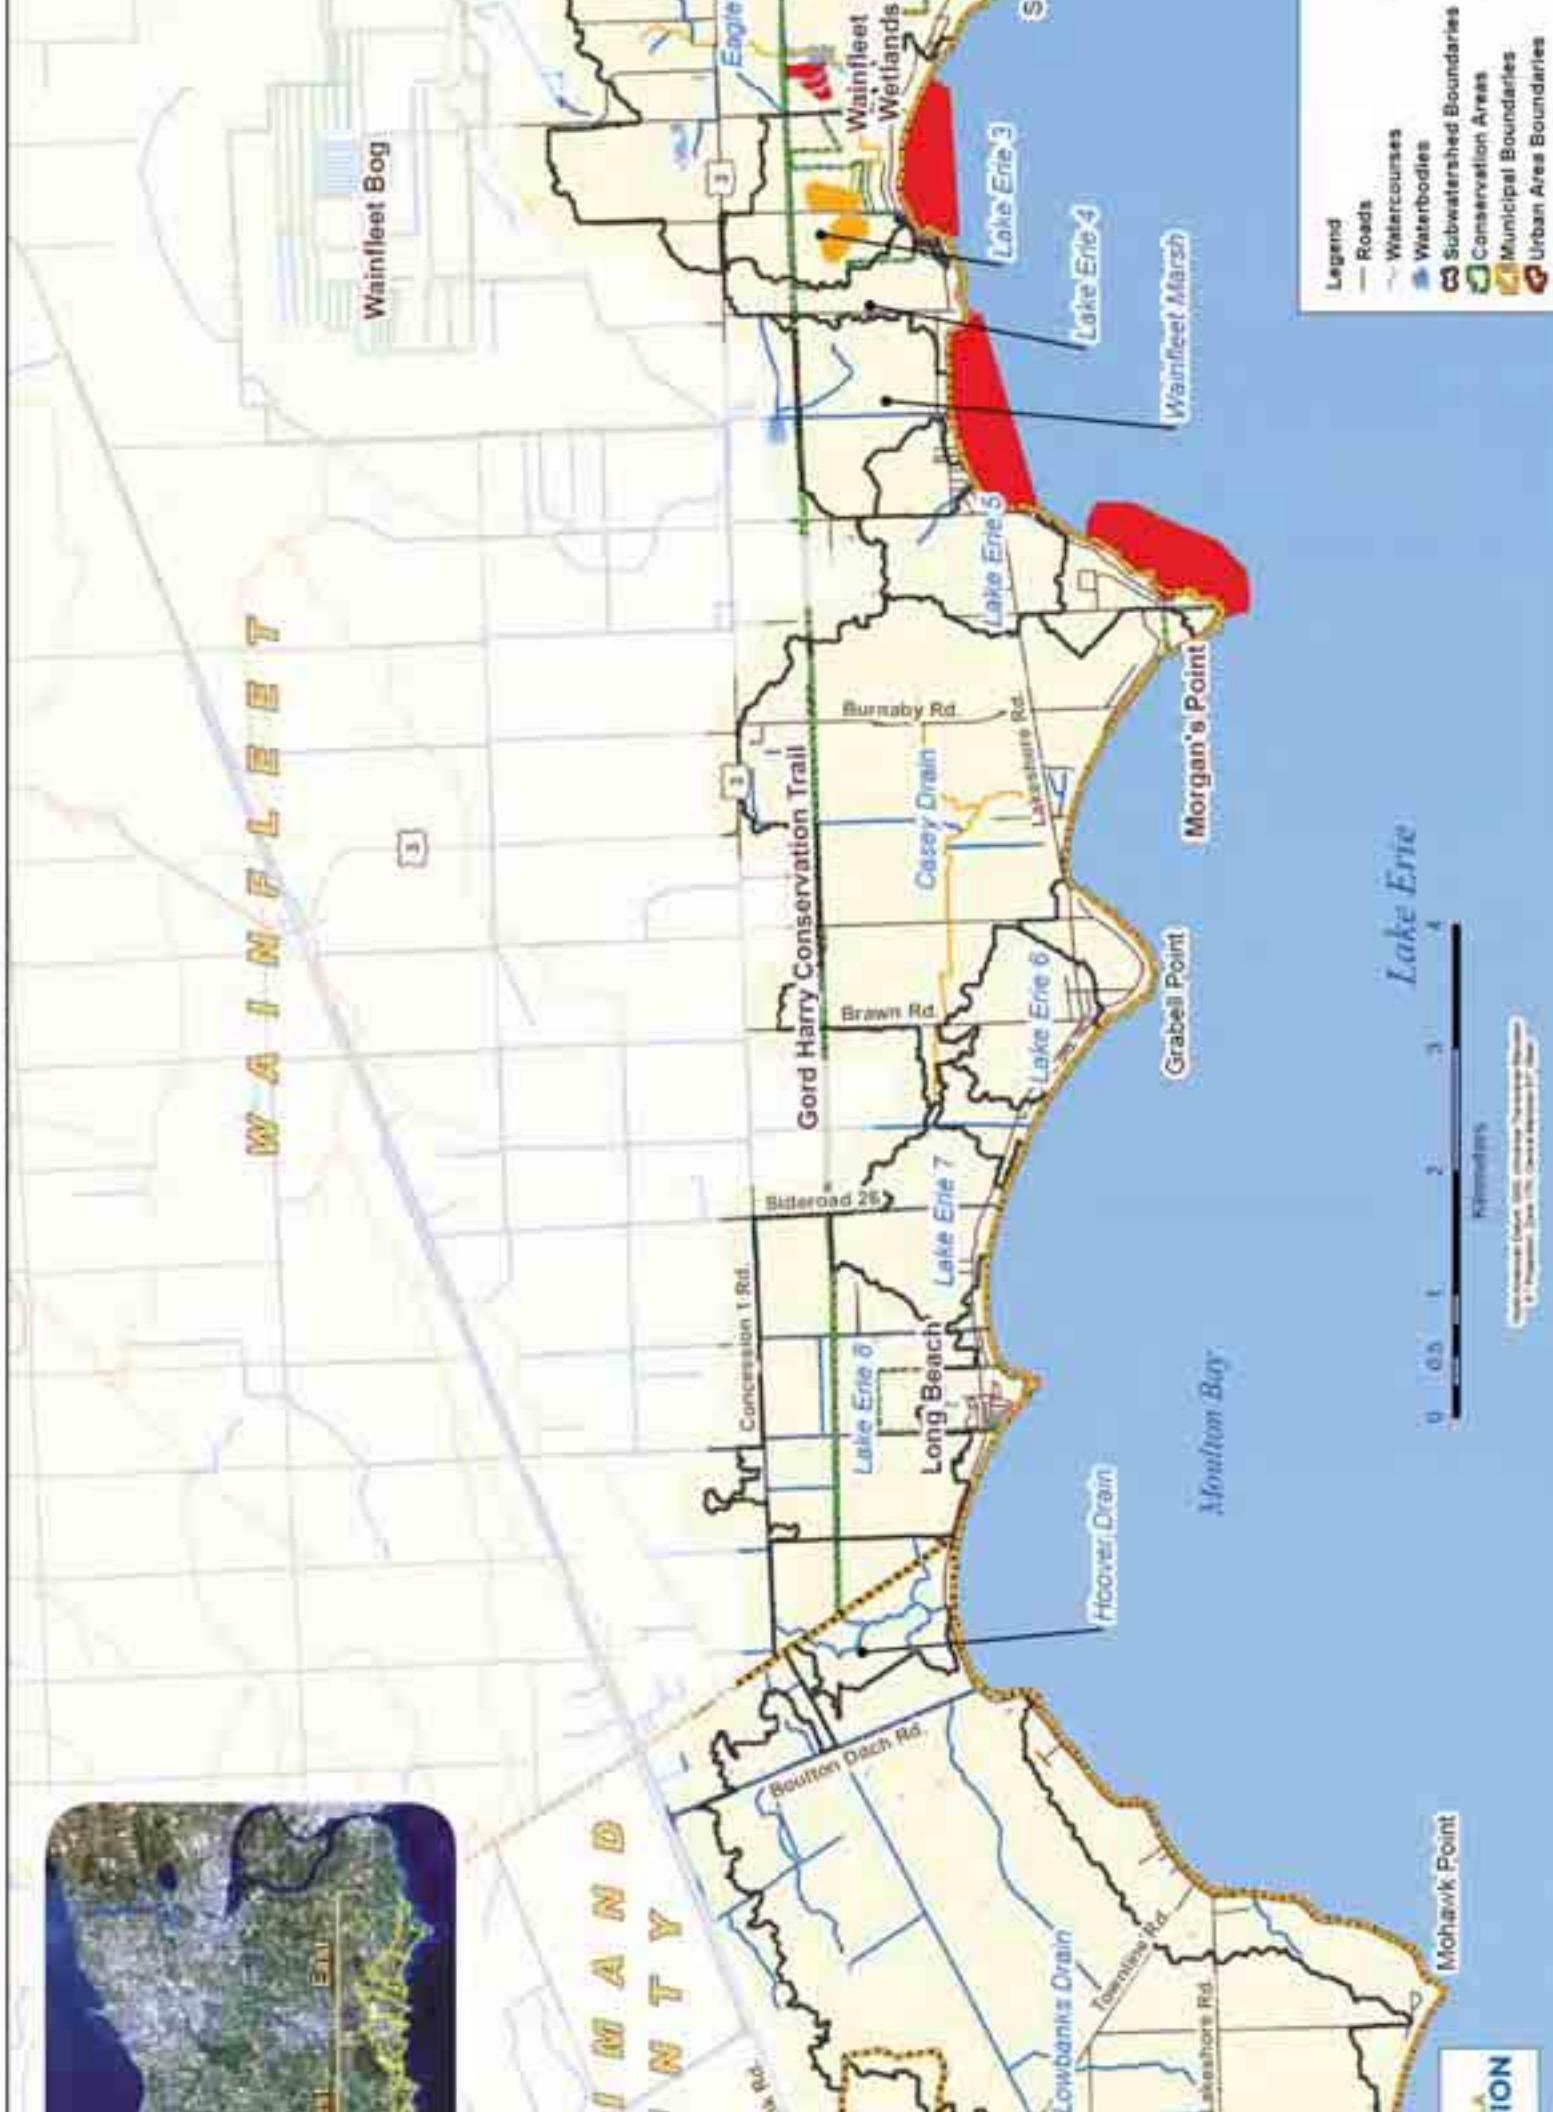
Fish Habitat

Lake Erie North Shore Watershed - West

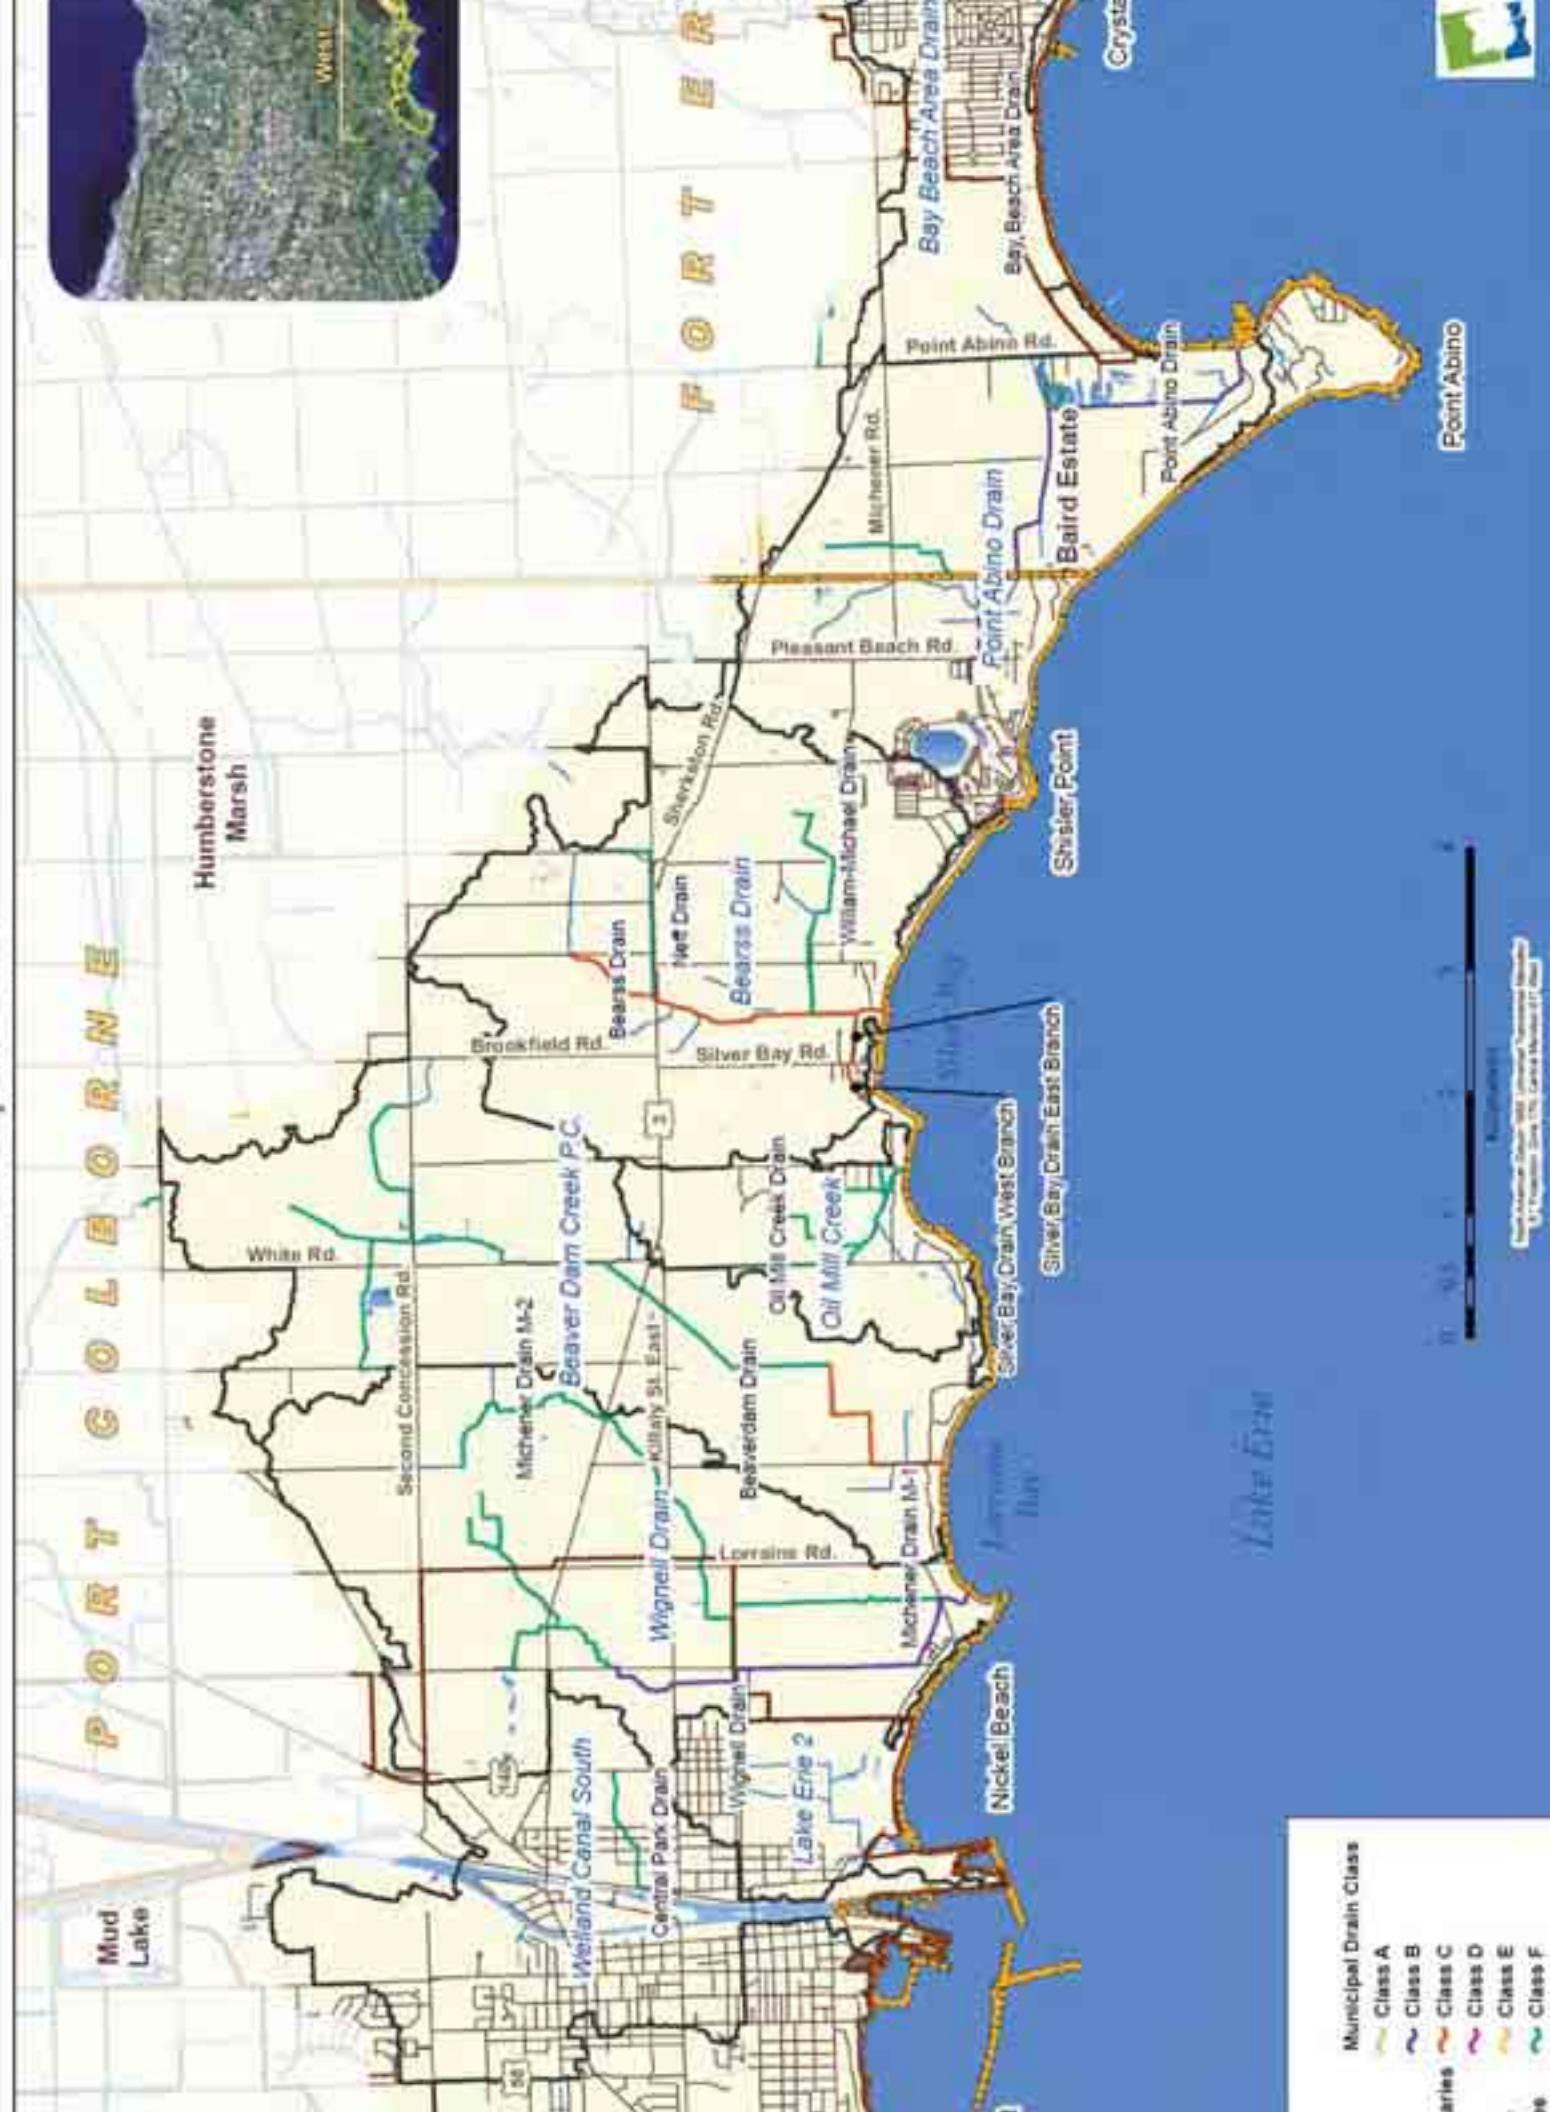
Municipal Drains

Lake Erie North Shore Watershed - East

Municipal Drain Class
Class A
Class B
Class C
Class D
Class E
Class F

A large quantity of municipal drains are present in the Lake Erie North Shore watershed (Figures 15a and 15b). Even though their purpose is to remove excess water from the land, municipal and agricultural drains do contain fish habitat. To better manage these drains, Fisheries and Oceans Canada has developed a classification system that identifies municipal drains as Types A through F using variables such as flow conditions, temperature, fish species present, and the length of time since the last clean out (Fisheries and Oceans Canada No Date). For example, a Class A drain has permanent flow with cold or cool water temperature and no presence of trout or salmon present. A Type E drain also has a permanent flow with warm water temperatures and top predators (e.g., largemouth bass, northern pike, muskellunge and crappie) present in the drain. Type F drains are characterized by intermittent flow (Fisheries and Oceans Canada No Date). This classification system has been created for use by municipal drainage superintendents for the purpose of drain maintenance.

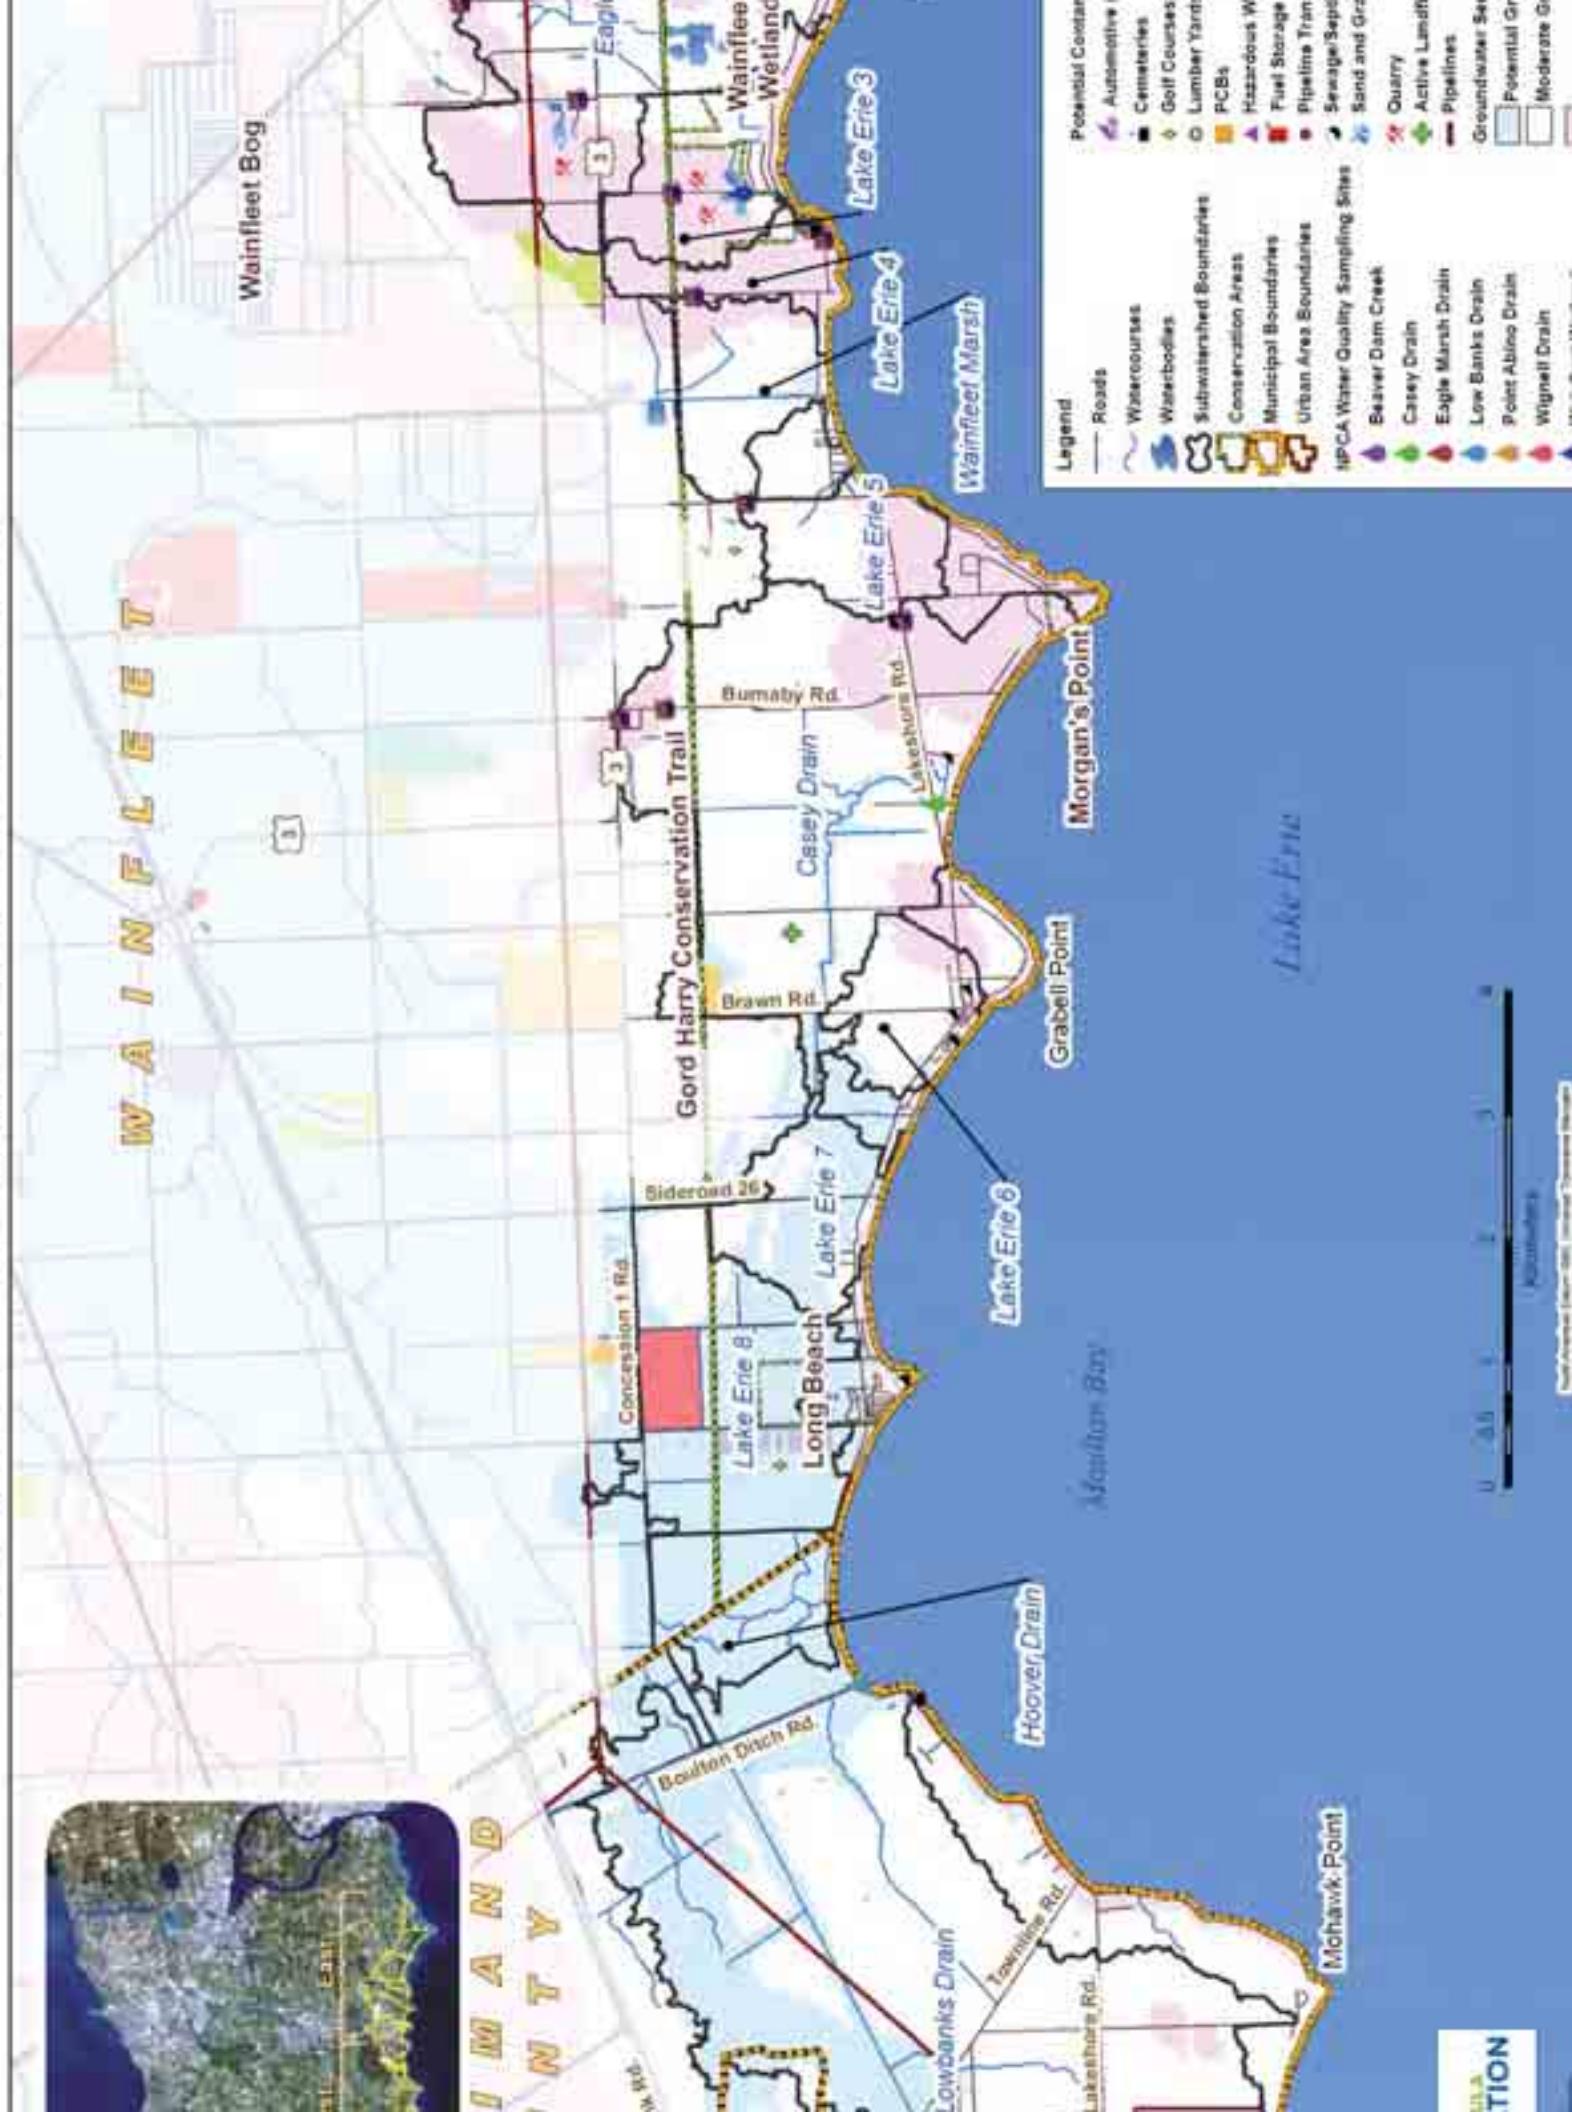
Water Quality Monitoring and Potential Contaminants

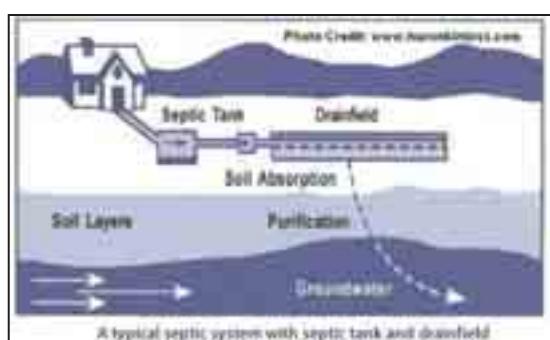
A well designed septic system can function properly for years. The basic design of a septic system includes a septic tank and a drainage field. Wastewater from toilets, bathtubs, sinks and other drains flow into the tank where bacteria that is naturally found in the wastewater breaks down any solid material. The liquid effluent travels through the perforated distribution pipes to the leaching bed. The water is then absorbed and filtered by the

ground in the drainage field. Problems with septic tanks often stem from improper use and maintenance. Faulty septic systems can create serious local contamination problems with the potential to contaminate groundwater wells (Pollution Probe 2004).

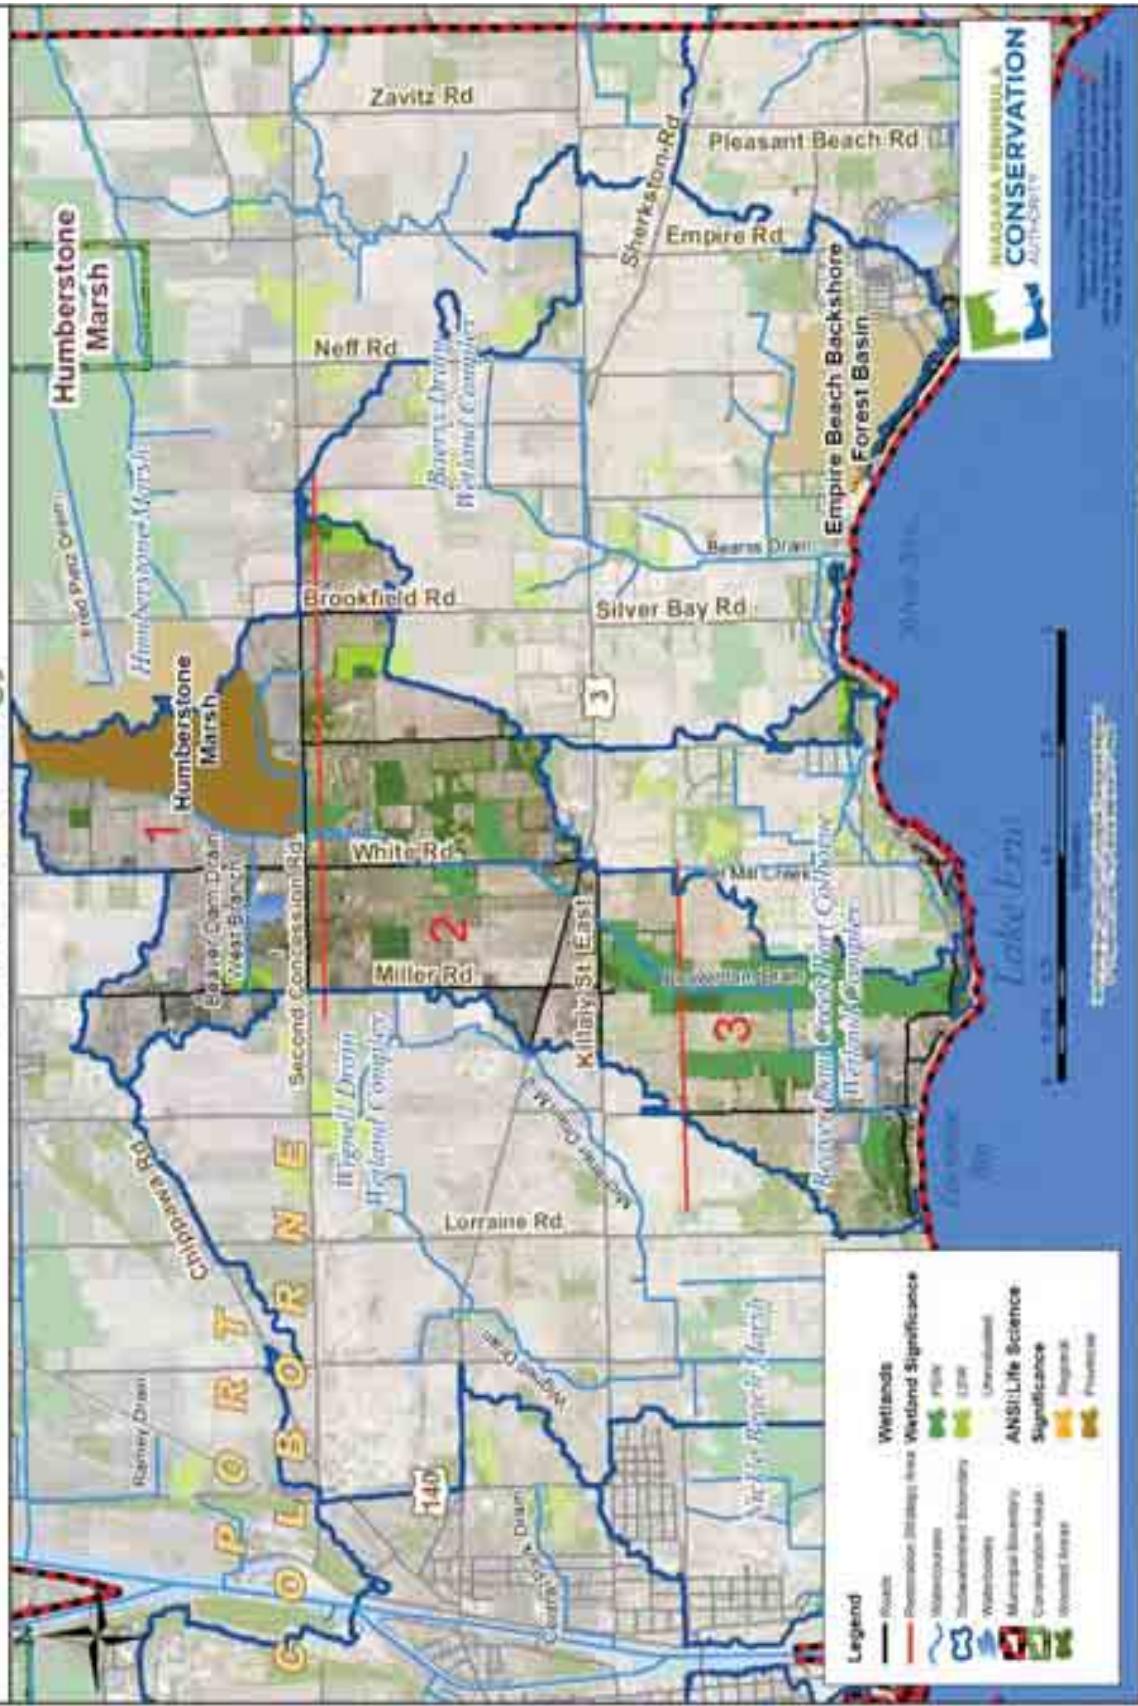
Figure 30: Beaver Dam Creek P.C. Subwatershed Restoration Strategy Study Area

The Beaver Dam Creek P.C. Subwatershed Restoration Strategy identifies three zones with specific stewardship and restoration recommendations (Table 19 and Figure 30).

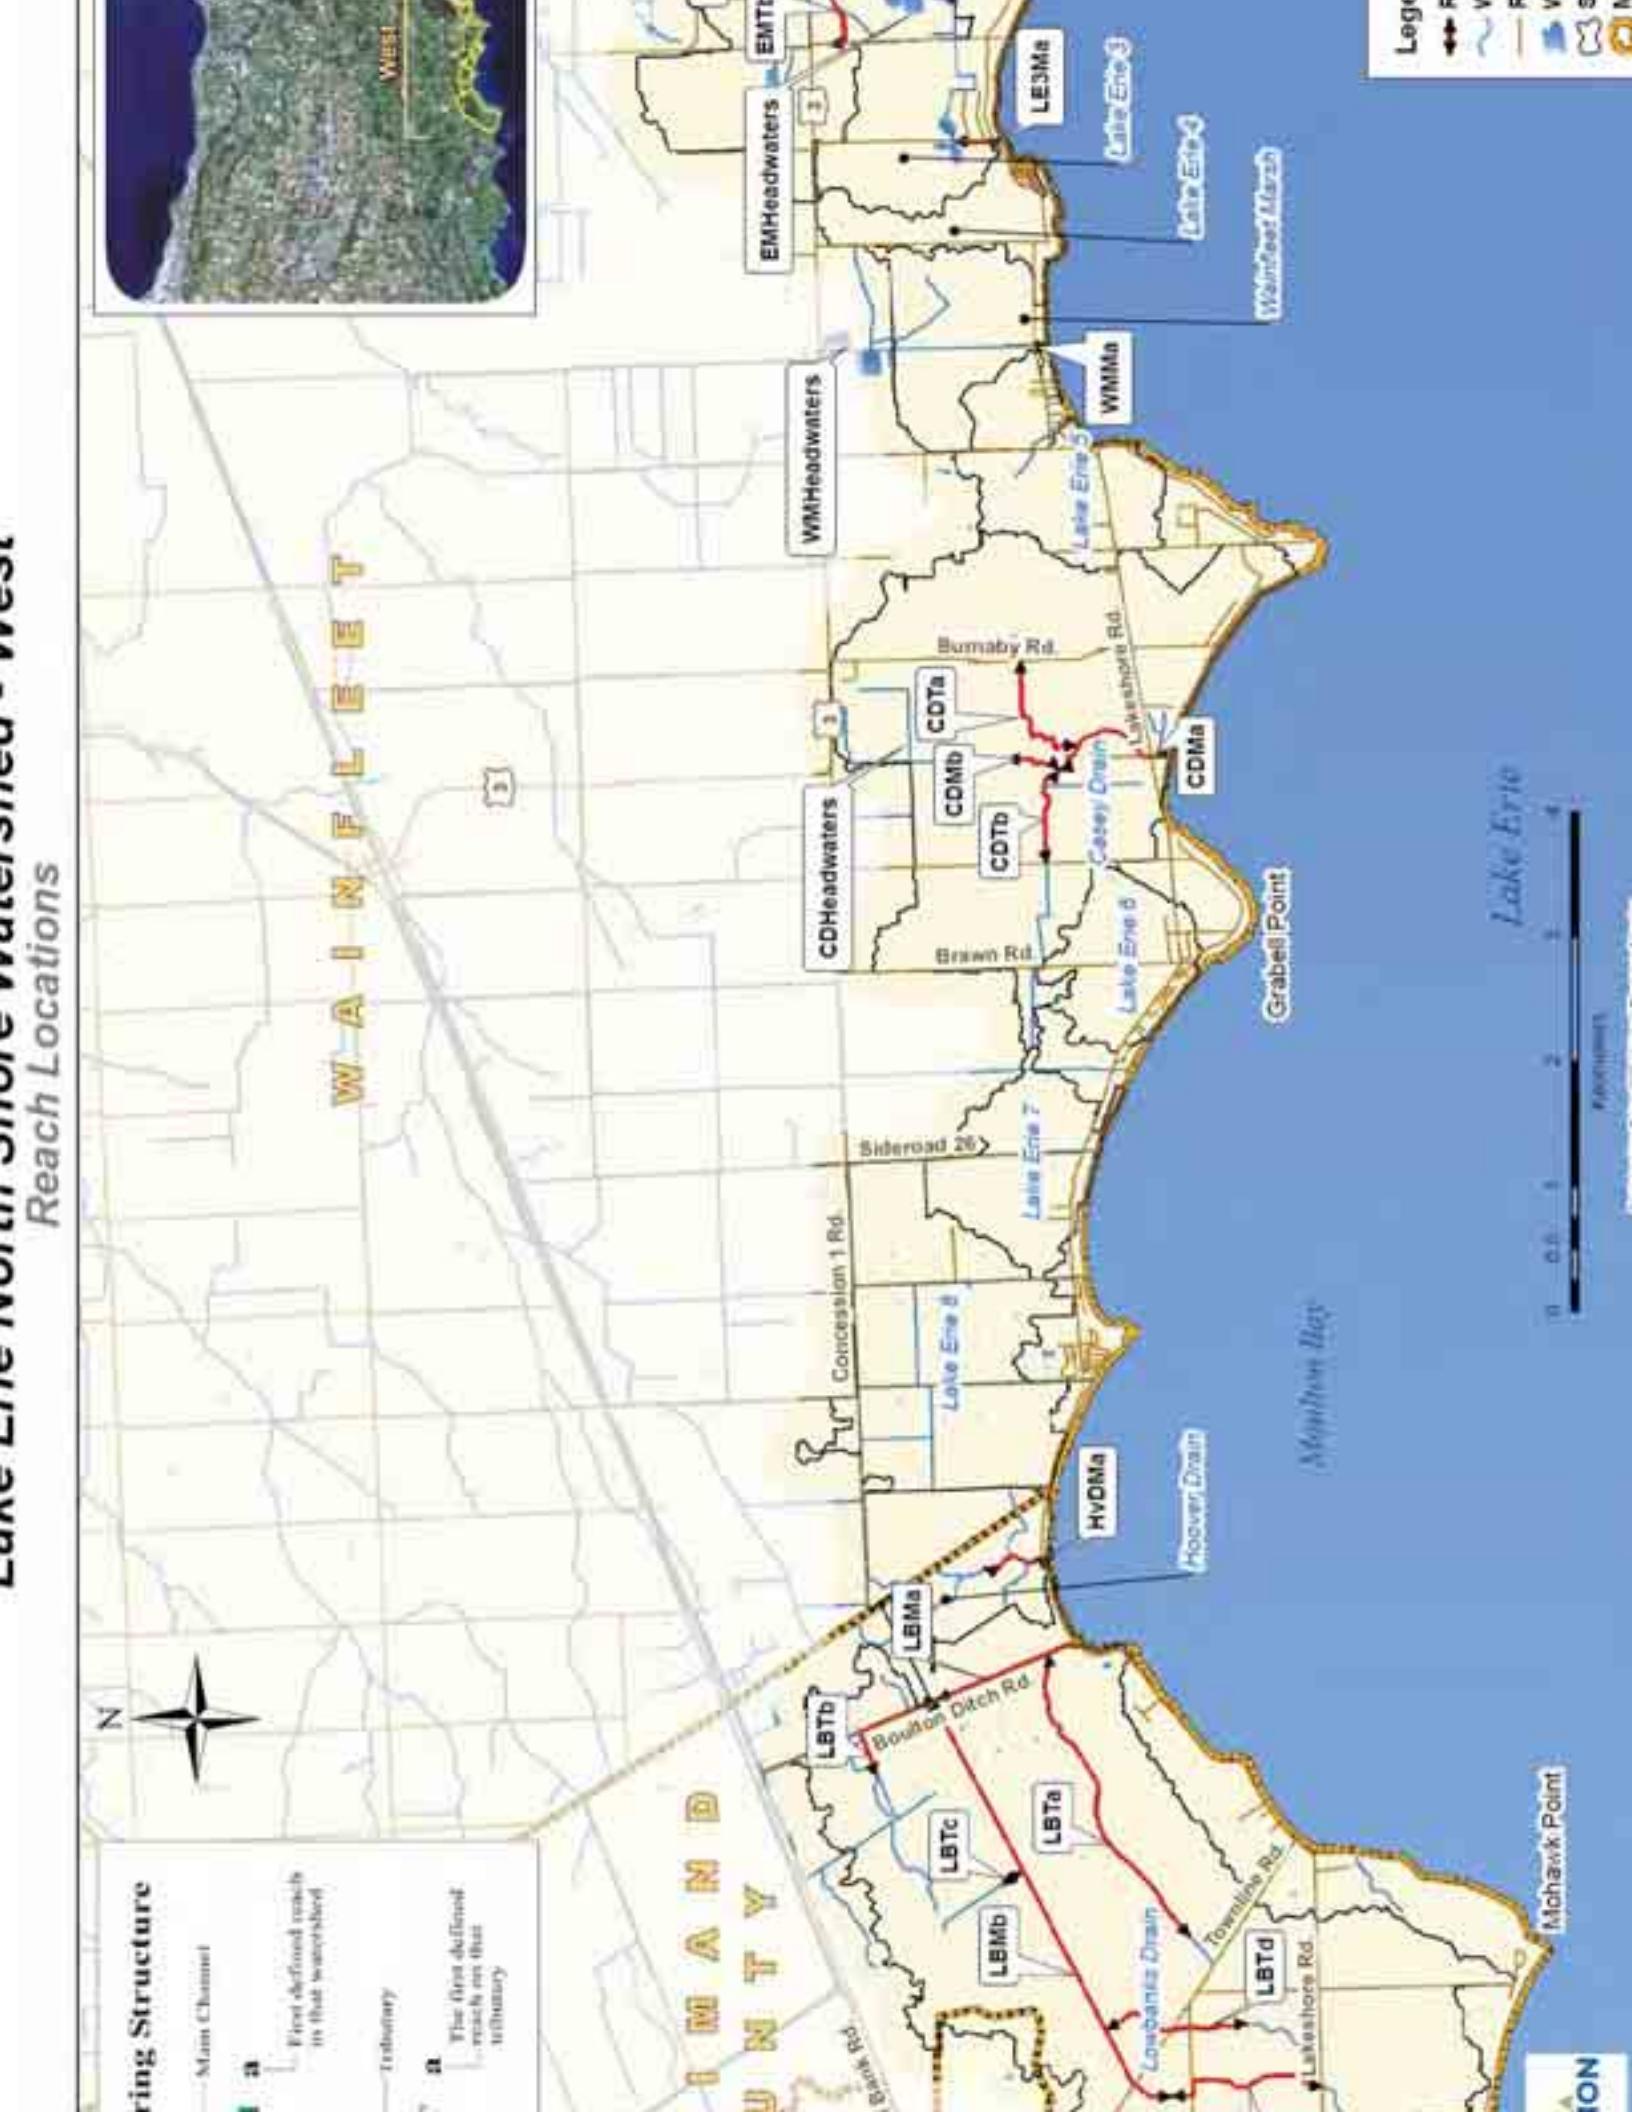
Lake Erie North Shore Watershed - West Reach Locations

Reach Locations
Base 37,000 / 31,000 - 2011

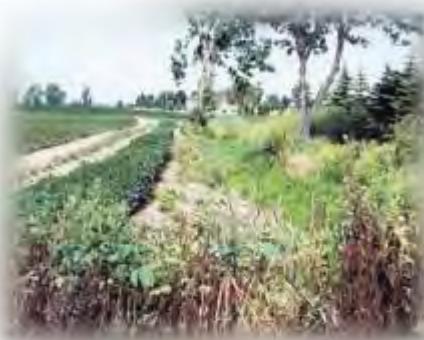
Conservation cropping, such as the soy beans planted to the left of the drain above, can help stabilize the bank, reduce future drain maintenance, and improve habitat for a wide variety of species.

Other means to prevent erosion, extend the life of the drain and improve habitat is to plant shrubs and trees and to increase the size of the vegetated buffer between the field and drain.

Bigger buffers can help remove more of the sediment carried by field runoff into the open ditch, and thus minimize the need for drain maintenance. This option might involve taking productive land out of operation. The alternative may be to look at planting such crops as hay or alfalfa as buffers along the drain. Once these crops are planted, the land can go a number of years without the need for being plowed up, crops can be harvested annually, and the root systems remain undisturbed.

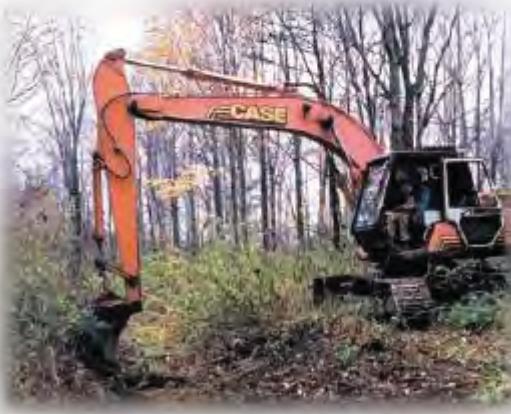
Mature or young trees should be left on either bank. These trees help stabilize the ditch, provide cover and insect food for fish, and shade the banks and the water. The shade from the trees also helps prevent the growth of vegetation that may create blockages to drain flow.

Depending on various circumstances, another option may be to remove vegetation at certain intervals. If an open drain has gone several years without maintenance – trees, shrubs and other brush may have grown to the point where removal of vegetation is required to allow a crane or backhoe access for proper drain clean out.

Rather than clearing out all the vegetation, one can remove for example, 20 metres of vegetation on one side of the bank, skip 20 metres, and then continue so on down the one side of the drain. Then to ensure total bottom clean out, do the same on the opposite bank. Later, when one needs to maintain the drain, vegetation removal and drain maintenance can be done from the spots that were originally left untouched. While this option may be a bit more costly and time-consuming, the landowner is always guaranteed that there will be mature vegetation along the drain to help stabilize it.

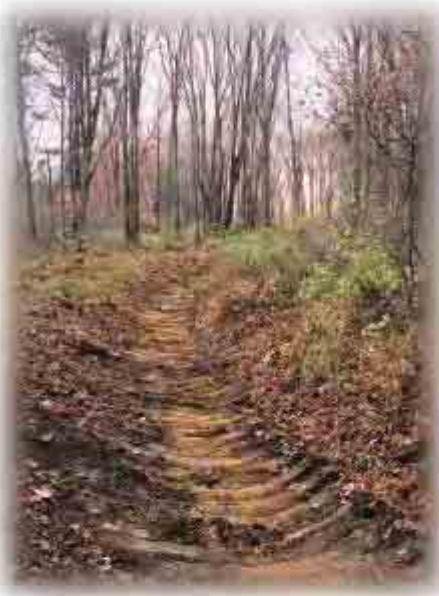
Gentle bank slopes help reduce erosion by reducing runoff speed.

When maintaining a drain, it is preferable to have gentle slopes on the banks rather than steep ones. The steeper the grade, the quicker the water enters the drain, the more unstable banks become, and the more likely erosion will take place.

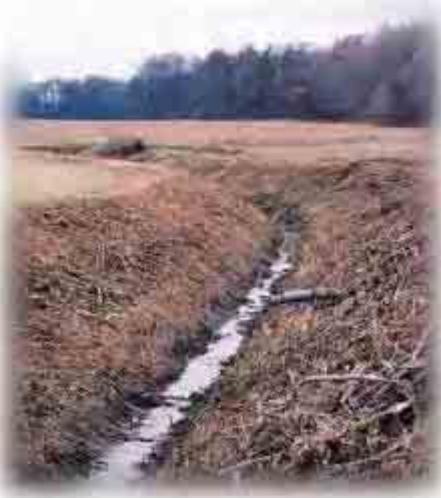
Brushing leaves the root systems intact, stabilizing the banks from erosion. Debris from the brushing protects the banks from wind and rain erosion.

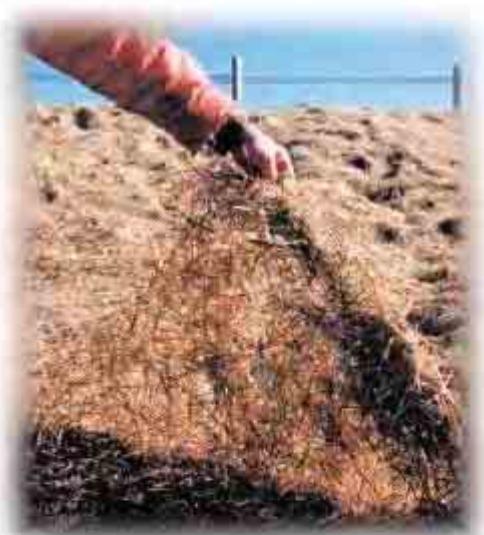
Straw blankets, such as the one seen above, help protect the exposed area from wind and rain erosion, and incorporate natural materials to help vegetation get reestablished.

As soon as the drain maintenance is done, one should consider leveling the spoils, or excavated material, created from clear-out and reseed the work area while the soil is still moist in order to reestablish vegetation and stabilize the bank. If immediate revegetation is not an option (maybe the growing season has passed) then using filter cloth, various mulches or erosion blankets made of natural material might help in protecting the banks from erosion.

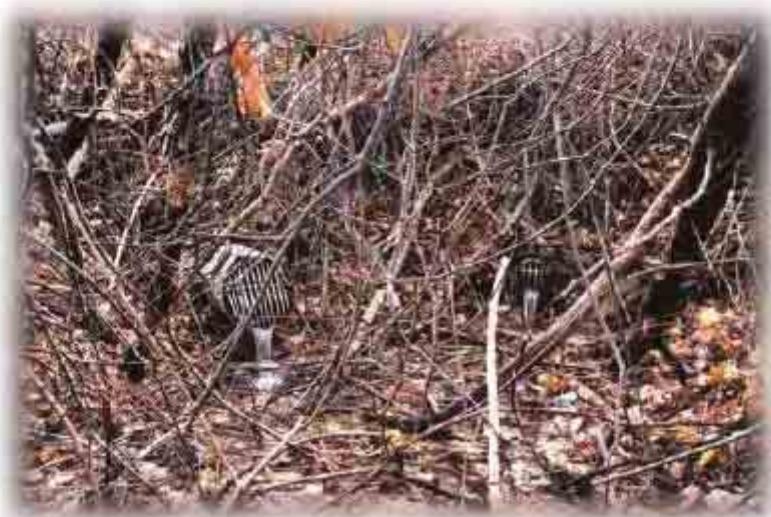
Natural channel design features can be incorporated into drains where appropriate. Natural channels are efficient at moving both water and sediment, as well as providing long-term stability for the drain and enhancing fish habitat.
