## **APPENDIX E**

# Niagara-On-The-Lake Dynamic Beach Evaluation and Regulatory Shoreline Hazard Update

**Final Report  
To : Aquafor Beech Ltd.**

**April 2006**

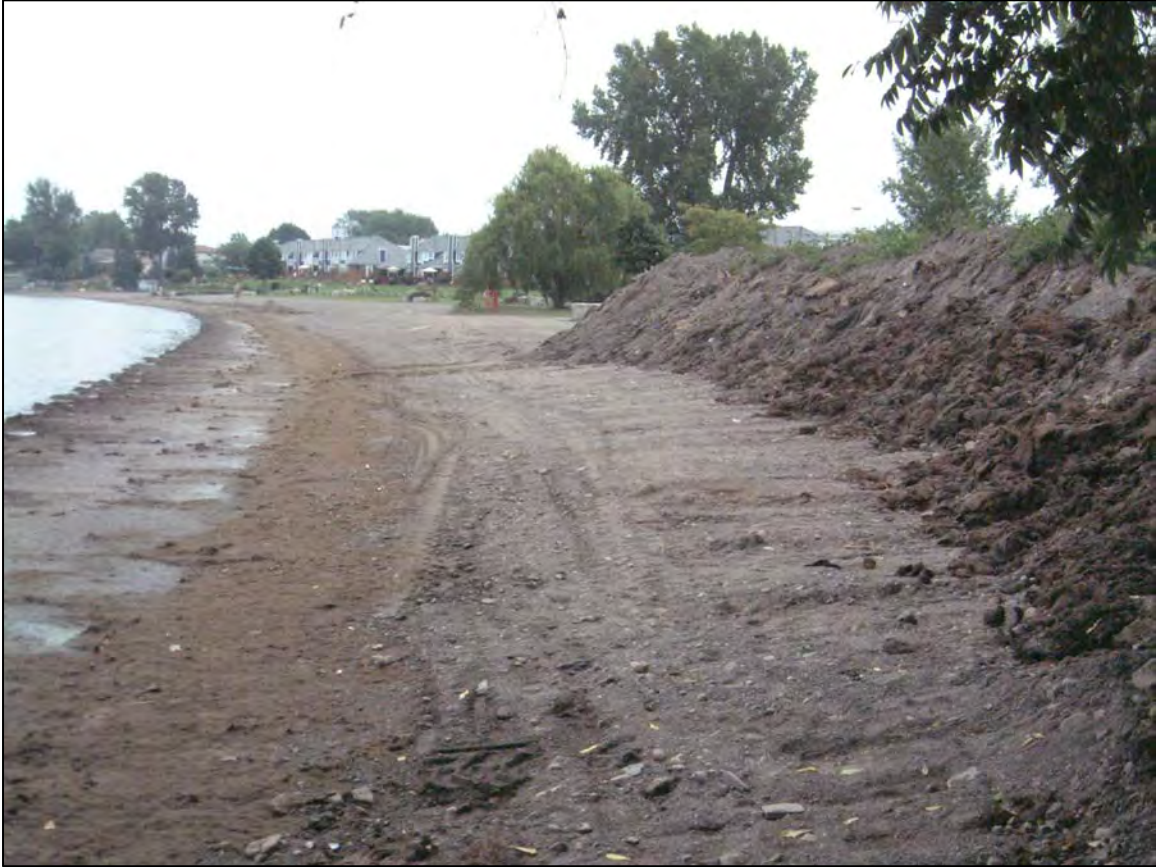
Figure 5.1: Jones Beach (Port Weller East)

The 1994 shoreline management plan describes the 330 m long beach as a low plain shoreline structure with sandy beach at the waterline, and glacial silt/clay materials in the nearshore area. The status of the beach was considered to be unaltered at that time, without any recessional tendencies; at present, there is a condominium development along the back of the beach area, situated well within the defined 1994 Dynamic Beach Hazard Limit. It is also evident that beach maintenance is ongoing in this area, as seen in **Figure 5.1**, which depicts the present beach conditions. Technical documentation supporting the condominium development proposed some minor shore protection works along the eastern portion of the beach, and cites accretion rates of approximately 3 m/yr (Proctor and Redfern, 1988)

A review of historic aerial photographs does suggest that the beach in the area is not erosional, probably due to the protection afforded by the Port Weller jetties. Classification of this beach within the Dynamic Beach Sub-Classification system would suggest a “Low Plain Headland-Bay Sand Beach” system (Sub-Class # 2-1-3), although the headland structures are not natural. Given this sub-class, and the inundation of the entire beach profile by the Regulatory Flood, the Dynamic Beach Extents have been defined at the transition from the unconsolidated beach materials to the low plain (typically the landscaped edge of the condominium development).

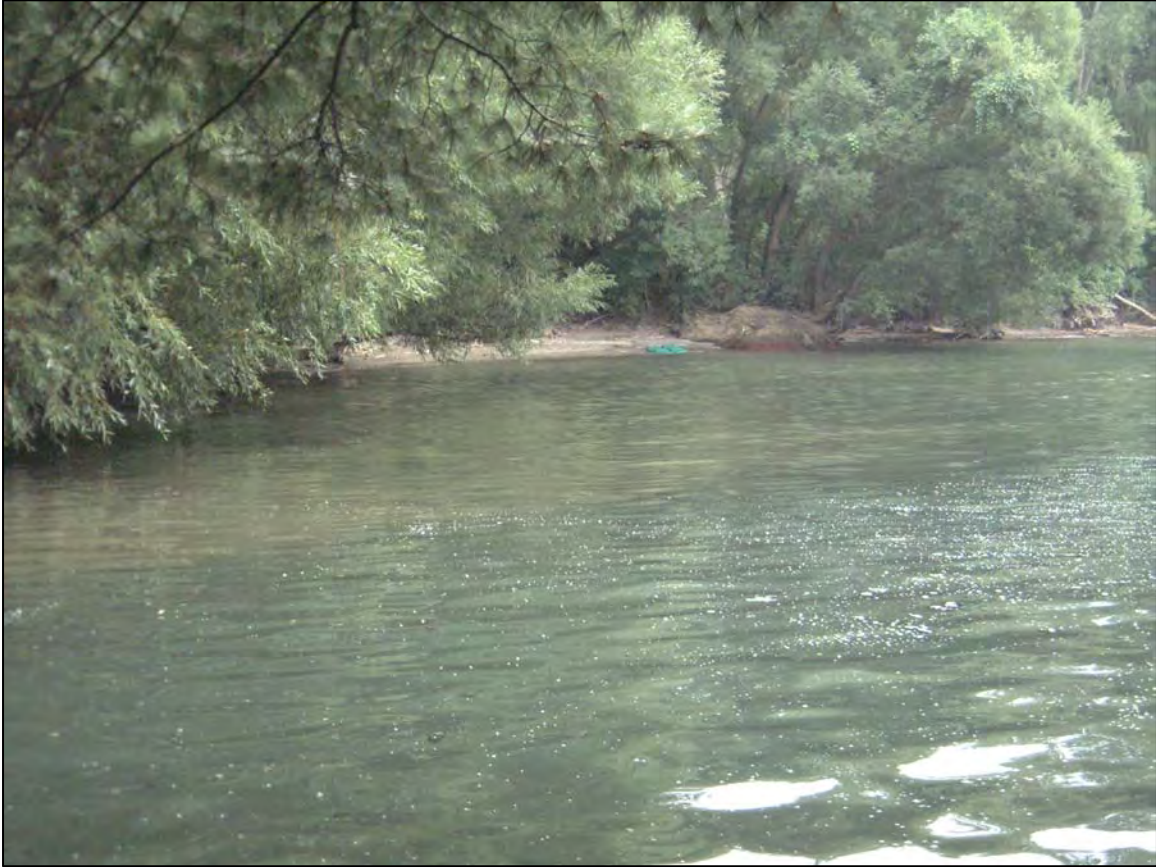
**Figure 5.2: Eight Mile Creek (Airport Drain) Barrier Beach**

Visual inspection of this area in late August of 2004 indicated that the beach width is virtually zero over the entire length of this reach, with shoreline erosion having claimed a number of trees at the back of the beach. A relatively narrow band of silt/sand material is evident in the nearshore zone, with the creek outlet cutting through this material. The section of beach immediately west of the creek mouth is shown in **Figure 5.2**.

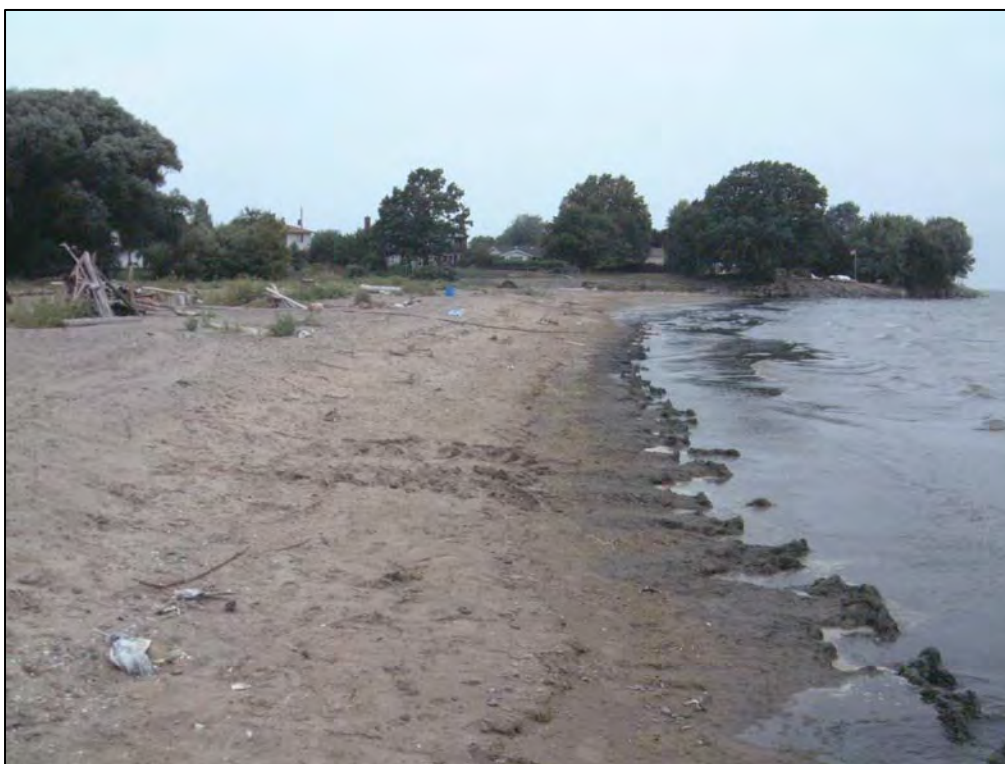
Figure 5.3: Looking West from Just West of Four Mile Creek

Visual inspection of the site in August, 2004, indicate that the beach to the west of the creek mouth (Reach 49) should be classified as dynamic beach as well. The beach to the west of Four Mile Creek is reported by local residents to be aggrading. This beach is anchored at the west end by a protected headland under residential development. Typical conditions within Reach 49 are depicted in **Figure 5.3**.

A review of historic aerial photographs shows that this reach is a historic river mouth / barrier beach site, where Four Mile Creek cut west from its current outlet behind a barrier beach outletting near the western end of Reach 50 in 1934. At this time, the beach was located offshore of its present location. The next available aerial photo (1960) shows the outlet in its current location with a recessed beach line, and subsequent aerial photos indicate a stable (slowly accreting) beach face. As indicated in the 1994 Shoreline Management Report (description of Reach 50), there is rubble at the west side of the creek, and the site inspection indicates that the present creek mouth is maintained to some degree, probably by the local residents.

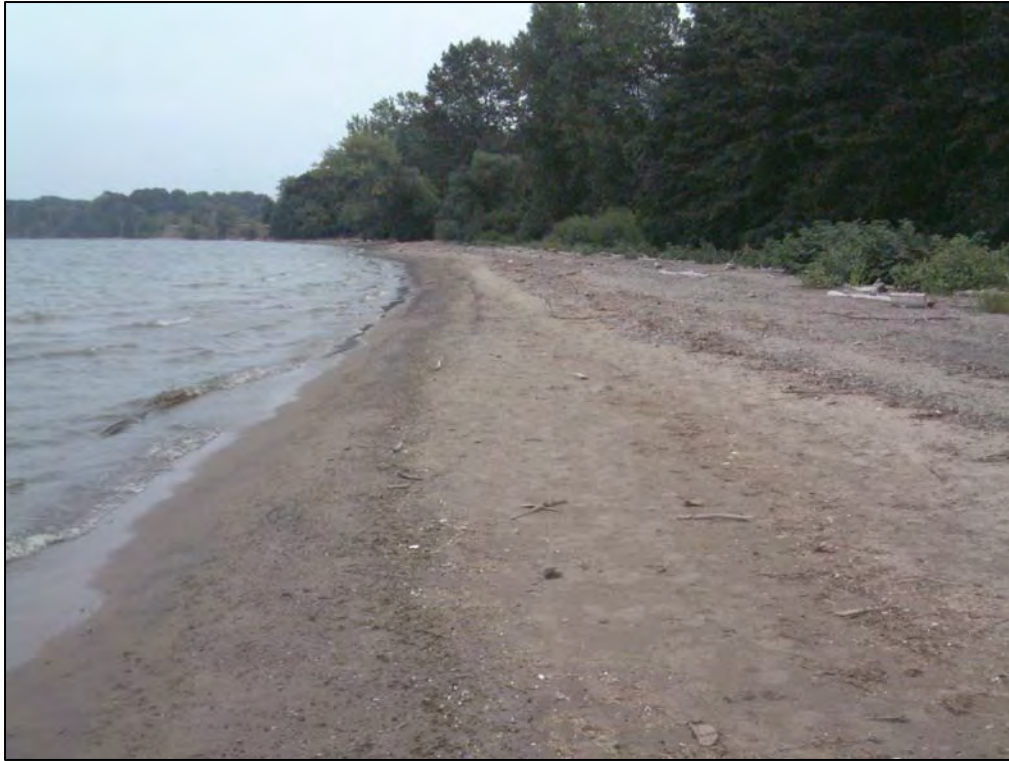
Figure 5.4: Looking East from Just East of Four Mile Creek

The 1994 shoreline management plan indicates that the barrier beach (Reach 50) at Four Mile Creek is 95% natural (with limited rubble protection on west side of creek) and it exhibits a representative recession rate of 1.2 m/yr. The water’s edge is described as a narrow sandy beach with glacial material and boulders in the nearshore zone. There are no obvious signs of active erosion or recession of the beach immediately east of the creek mouth, although a little further to the east, it is obvious that the bluffs that back the narrowing beach in this area are in an active state of erosion. Typical conditions along the beach sections immediately east of the creek mouth and further to the east fronting the bluffs are depicted in **Figures 5.4** and **5.5** respectively.

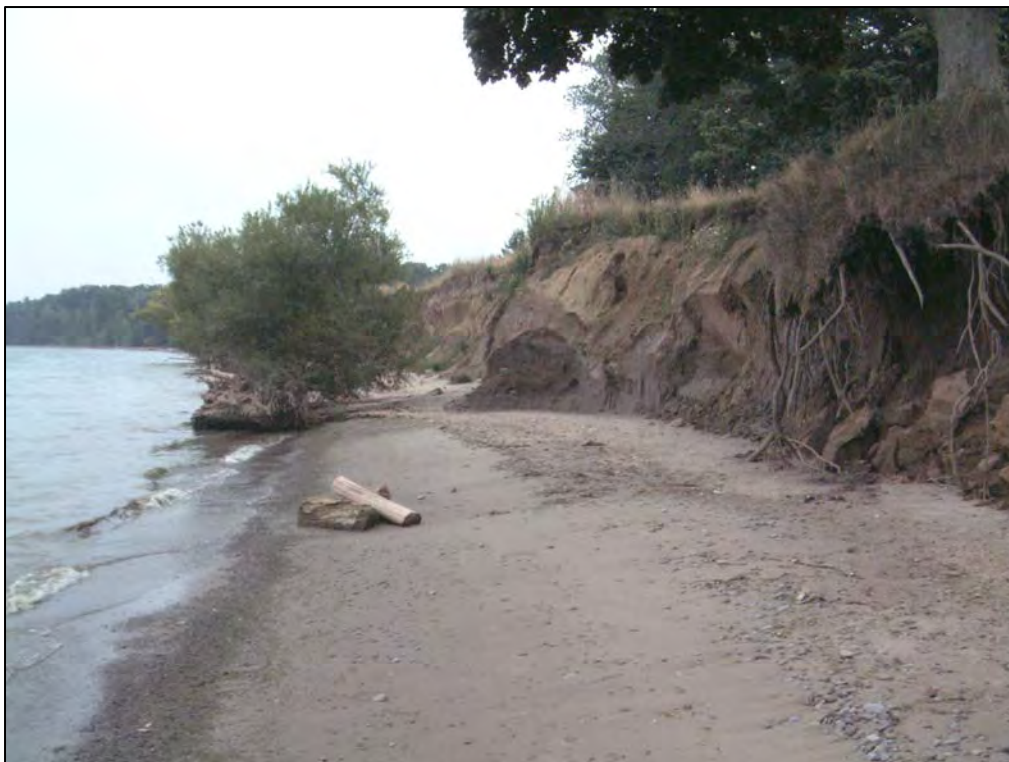
Figure 5.5: Looking East Along Bluffs East of Four Mile Creek

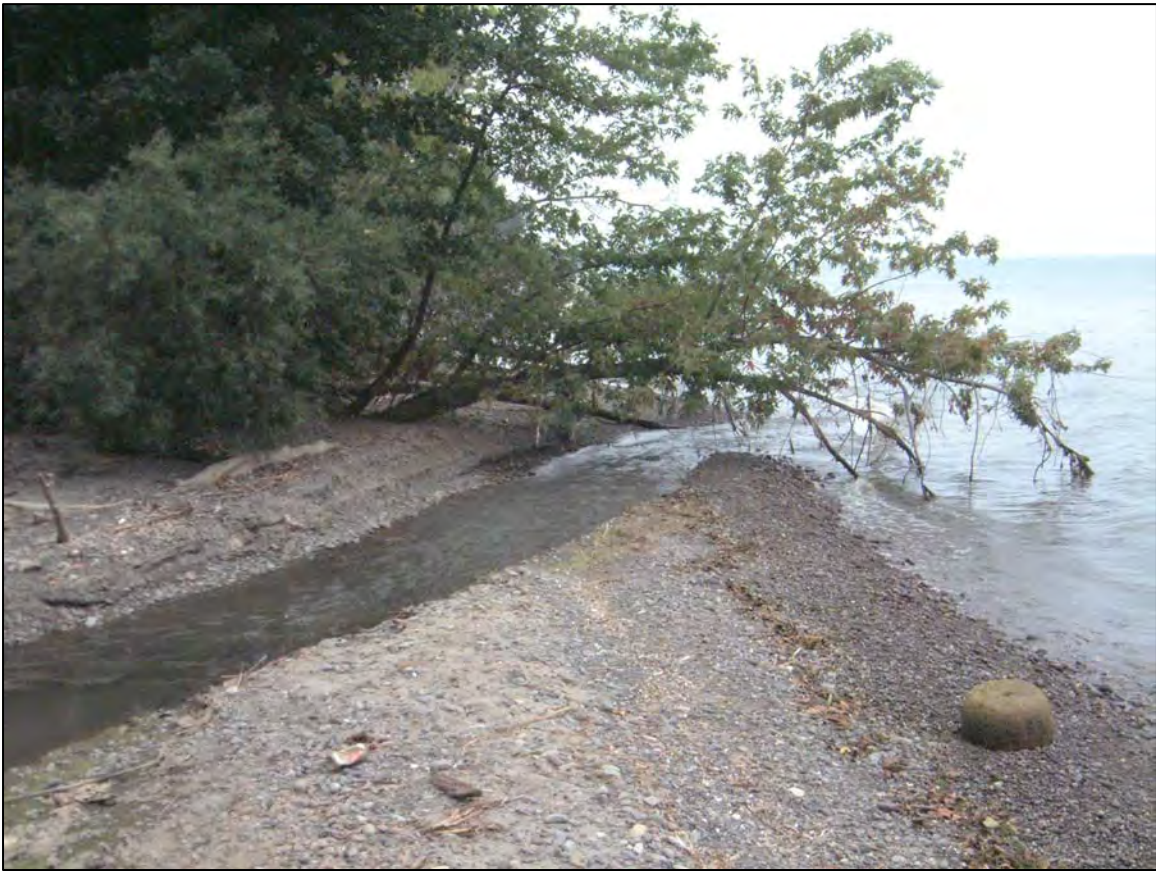
**Figure 5.6 : Looking West from Two Mile Creek Outlet**

The 1994 shoreline management plan indicates that the barrier beach at Two Mile Creek is 100 % natural and it exhibits a representative recession rate of 0.8 m/yr. The water's edge is described as a narrow sandy beach and creek mouth with glacial material in the nearshore zone. Visual inspection of the site in late August, 2004, shows that the beach is relatively narrow with a significant amount of small cobble material. The trees along the shoreline are partially buried by the littoral materials. Typical conditions at the creek mouth are shown in **Figure 5.6**.
