**NPCA WATER QUALITY MONITORING PROGRAM:**  
**SUMMARY REPORT OF THE YEAR 2021**

**JUNE 2022**

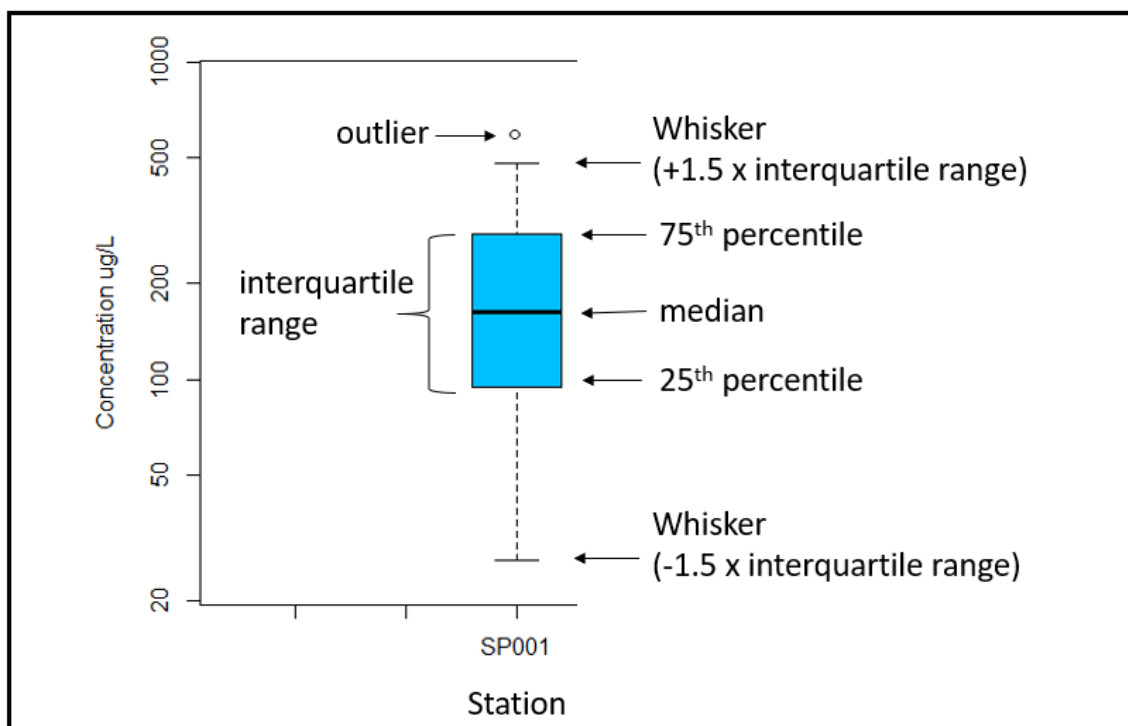
Example of a boxplot

The calculation of the WQI is dependent on the water quality parameters and objectives selected for analysis. The indicator parameters and objectives summarized in **Table 1** were used to determine the WQI for NPCA monitoring stations. Benthic invertebrate data is not included in the WQI and is presented separately. It is important to note that the water quality information presented in this report is limited by the size of the dataset which represents 1 to 5 years of data, depending on the station. The reliability of the WQI rating improves over time (> 3 years) as more data is collected and a wider range of water quality conditions are captured in the dataset. In addition, water quality indicator parameters were summarized using boxplots which allow for comparison of the data distributions and basic statistical attributes such as median, percentiles, overall range, and outliers.

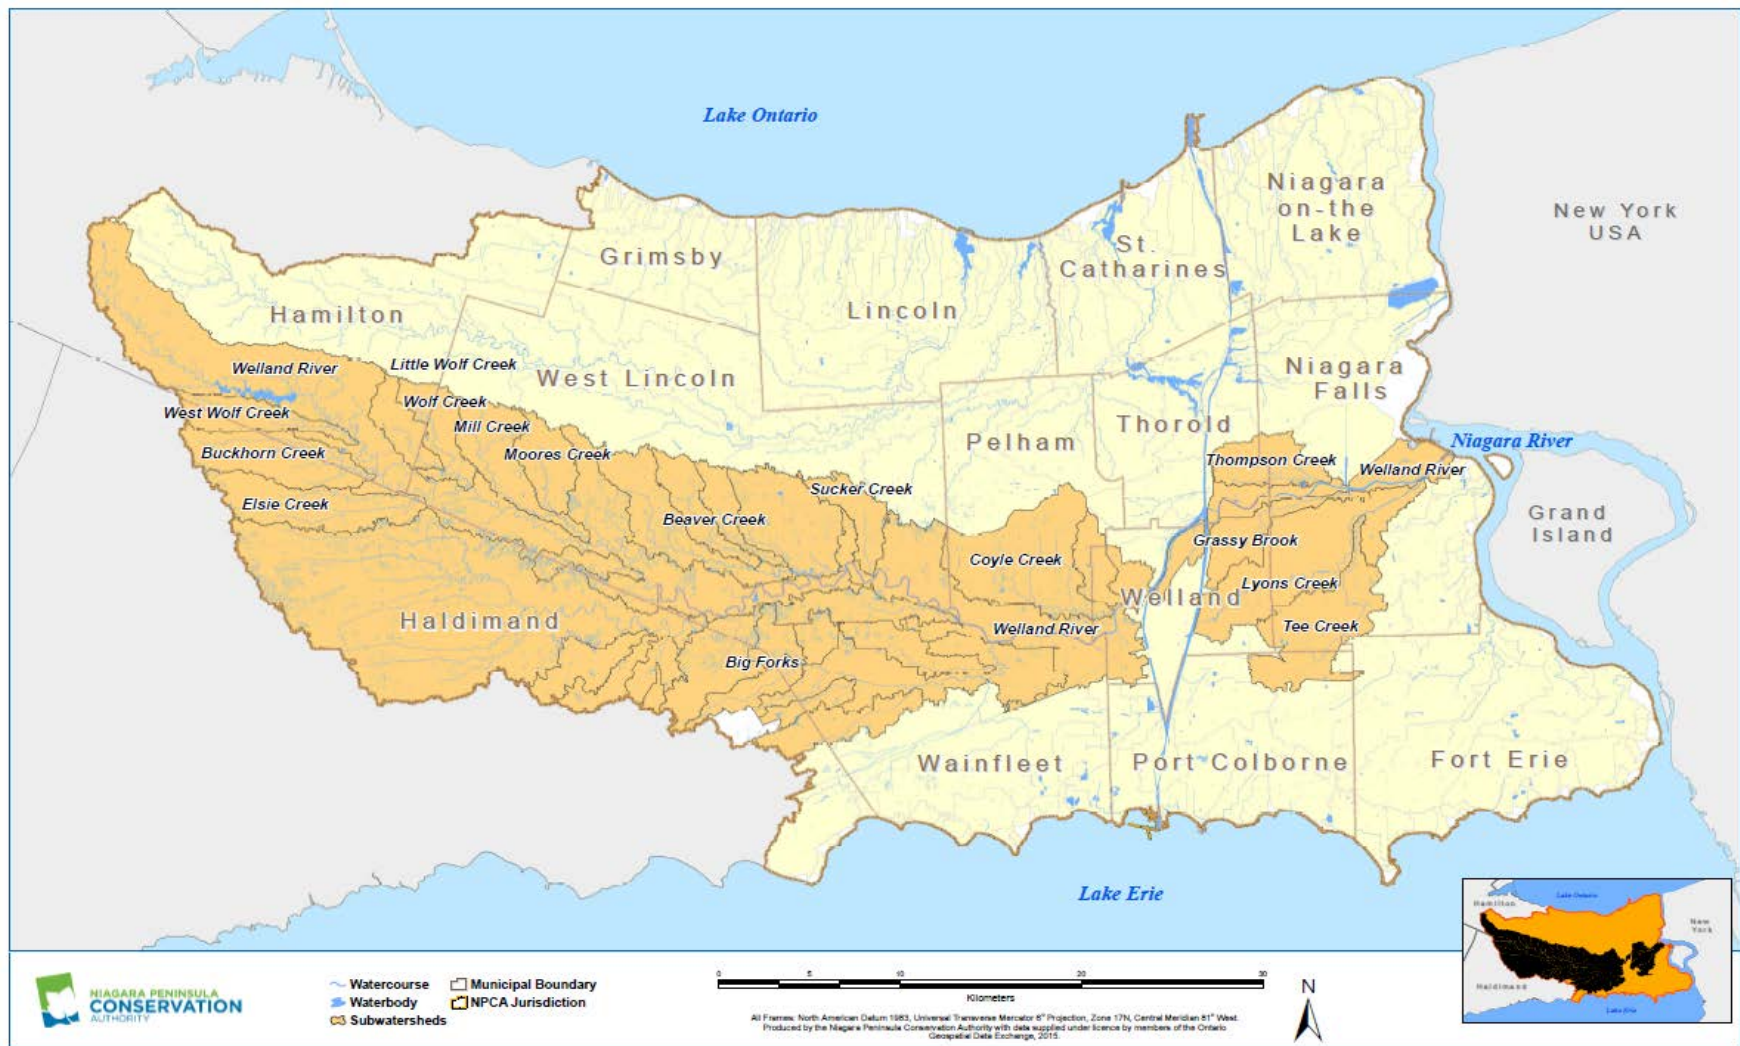
**Figure 1:** Map of the subwatersheds monitored for water quality within the Welland River watershed

The calculated WQI for the Welland River ranges from *poor* to *fair*. Based on the 2017-2021 data collected, six of fourteen Welland River stations have *poor* water quality, six stations were rated as *marginal*, and two stations were rated as fair. WQI results are illustrated in **Appendix A**. Mapping showing the spatial distribution and boxplots of the eight indicator parameters from 2017 to 2021 are found in **Appendix B** to **Appendix I**. Highlights of the water quality monitoring in the Welland River are summarized in **Table 3**:

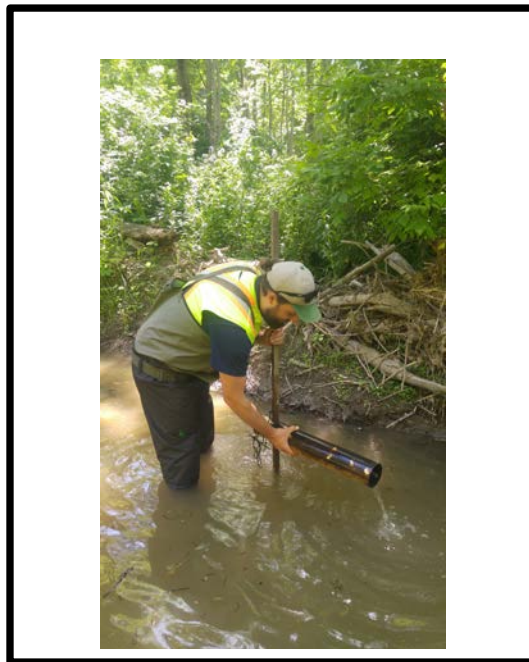
NPCA staff installing water quality sensors

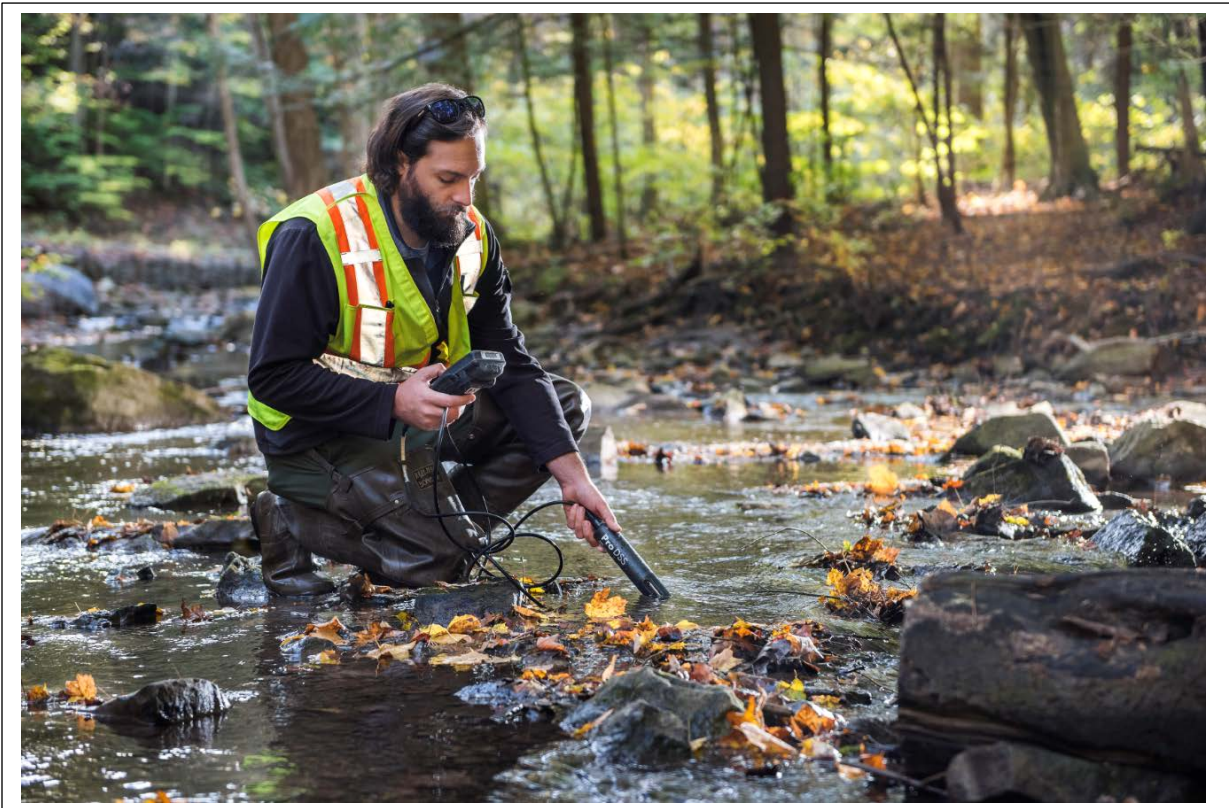
NPCA staff using a water quality sensor to measure stream temperature.

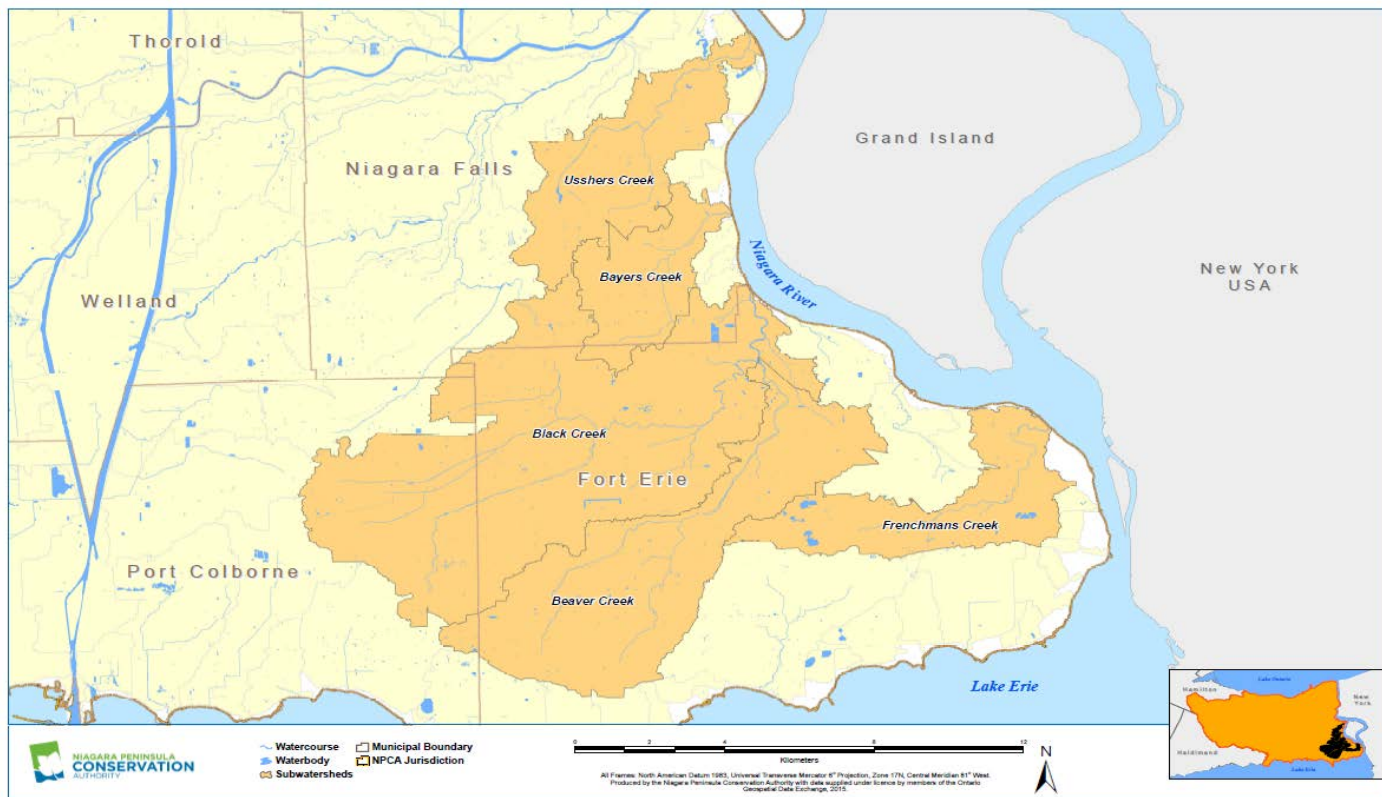
**Figure 8:** Map of the subwatersheds monitored for water quality in the Niagara River watershed outside of the Welland River

Based on the results of the WQI, Usshers Creek (US001), Bayer Creek (BA001), and Frenchman Creek (FR003) stations were rated as *poor* water quality, Black Creek (BL003) station was rated as *marginal* and Beaver Creek (BR001) was rated as *fair*. WQI results are illustrated in **Appendix A**. Mapping showing the spatial distribution and boxplots of the eight indicator parameters from 2017 to 2021 are found in **Appendix B** to **Appendix I**. Highlights of the water quality monitoring in the Niagara River Tributaries are summarized in **Table 7**.

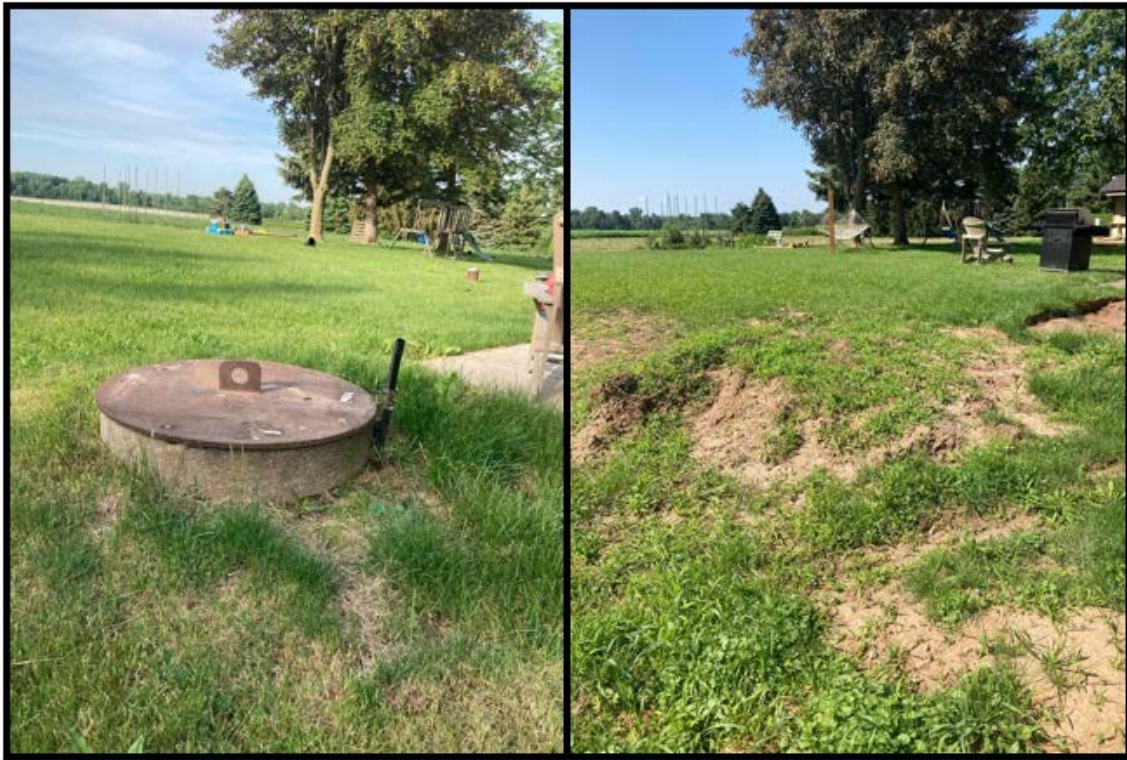
**Figure 12:** An example of a NPCA Water Well Decommissioning Project. Left photo shows an abandoned dug well in need of decommissioning and the right photo shows same well after decommissioning had been completed by a licensed well contractor.

In 2021, the NPCA continued to provide grants to watershed residents interested in properly decommissioning abandoned water wells on their property through the NPCA Water Well Decommissioning Program. The grant program offers an 80% subsidy for water well decommissioning to a maximum of \$1000 per well. Grant applications are prioritized in areas designated as highly susceptible to groundwater contamination in the NPCA Groundwater Study (Waterloo Hydrogeologic Inc. 2005), areas where there is a high density of private wells used for domestic purposes, and areas where a watershed plan has been completed or is underway. Numerous improperly abandoned water wells are known to exist in the NPCA watershed, and these wells can serve as a direct pathway between potential contaminants at ground surface and deeper aquifers. The implementation of this program will reduce the risk of groundwater contamination and fulfills a recommendation made in the Groundwater Management Strategy of the NPCA Groundwater Study (Waterloo Hydrogeologic Inc. 2005). To date, 112 water wells have been decommissioned with the NPCA water well decommissioning program **Table 10**. An example of a water well decommissioning project is shown in **Figure 12**.

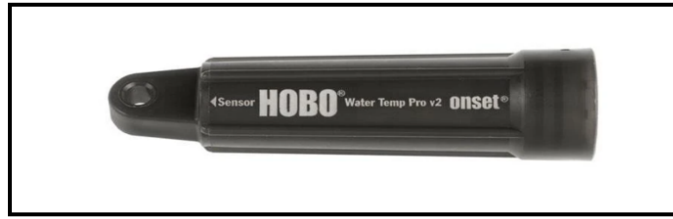
**Figure 14:** Hobo Water Temperature Logger

The NPCA monitored summer stream temperature at nine stream sites in 2021 (**Figure 13**). The stations were chosen due to the availability of background data, including water chemistry, benthic macroinvertebrate data, fisheries, stream morphology, hydrology data and stream temperature data. Onset HOBO Water Temp Pro dataloggers (**Figure 14**) were deployed at seven locations and stream temperature data was used from NPCA stream flow stations that are instrumented with temperature loggers. Hobo temperature loggers were deployed in June 2021 and collected in November 2021, recording at fifteen-minute intervals.

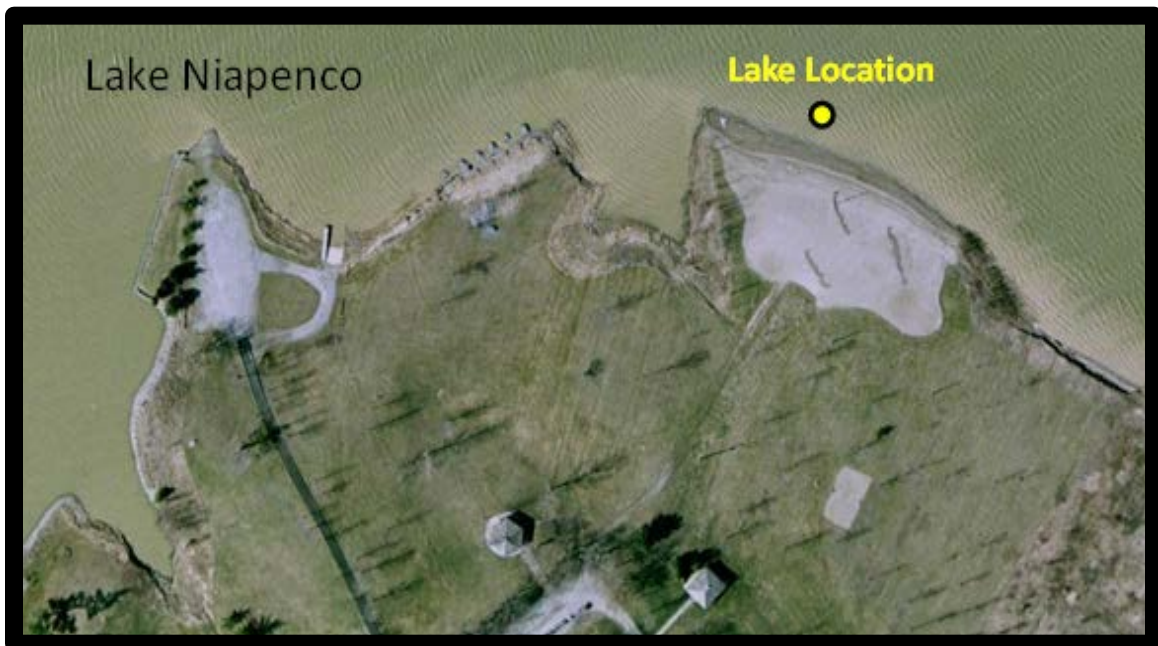
**Figure 17:** Sample Location at Lake Niapenco

NPCA collected a water sample at Lake Niapenco on July 30, 2021. **Figure 17** shows the sample location in the Conservation Area. Water samples were collected following the same protocol used by the NPCA's Operation Department. This protocol was as follows: 1) Lake Niapenco samples were collected in waist-deep water at the beach (**Figure 18**); and 2) Samples were collected and placed in a cooler with ice and shipped the next day for PFC analysis.

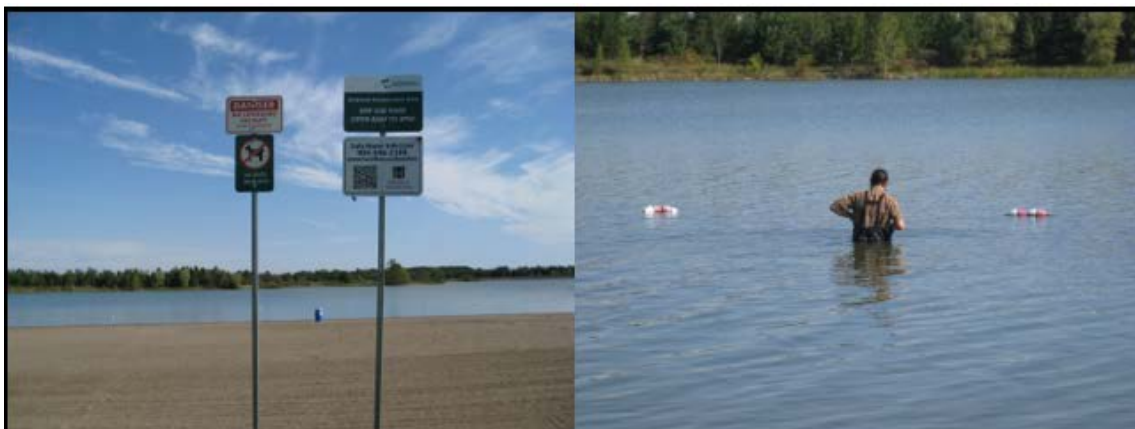
**Figure 18:** Sample location at the beach Lake Niapenco

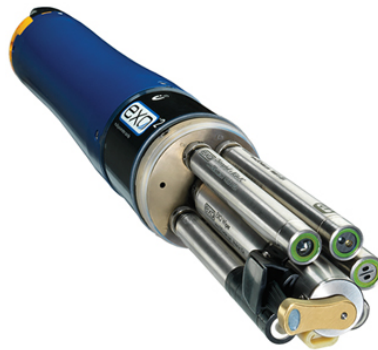
**Figure 25.** YSI EXO Sensor used at Lake Niapenco

The Glanbrook Conservation Committee requested that the NPCA monitor wintertime dissolved oxygen (DO) concentrations in Lake Niapenco. The Glanbrook Conservation Committee was concerned that recent declines in crappie fish populations were the result of low wintertime DO concentrations in Lake Niapenco. Cold winters can cause significant ice cover on Lake Niapenco from January to April. It was hypothesized that ice cover was reducing DO levels within Lake Niapenco and negatively impacting the crappie populations. To address this concern the NPCA monitored DO concentration during the 2021-2022 winter by installing YSI EXO Water Quality Sondes (**Figure 25**) in Lake Niapenco (**Figure 26**). Before deployment, the logger was lab calibrated for use. The logger was deployed to a depth of 3 m from surface of Lake Niapenco. The logger was suspended with buoys on a steel aircraft cable that was secured with an anchor. The logger was programmed to take DO readings every 15 minutes. The YSI loggers were taken to the NPCA main office, and the data downloaded to a computer. All data was analyzed with Excel. A sensor error resulted in lost data from December 2021 until January 28, 2022.
