NPCA WATER QUALITY MONITORING PROGRAM:
SUMMARY REPORT OF THE YEAR 2021

JUNE 2022

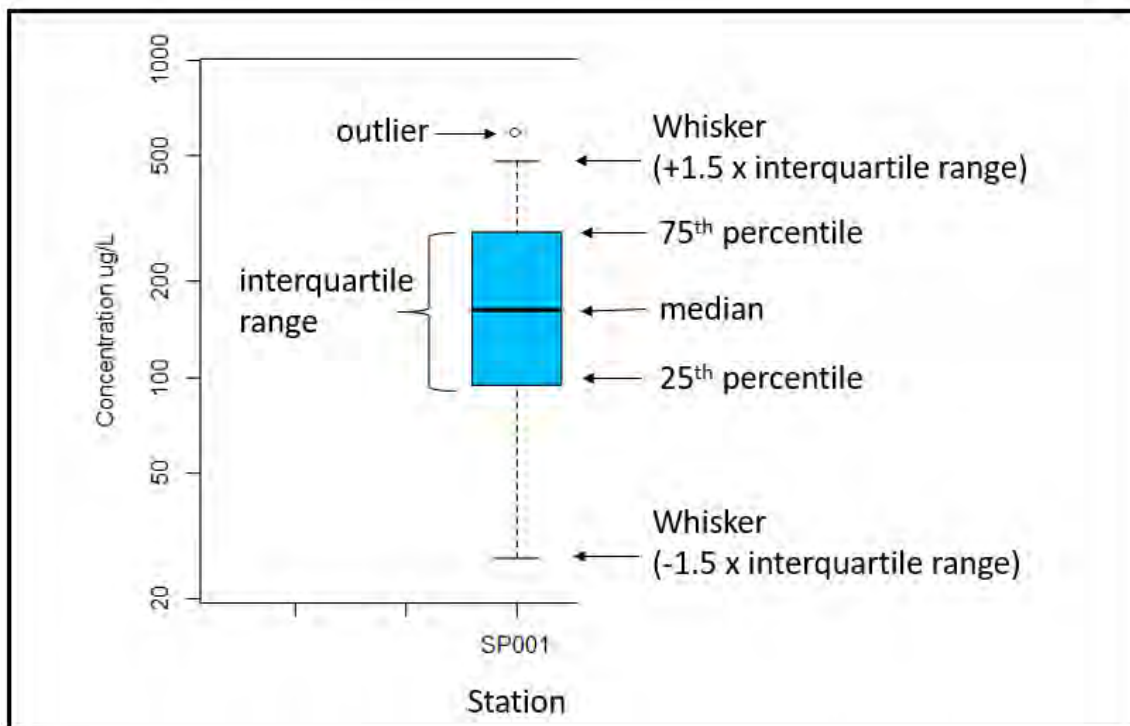
Example of a boxplot

The calculation of the WQI is dependent on the water quality parameters and objectives selected for analysis. The indicator parameters and objectives summarized in **Table 1** were used to determine the WQI for NPCA monitoring stations. Benthic invertebrate data is not included in the WQI and is presented separately. It is important to note that the water quality information presented in this report is limited by the size of the dataset which represents 1 to 5 years of data, depending on the station. The reliability of the WQI rating improves over time (> 3 years) as more data is collected and a wider range of water quality conditions are captured in the dataset. In addition, water quality indicator parameters were summarized using boxplots which allow for comparison of the data distributions and basic statistical attributes such as median, percentiles, overall range, and outliers.

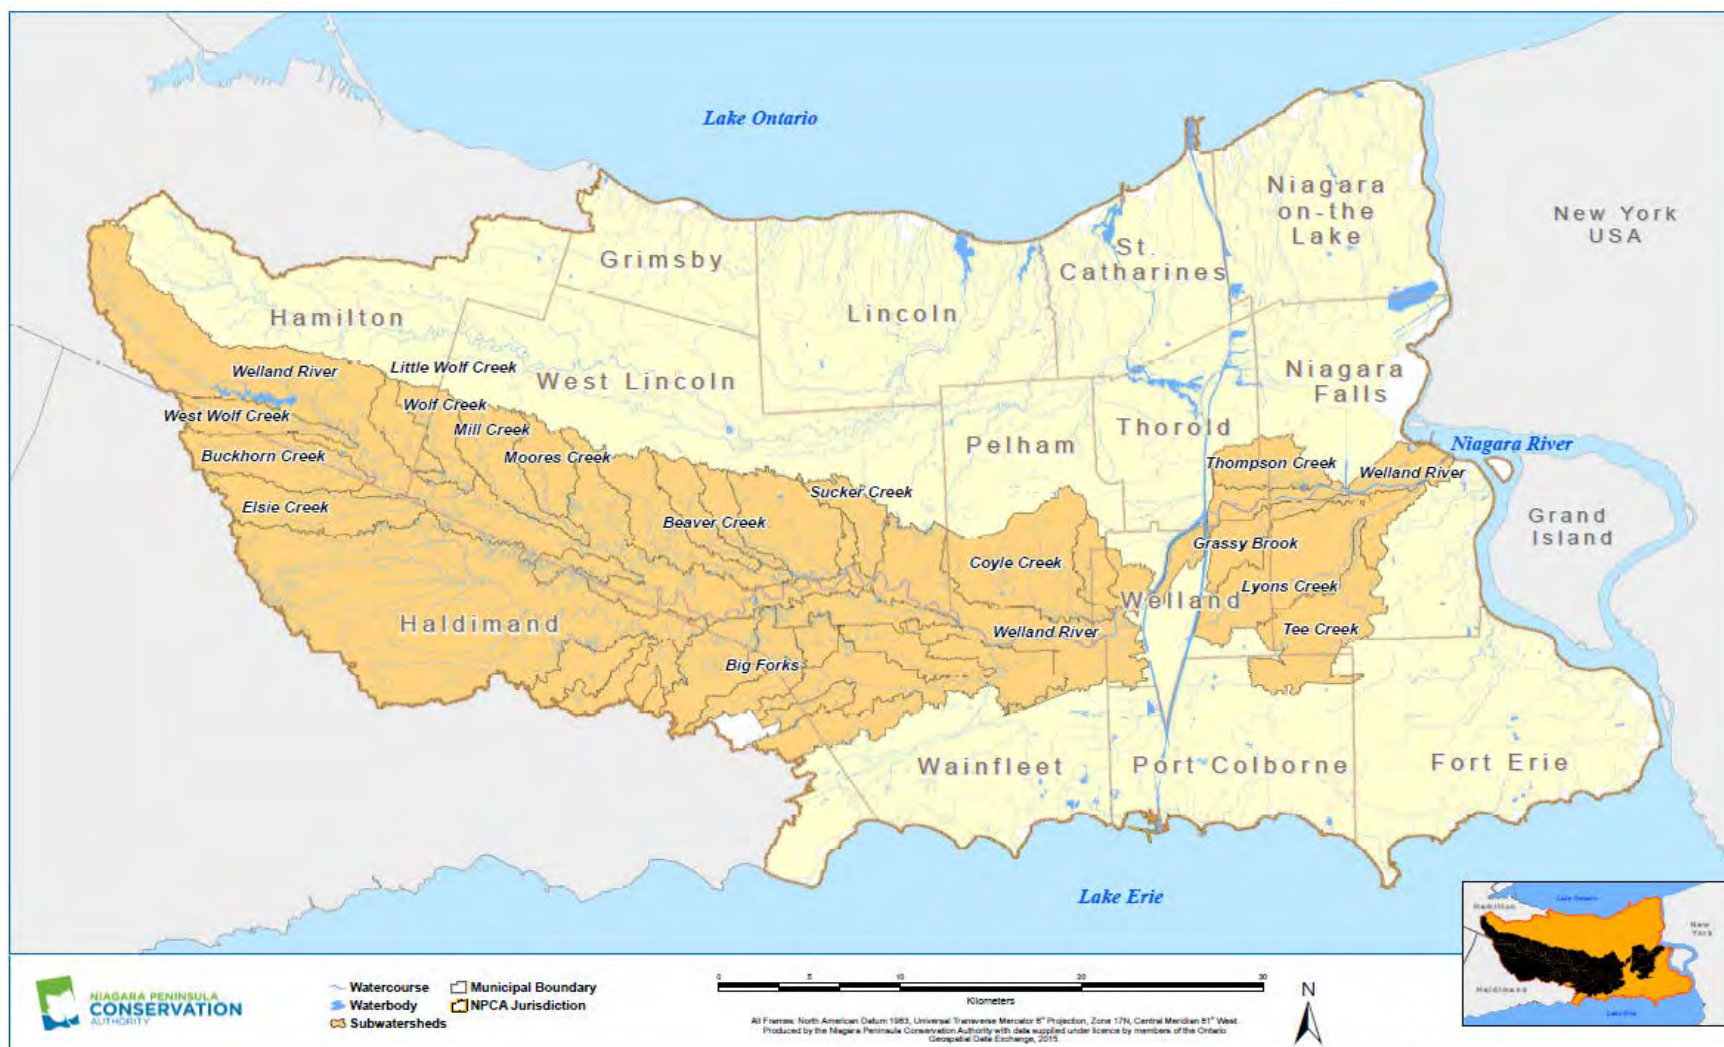
Figure 1: Map of the subwatersheds monitored for water quality within the Welland River watershed

The calculated WQI for the Welland River ranges from *poor* to *fair*. Based on the 2017-2021 data collected, six of fourteen Welland River stations have *poor* water quality, six stations were rated as *marginal*, and two stations were rated as fair. WQI results are illustrated in **Appendix A**. Mapping showing the spatial distribution and boxplots of the eight indicator parameters from 2017 to 2021 are found in **Appendix B** to **Appendix I**. Highlights of the water quality monitoring in the Welland River are summarized in **Table 3**:

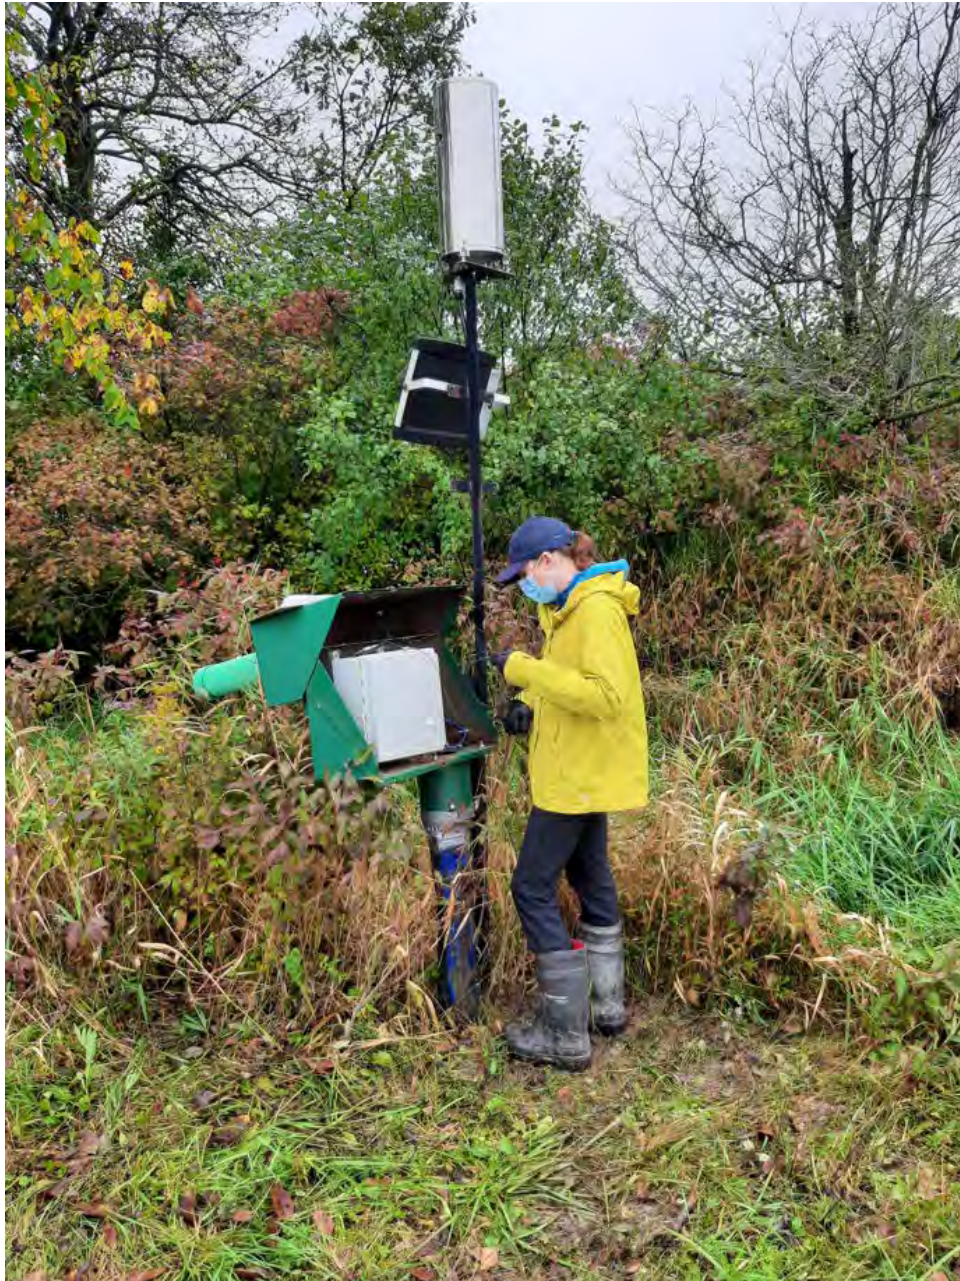
Provincial Groundwater Monitoring Program Well W0000080-1 in West Lincoln

After the completion of the OGS project in 2018, the NPCA has continued to sample water geochemistry yearly in 23 Contact-Zone Aquifer wells and all these wells are instrumented with datalogging equipment which records hourly groundwater levels to provide a better understanding of ambient groundwater conditions across the NPCA watershed.

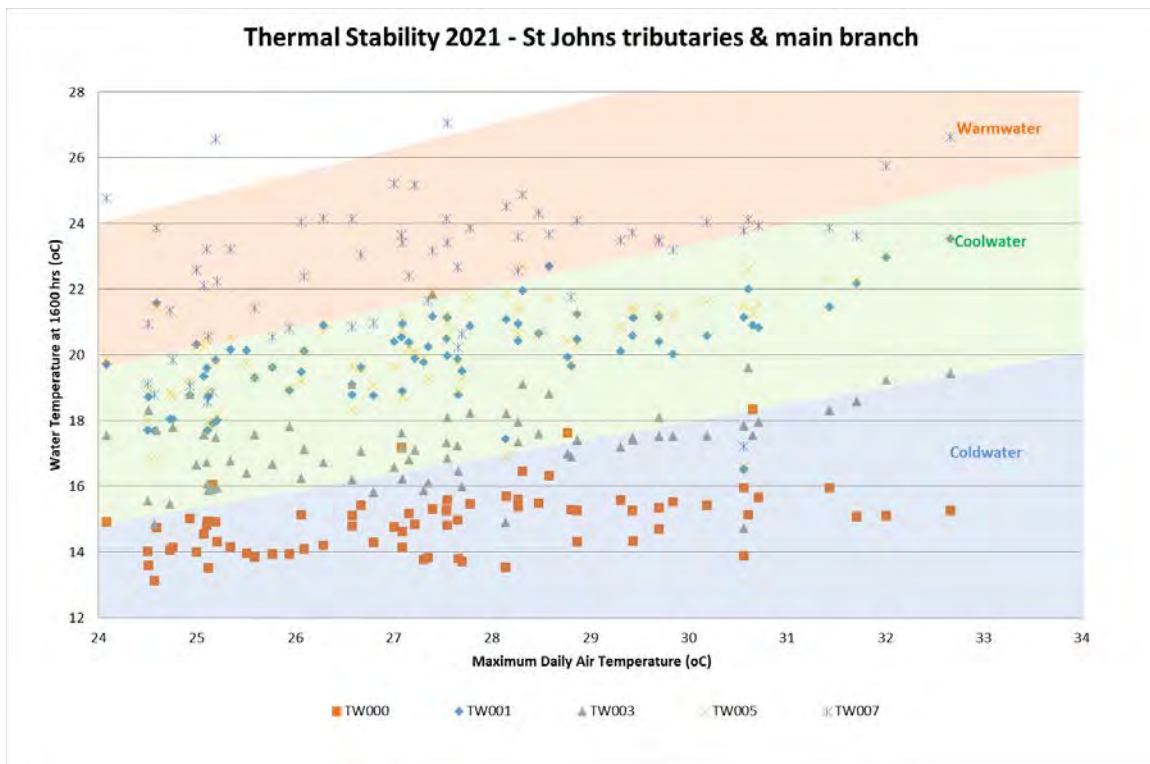
Figure 16: Thermal stability nomograms for 12 Mile Creek St. John's Tributary and main channel

The classification changed at TW003 and Sulphur Spring sites from coldwater to coolwater (**Table 11**) when compared to 2020 data. NPCA could not identify a specific reason for the change in classification but it likely a caused by yearly natural variation of stream temperatures. The classifications of these sites are consistently at the boundary of coldwater-coolwater interface and often transition between these classifications over the NPCA observations. Additional years of monitoring are required to determine if there are warming trends in these tributaries. The classifications of all other sites have generally remained stable with previous assessments.

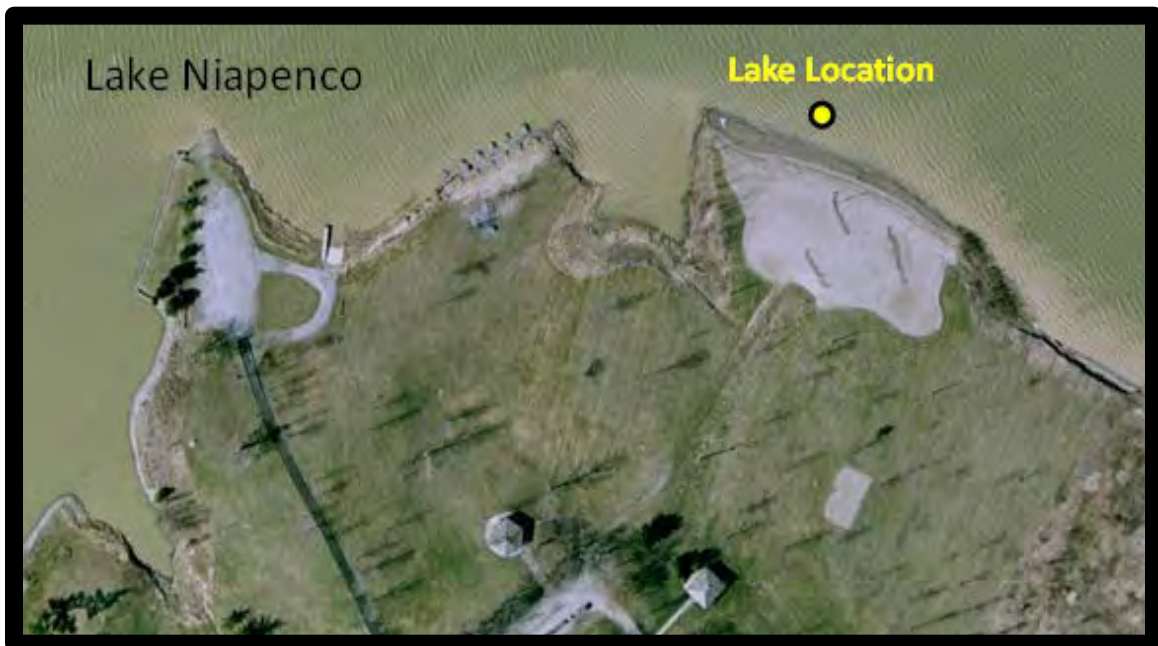
Figure 17: Sample Location at Lake Niapenco

NPCA collected a water sample at Lake Niapenco on July 30, 2021. **Figure 17** shows the sample location in the Conservation Area. Water samples were collected following the same protocol used by the NPCA's Operation Department. This protocol was as follows: 1) Lake Niapenco samples were collected in waist-deep water at the beach (**Figure 18**); and 2) Samples were collected and placed in a cooler with ice and shipped the next day for PFC analysis.

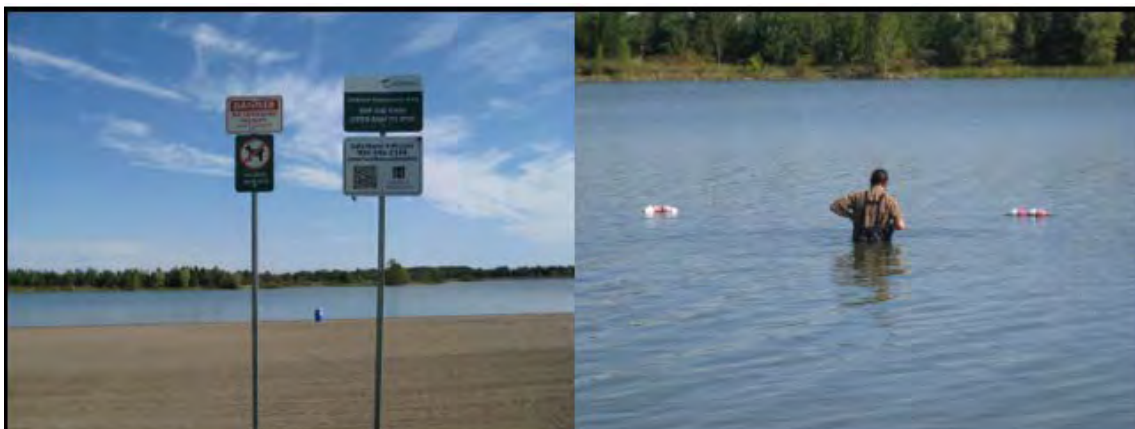
Figure 18: Sample location at the beach Lake Niapenco

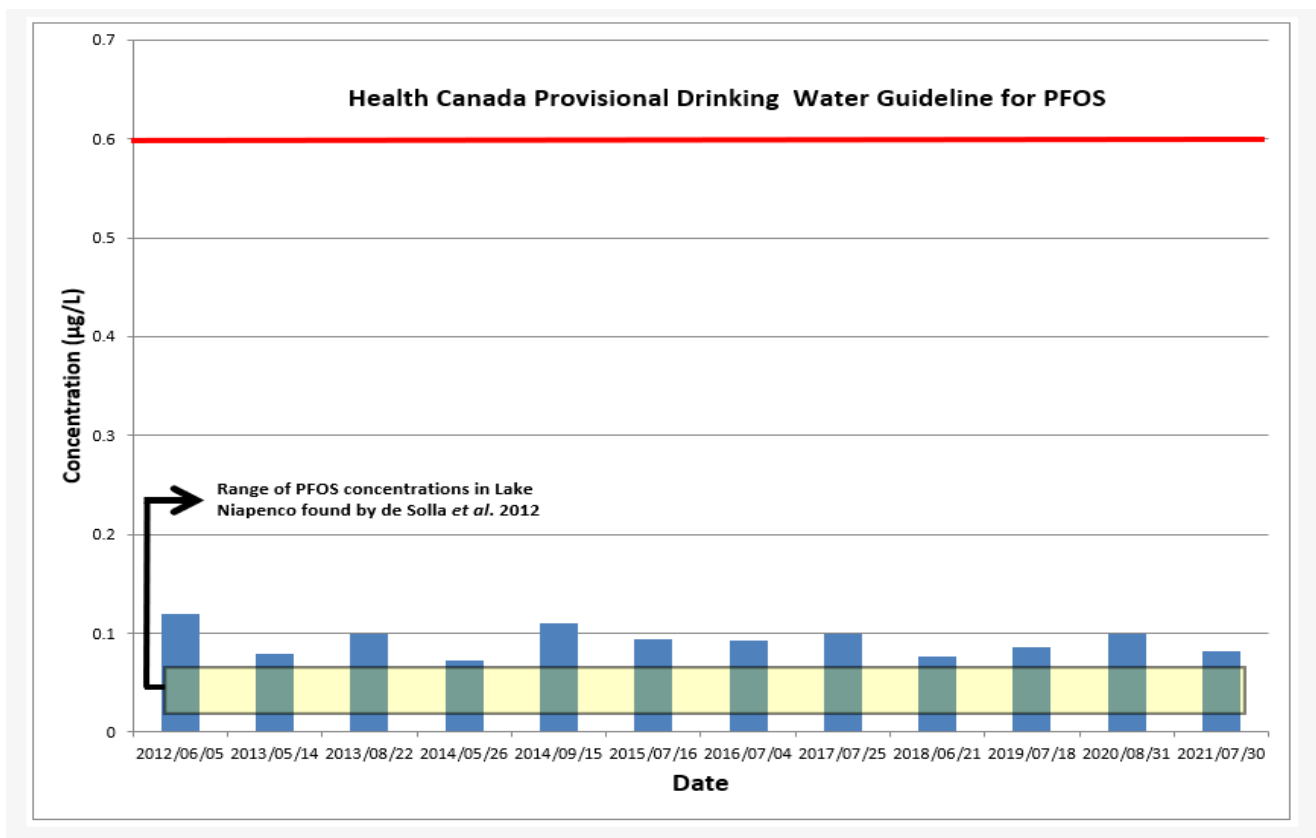
Figure 19. PFOS concentrations found in Lake Niapenco by NPCA monitoring (2012-2021)

Eurofins Lancaster Laboratories Environmental provided the results to the NPCA on August 12, 2021. The water chemistry results from Lake Niapenco indicated the present of PFOS at concentrations below Health Canada Provisional Drinking Water Guidelines (**Figure 19**). The concentration of PFOS generally matched the PFOS concentrations observed in previous NPCA sampling events but higher than the range of mean concentrations detected by de Solla *et al.* (2012) shown in **Figure 19**. Several other PFCs were detected in the Lake Niapenco. These included Perfluorooctanoic acid (PFOA), Perfluorohexane Sulfonate (PFHxS), Perfluorohexanoic Acid (PFHxA) and Perfluoropentanoic Acid (PFPeA) (**Figure 20**). These concentrations generally matched previous sampling event concentrations and PFPeA concentrations were higher than those detected in the study by de Solla *et al.* (2012). The concentration of PFOA in Lake Niapenco was below Health Canada Provisional Drinking Water Guidelines. The other PFCs (PFHxS, PFHxA and PFPeA) have no drinking water guidelines.

Lake Niapenco was contaminated by historic PFC usage from Hamilton International Airport (de Solla 2012 and Fowler 2011). The NPCA's monitoring at Binbrook Conservation Area continues to support the evidence that PFCs and specifically PFOS are present in Lake Niapenco but not at concentrations above Health Canada drinking water guidelines. It is expected that PFCs will continue to be present in Lake Niapenco due the persistence of PFCs in the environment and due to the delay to contain upstream sources. It should be noted that Hamilton Public Health has evaluated previous PFC water quality data at Binbrook Conservation Area and determined that the PFC concentrations detected would not adversely affect the park users.

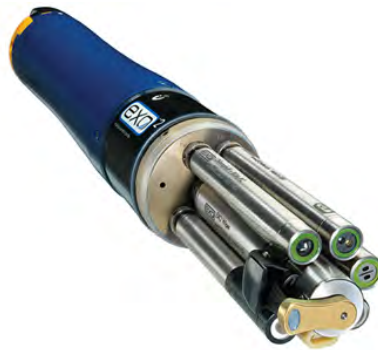
Figure 25. YSI EXO Sensor used at Lake Niapenco

The Glanbrook Conservation Committee requested that the NPCA monitor wintertime dissolved oxygen (DO) concentrations in Lake Niapenco. The Glanbrook Conservation Committee was concerned that recent declines in crappie fish populations were the result of low wintertime DO concentrations in Lake Niapenco. Cold winters can cause significant ice cover on Lake Niapenco from January to April. It was hypothesized that ice cover was reducing DO levels within Lake Niapenco and negatively impacting the crappie populations. To address this concern the NPCA monitored DO concentration during the 2021-2022 winter by installing YSI EXO Water Quality Sondes (**Figure 25**) in Lake Niapenco (**Figure 26**). Before deployment, the logger was lab calibrated for use. The logger was deployed to a depth of 3 m from surface of Lake Niapenco. The logger was suspended with buoys on a steel aircraft cable that was secured with an anchor. The logger was programmed to take DO readings every 15 minutes. The YSI loggers were taken to the NPCA main office, and the data downloaded to a computer. All data was analyzed with Excel. A sensor error resulted in lost data from December 2021 until January 28, 2022.

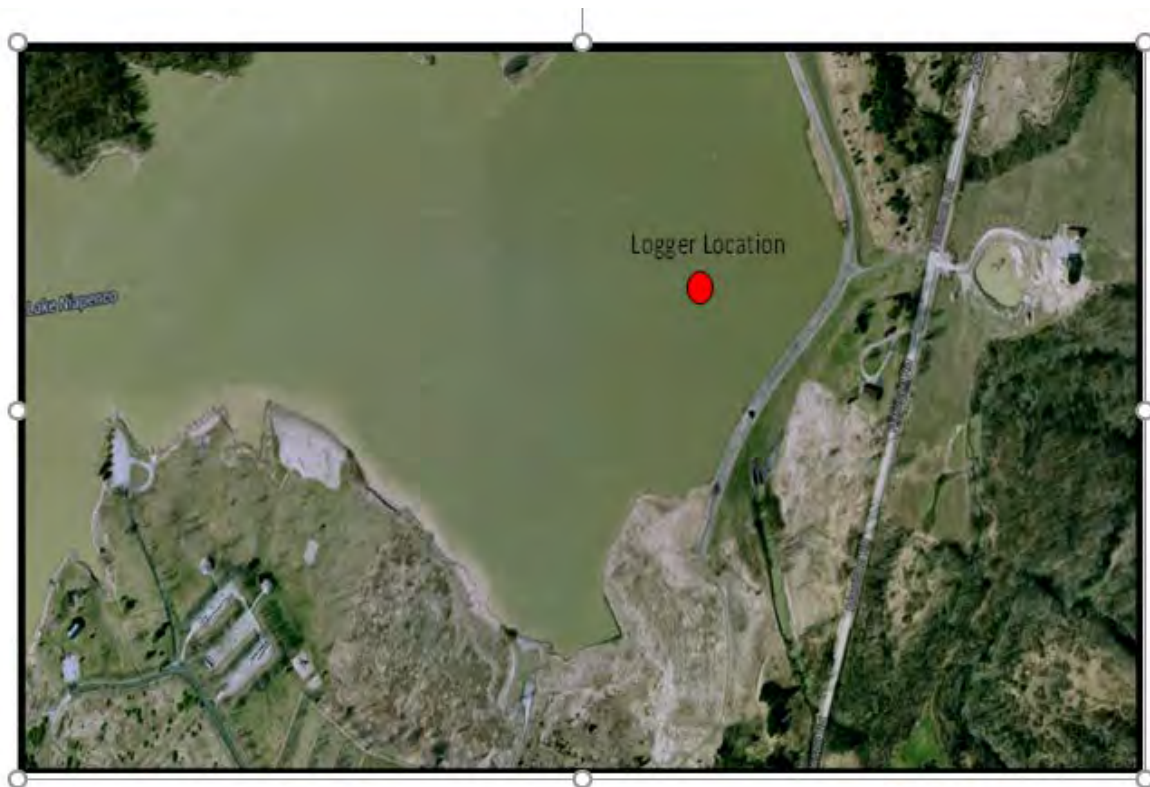
Figure 26. Logger Location at Lake Niapenco

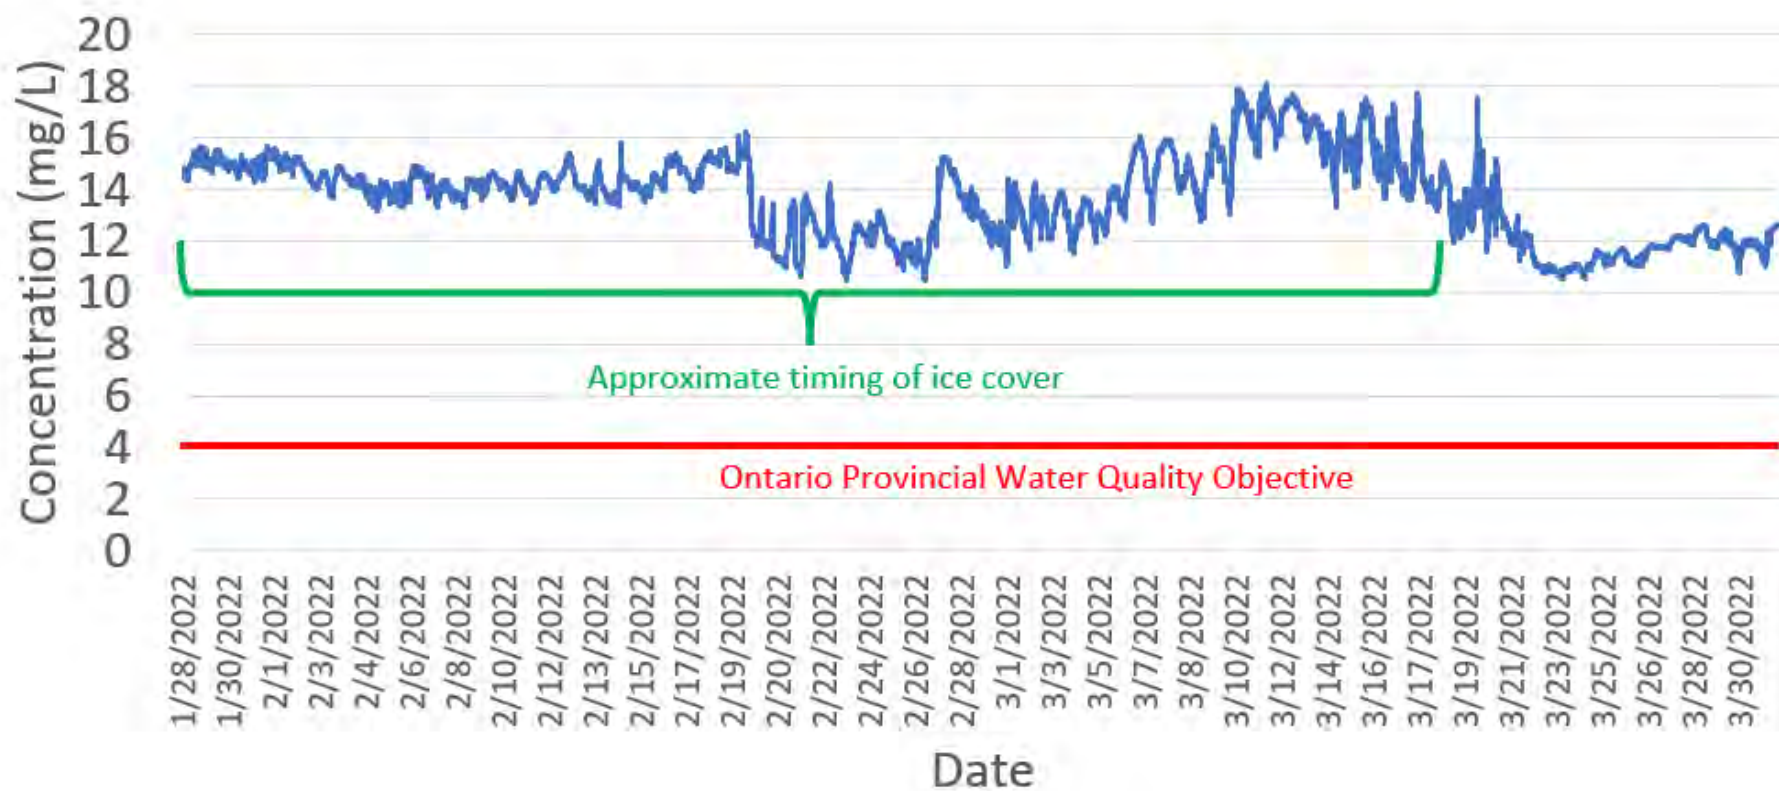
Lake Niapenco Dissolved Oxygen Concentrations Winter 2022

Figure 27. Lake Niapenco Dissolved Oxygen Concentrations (Jan 2022 to March 2022)

During the winter 2021-2022 Lake Niapenco was covered with ice from the second week in January until the second week of March 2022 DO concentrations are shown in **Figure 27**. At the 2m depth DO concentrations during this study period did not dip below the Ontario Ministry of Environment's Provincial Water Quality Objective of 4.0 mg/L (Ontario Ministry of the Environment. 1994). The data provided by the logger demonstrate there was sufficient dissolved oxygen in Lake Niapenco to sustain warm water fish populations during the 2021-2022 winter. It is recommended that the NPCA monitor DO concentrations for the 2021-2022 winter by redeploying the YSI logger to assist the Glanbrook Conservation Committee.
