Niagara Peninsula Conservation Authority
Water Quality Monitoring Program Summary Report 2023

June 2024

Niagara Peninsula Conservation Authority

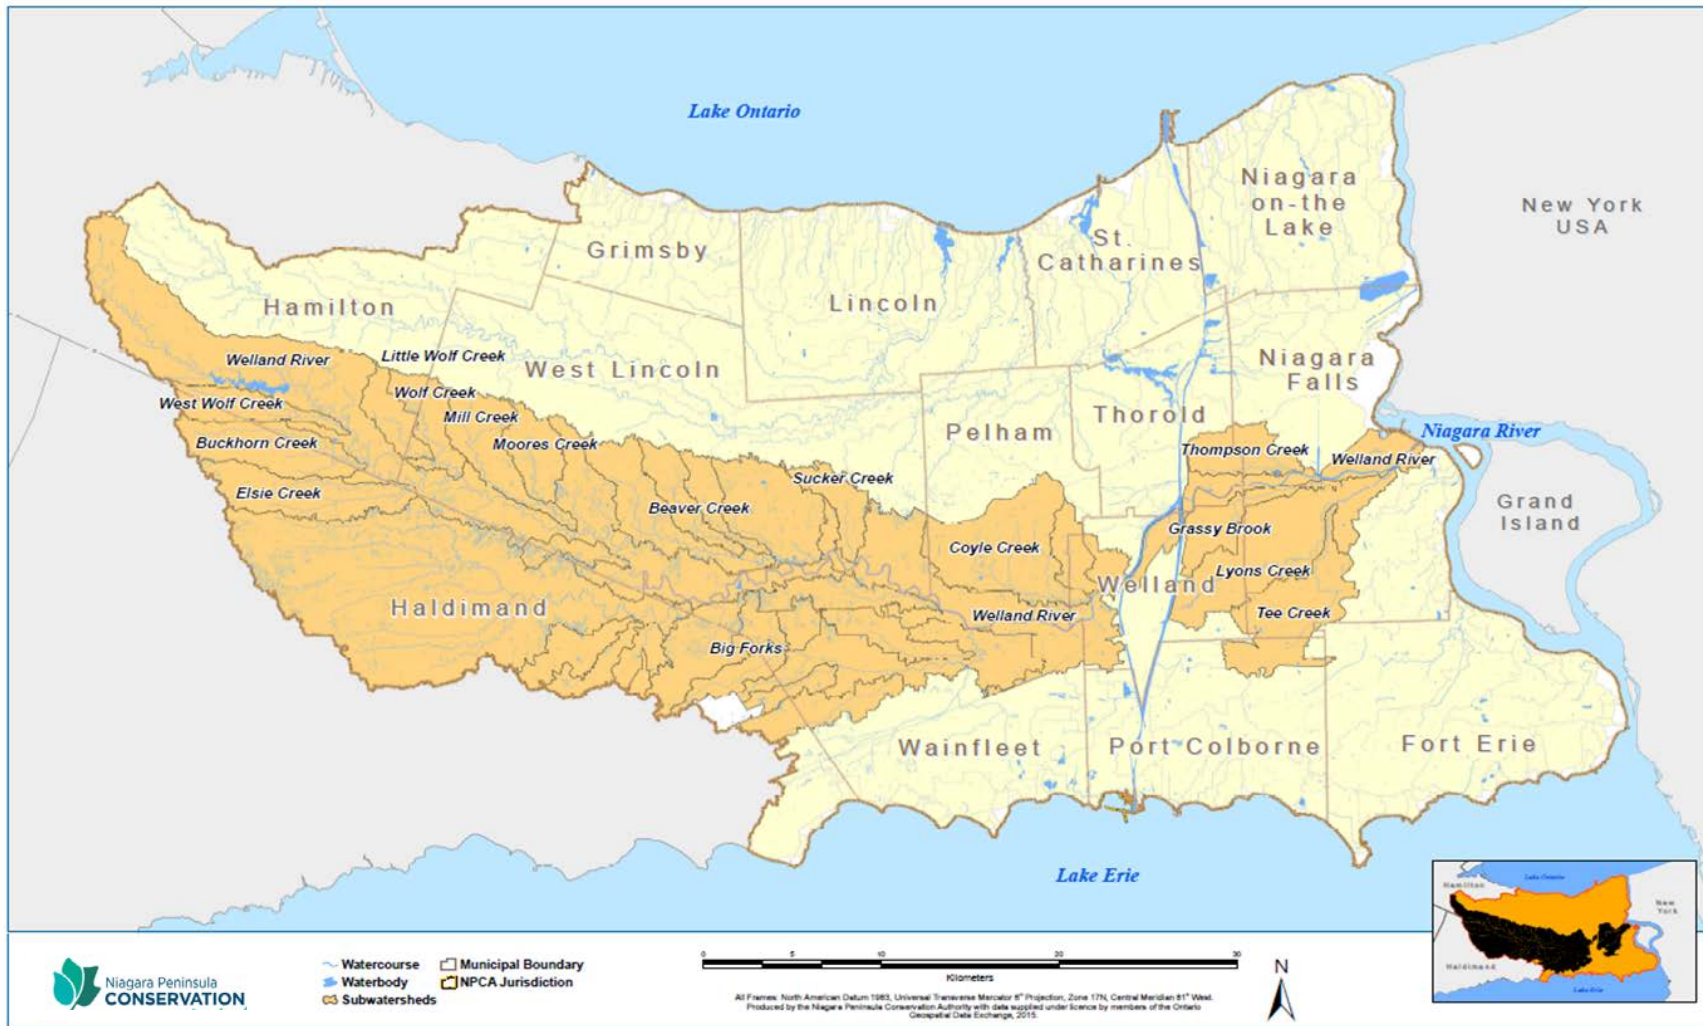
Figure 2: Welland River watershed.

The Welland River is the largest watershed in the NPCA jurisdiction with a total drainage area of 1,023 km². The watershed covers eleven local municipalities, originating in the Town of Ancaster and spanning the center of the Niagara Peninsula to its physical outlet in the City of Niagara Falls at the Niagara River (**Figure 2**). Over 70% of the watershed is classified as rural. The Welland River is part of the Niagara River Area of Concern (AOC). As shown in **Appendix A**, 30 of the 84 surface water quality monitoring stations are in the Welland River watershed, and 14 of these 30 stations are located on the main Welland River channel.

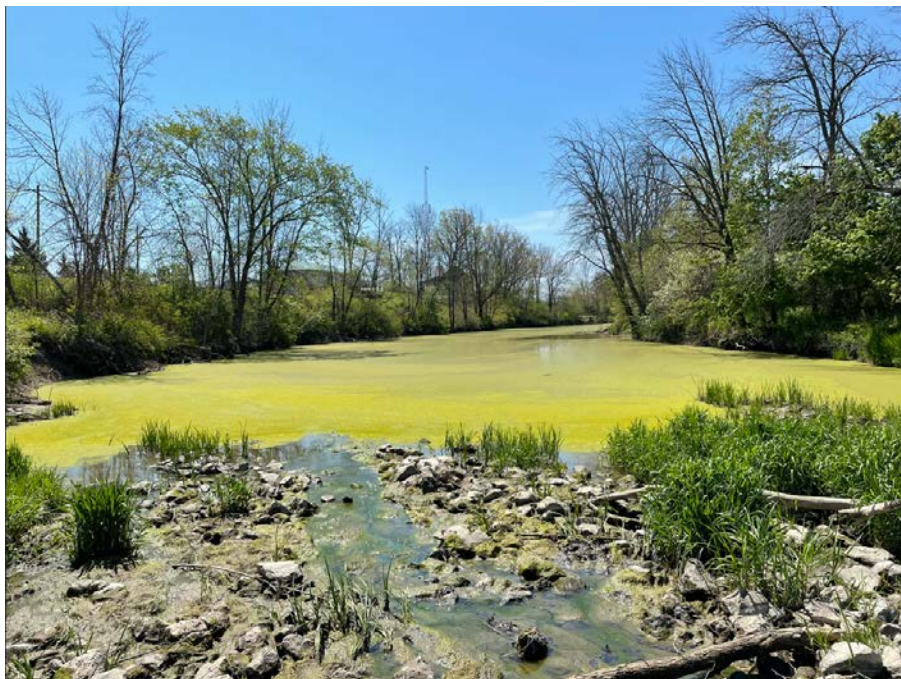
Figure 3: Excessive algae growth in the Central Welland River

Based on the 2019-2023 data, elevated concentrations of total phosphorus are a widespread cause of water quality impairment in the Welland River. Greater than 95% of samples collected in the main Welland River exceeded the PWQO with some concentrations greater than 20 times the PWQO. High phosphorus in the Welland River has stimulated the overgrowth of algae and duckweed throughout the watershed. When these plants transpire, and decompose they deplete dissolved oxygen in the water and this in turn stresses aquatic organisms such as fish and benthic invertebrates. Manure from livestock operations, sewage discharges, soil erosion, fertilizers, and pesticides are sources of total phosphorus in the Welland River.

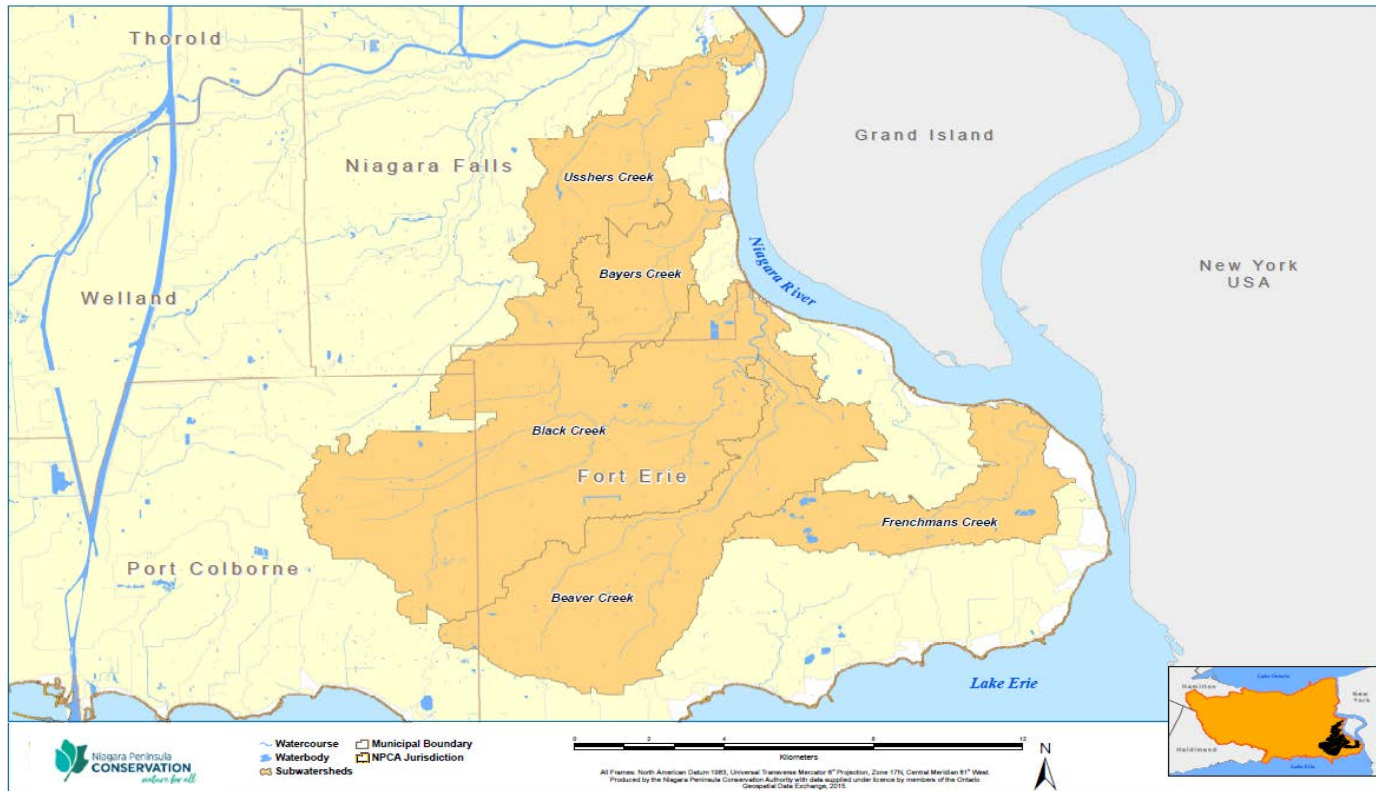
Figure 9: Map of subwatersheds that drain into Niagara River.

Four tributaries discharging to the Niagara River are monitored through the NPCA Water Quality Monitoring Program. These tributaries include: Bayer Creek, Black Creek (including Beaver Creek), Frenchman's Creek, and Usshers Creek (**Figure 9**).

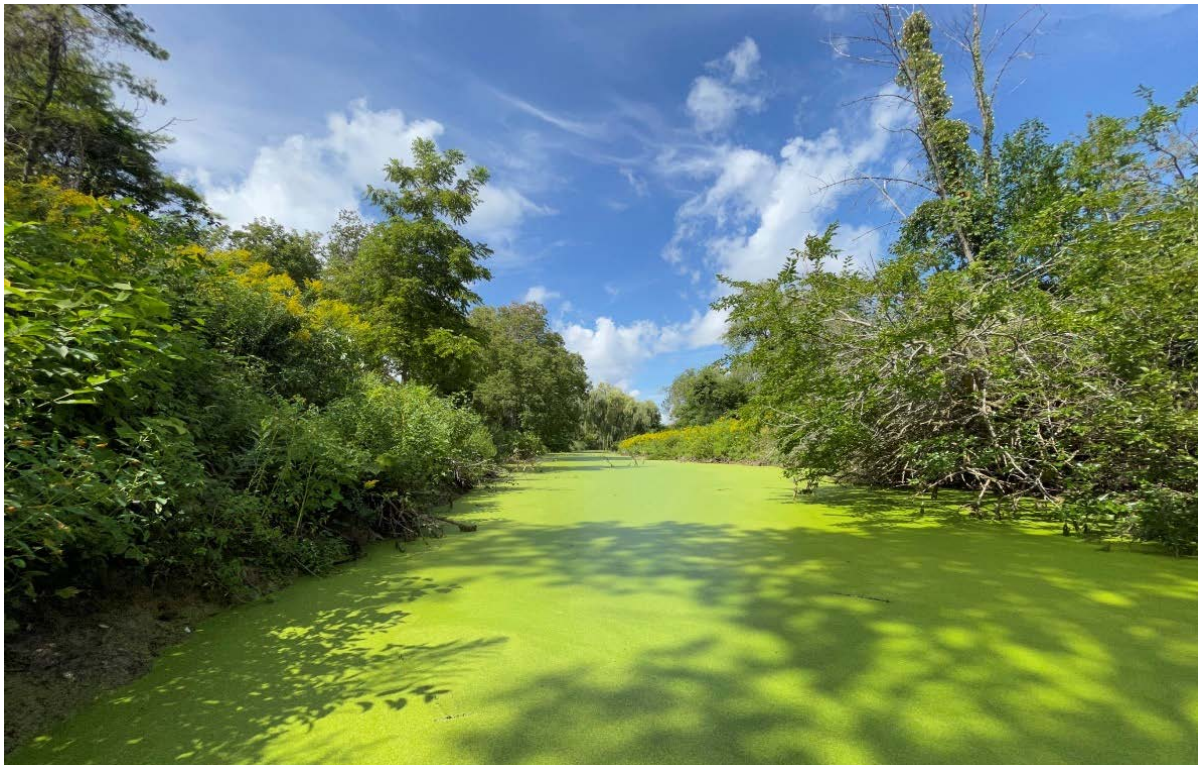
Figure 11: A drain to Lake Erie with excessive duckweed growth.

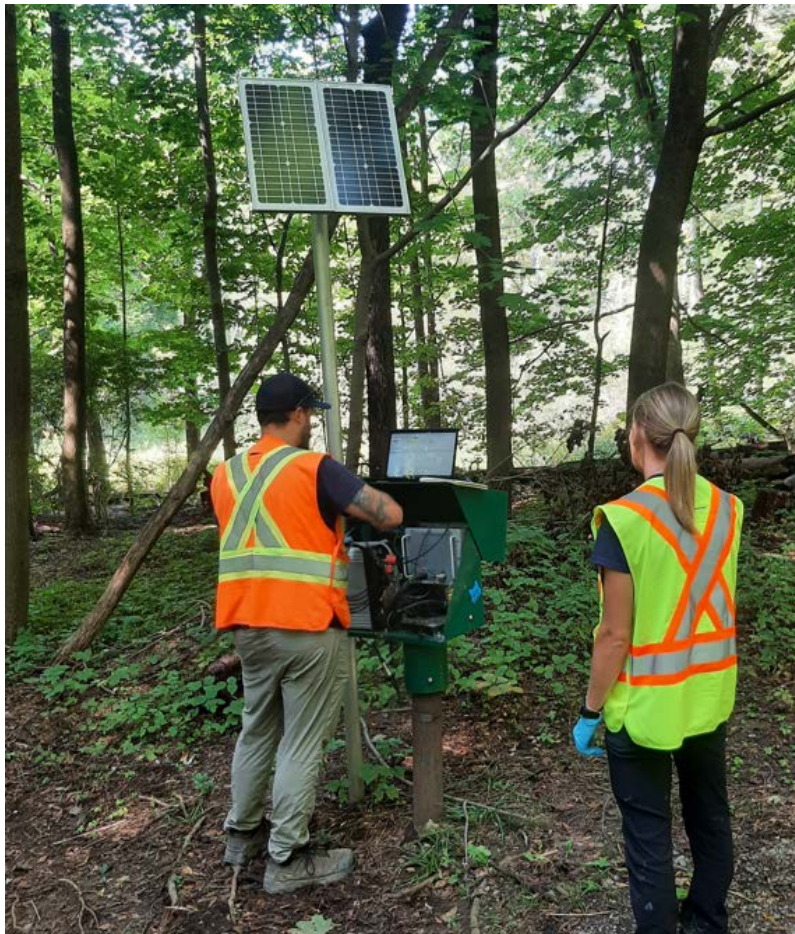
The NPCA has been monitoring water levels at all PGMN wells since 2003 and other NPCA wells since 2014. Groundwater levels are typically at their highest during the late-winter and spring but begin to drop during the dry summer months and are lowest in the fall. There is also yearly variation in the groundwater levels which is dependent on precipitation. In dry years (such as 2016), water levels can drop substantially from their seasonal highs; and conversely the water level drops in wet years (2009) are not as substantial. PGMN monitoring wells each have water levels that are seasonally and yearly variable due to several factors (geologic formation the well is installed in, soils, precipitation, etc.). The groundwater level data from the NPCA groundwater monitoring network will be used to help better understand the impacts of local/provincial scale drought events and its connection to climate change. Groundwater level data for 2023 is unavailable for this report, and will be reported on in the future.

Figure 13: NPCA staff performing routine monitoring on a groundwater well.

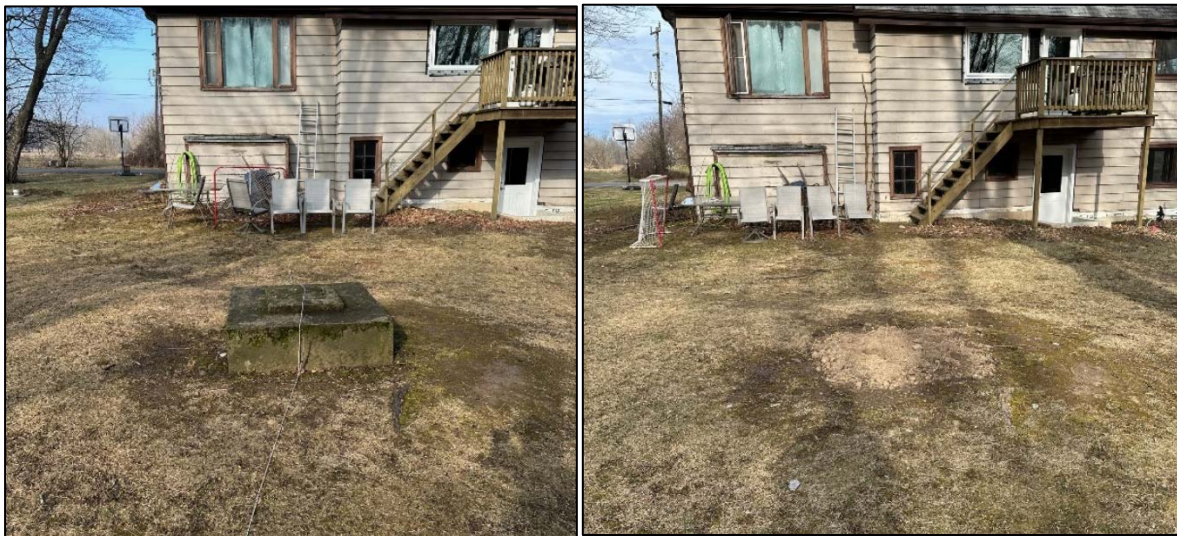
Figure 14: Before and after photos from a water well decommissioning project.

In 2023, the NPCA continued to provide grants to watershed residents interested in properly decommissioning abandoned water wells on their property through the NPCA Water Well Decommissioning Program. The grant program offers an 80% subsidy for water well decommissioning to a maximum of \$1000 per well. Grant applications are prioritized in areas designated as highly susceptible to groundwater contamination in the NPCA Groundwater Study (Waterloo Hydrogeologic Inc. 2005), areas where there is a high density of private wells used for domestic purposes, and areas where a watershed plan has been completed or is underway. Numerous improperly abandoned water wells are known to exist in the NPCA watershed, and these wells can serve as a direct pathway between potential contaminants at ground surface and deeper aquifers. The implementation of this program will reduce the risk of groundwater contamination and fulfills a recommendation made in the Groundwater Management Strategy of the NPCA Groundwater Study (Waterloo Hydrogeologic Inc. 2005). To date, 114 water wells have been decommissioned with the NPCA water well decommissioning program. An example of a water well decommissioning project is shown in **Figure 14**.

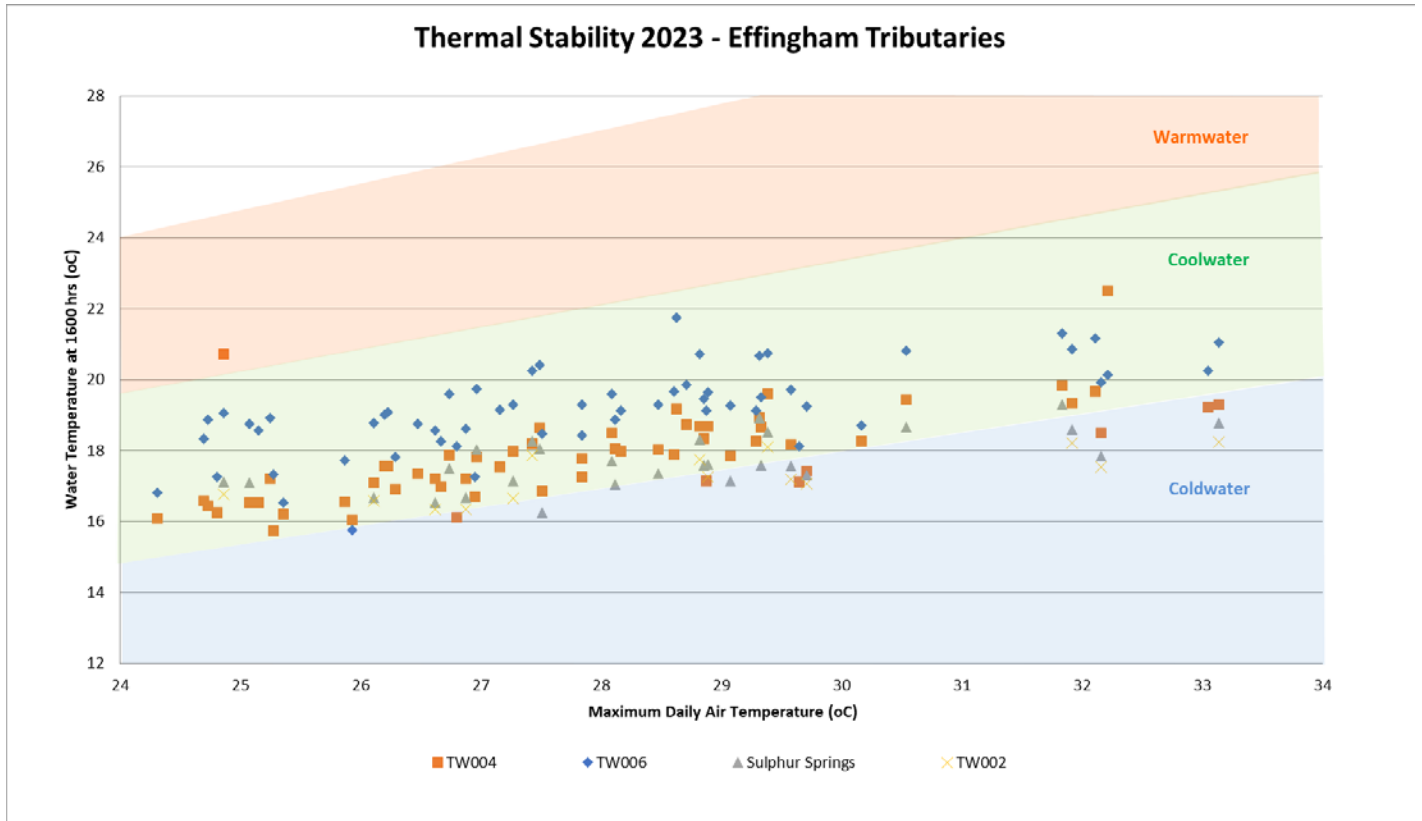
Figure 16: Thermal stability nomogram for Effingham Tributaries of Upper Twelve Mile Creek.

Nomograms (**Figures 16 and 17**) were created for the Effingham and St Johns Tributaries of the Upper Twelve Mile Creek with the stream temperature data collected from July 1st to September 10th 2023. The findings of these nomograms classify sites TW000 and TW003 as coldwater. Sites TW001, TW004, TW006, TW007 and TW012 were classified as coolwater. Sites TW002, TW005 and Sulphur Springs encountered logger failure and did not have sufficient temperature data to determine a classification. No sites were classified as warmwater.

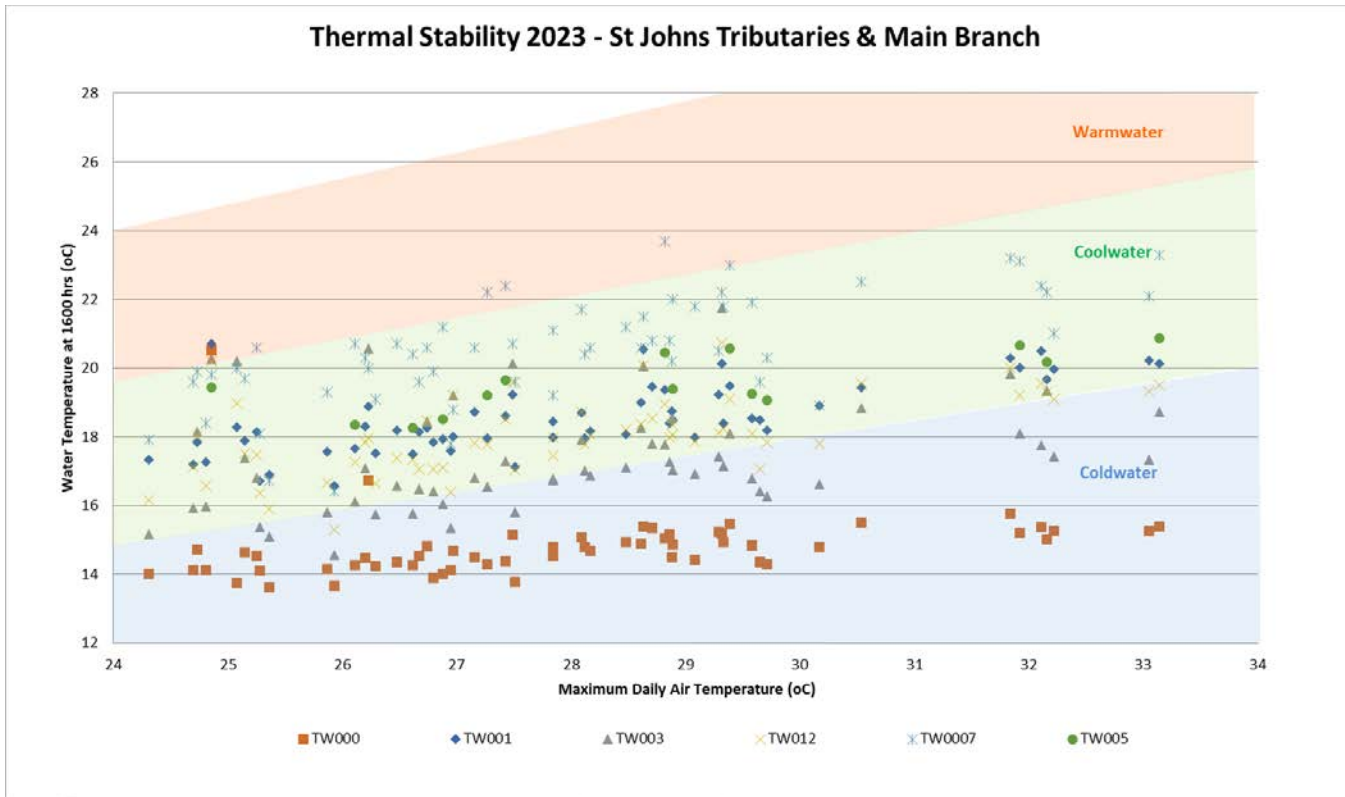
Figure 17: Thermal stability nomogram for St Johns tributary and the main branch of Upper Twelve Mile Creek.

The headwaters of the St. Johns tributary have continued to maintain a coldwater classification from 2011-2023 (**Table 13**). Site TW004 shifted from coldwater in 2022 to coolwater in 2023. Site TW012 was added to the list of monitoring sites in 2023 and will continue to be monitored in future years. In general, the classification of the monitoring sites has remained stable with previous assessments. In 2023, equipment failures at sites TW002, Sulphur Springs, and TW005 meant that data was missing during the summer and therefore these streams have not been classified in 2023.

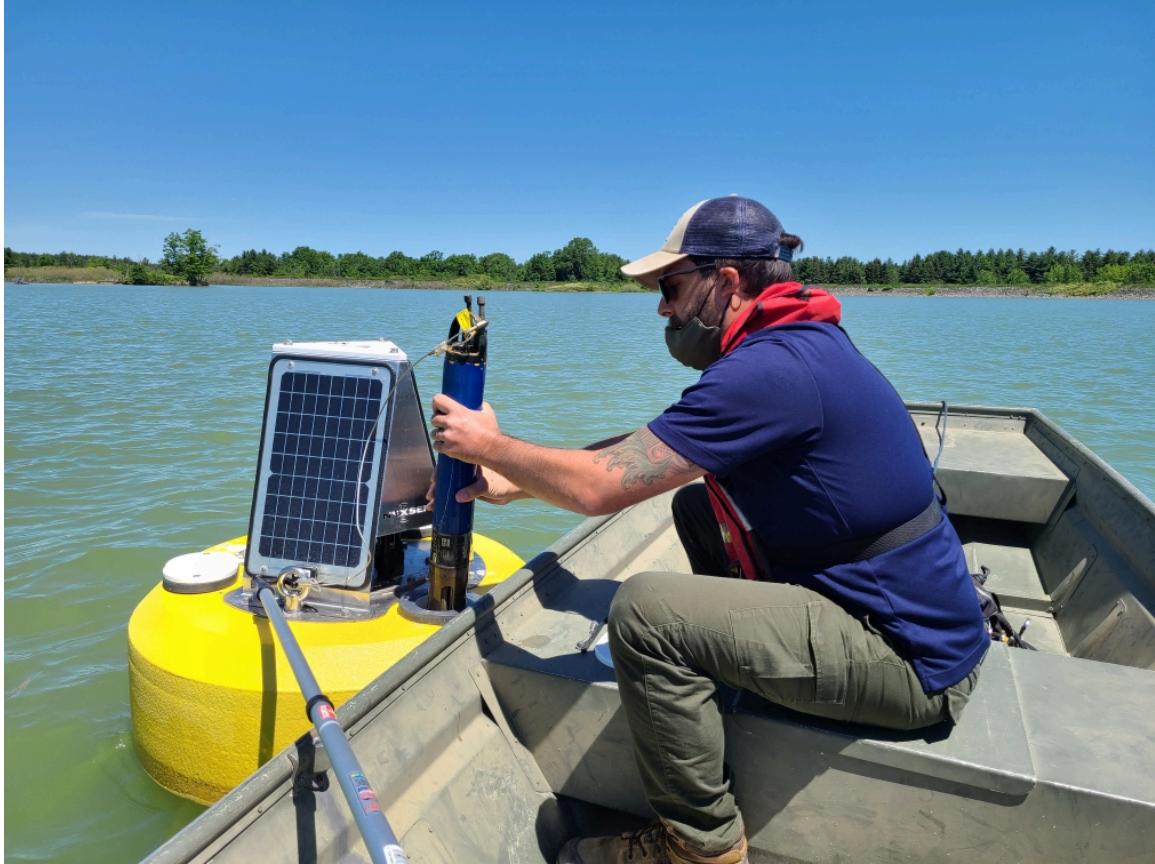
Figure 18: NPCA staff installing an EXO multiparameter sonde in a buoy.

Sensor	Location	Parameters
HOBO U26 Dissolved Oxygen Data Logger	Big Forks Creek	Water temperature, dissolved oxygen
HOBO U26 Dissolved Oxygen Data Logger	Wignell Drain	Water temperature, dissolved oxygen
HOBO U26 Dissolved Oxygen Data Logger	Beaver Dam Drain	Water temperature, dissolved oxygen
YSI EXO 2 Multiparameter Sonde	O'Reilly's Bridge, Welland River	Water temperature, pH, conductivity, dissolved oxygen, turbidity
YSI EXO 2 Multiparameter Sonde	Lake Niapenco, Binbrook Conservation Area	Water temperature, pH, conductivity, dissolved oxygen, turbidity, total algae
YSI EXO 3 Multiparameter Sonde	Twelve Mile Creek downstream of Short Hills Provincial Park	Water temperature, pH, conductivity, dissolved oxygen, turbidity
YSI EXO 3 Multiparameter Sonde	Welland River, Caistorville	Water temperature, pH, conductivity, dissolved oxygen, turbidity
YSI EXO 3 Multiparameter Sonde	Twenty Mile Creek, Woodburn	Water temperature, pH, conductivity, dissolved oxygen, turbidity

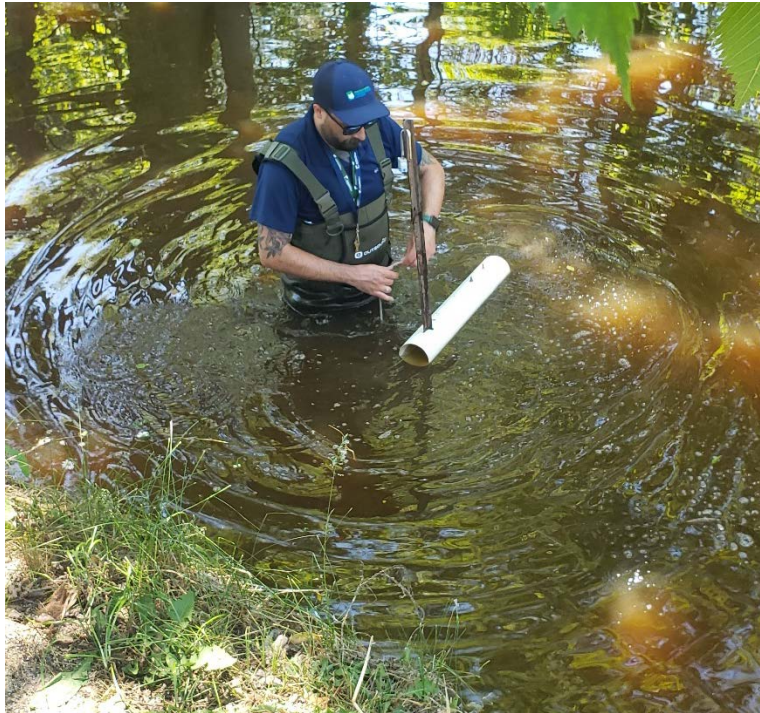
Figure 19: NPCA staff installing a dissolved oxygen logger in a creek.

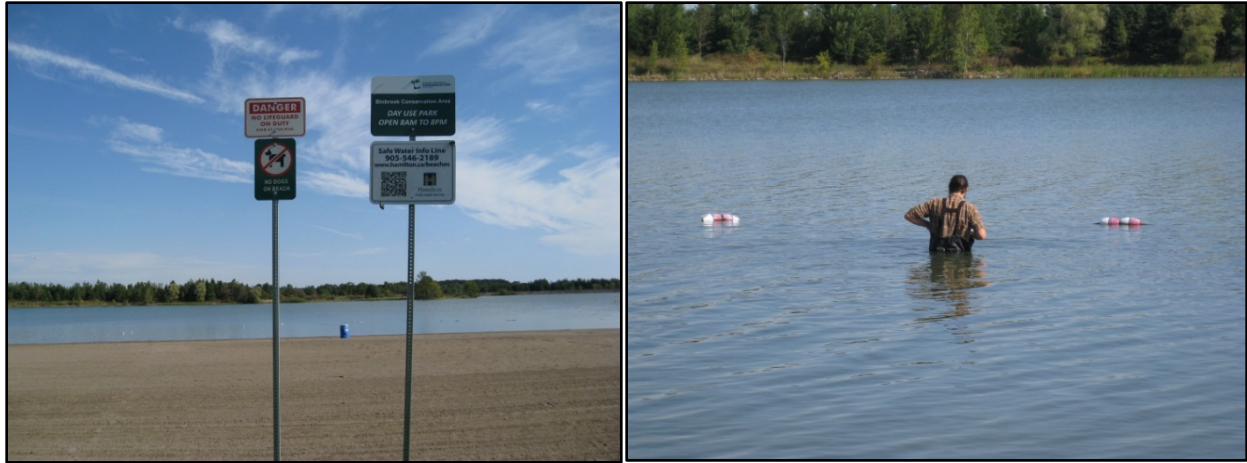
Figure 21: Beach sampling for PFAS in Lake Niapenco.
