NPCA WATER QUALITY MONITORING PROGRAM:
SUMMARY REPORT OF THE YEAR 2019

MAY 2020

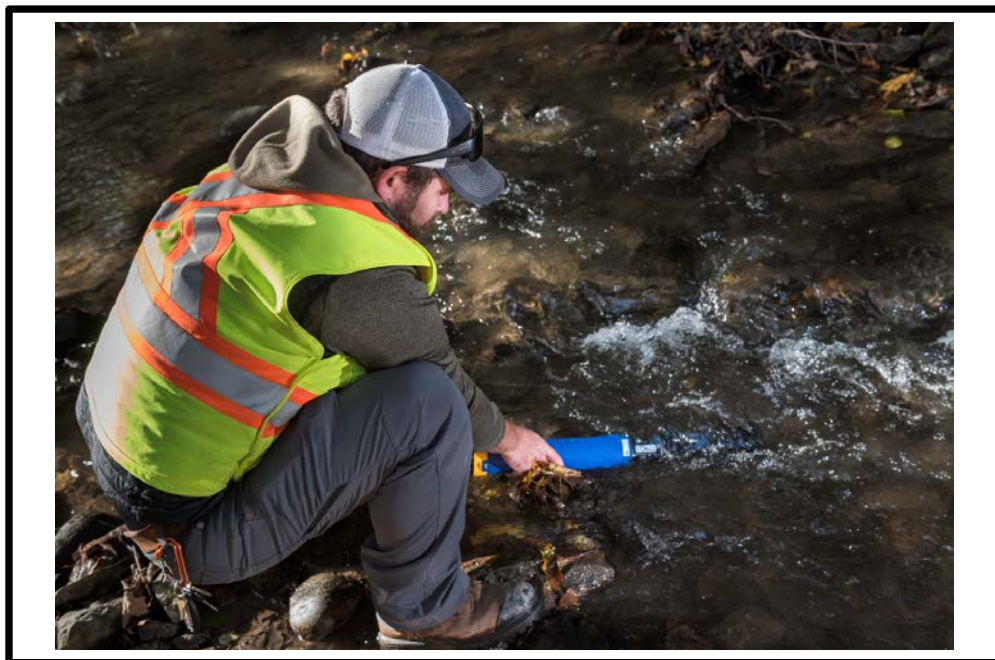
NPCA staff using a water quality sensor to measure dissolved oxygen.

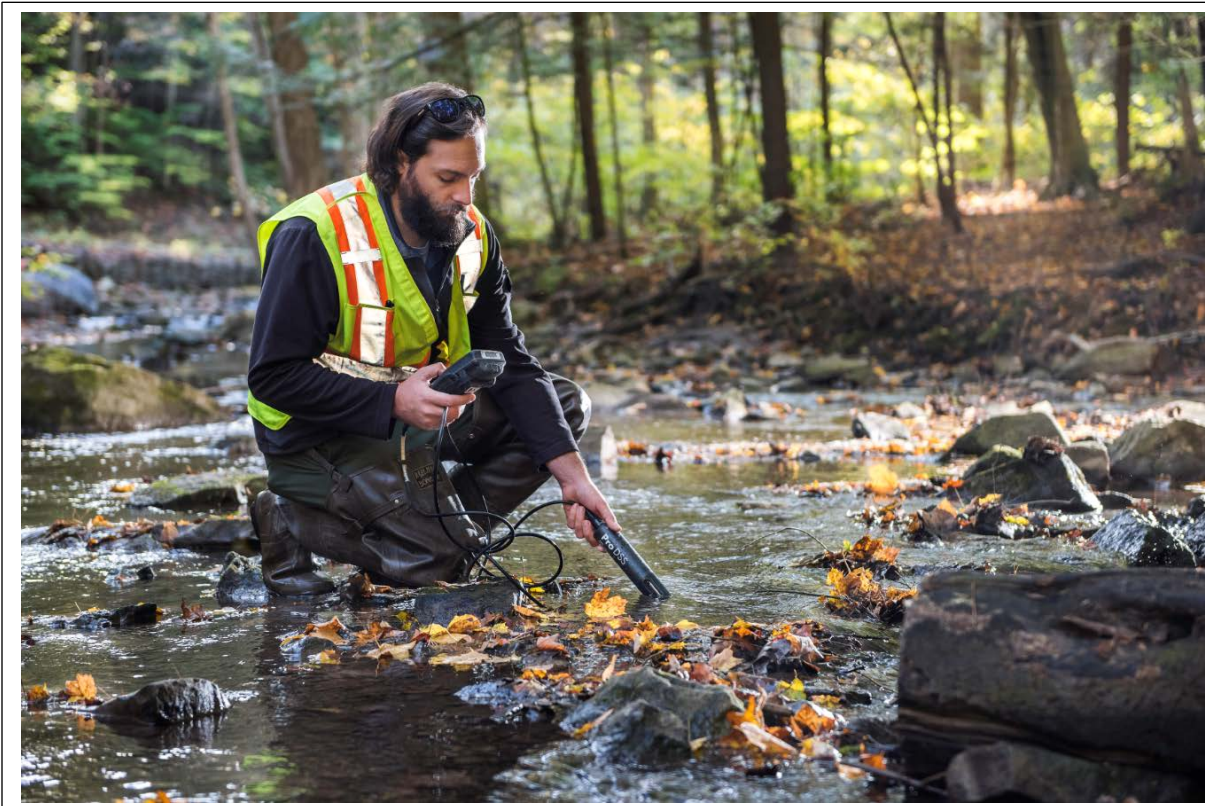
NPCA staff using a water quality sensor to measure stream temperature.

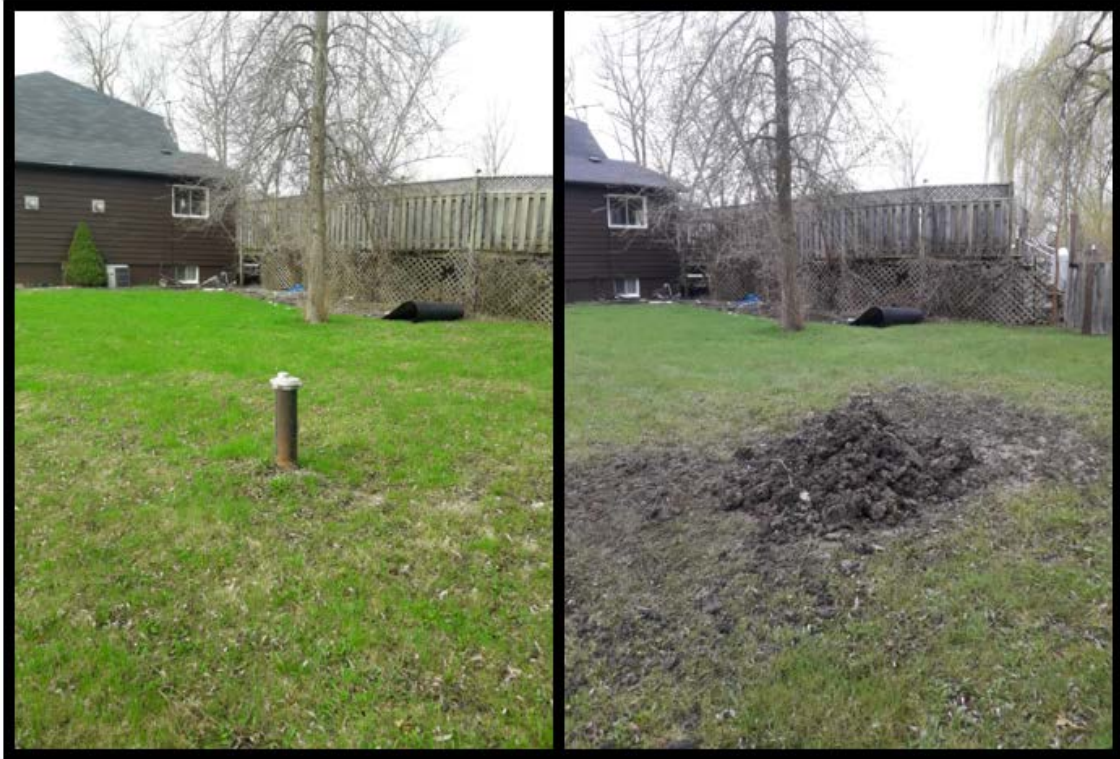
Figure 12: An example of a NPCA Water Well Decommissioning Project. Left photo shows an abandoned drilled well in need of decommissioning and the right photo shows same dug well after decommissioning had been completed by a licensed well contractor.

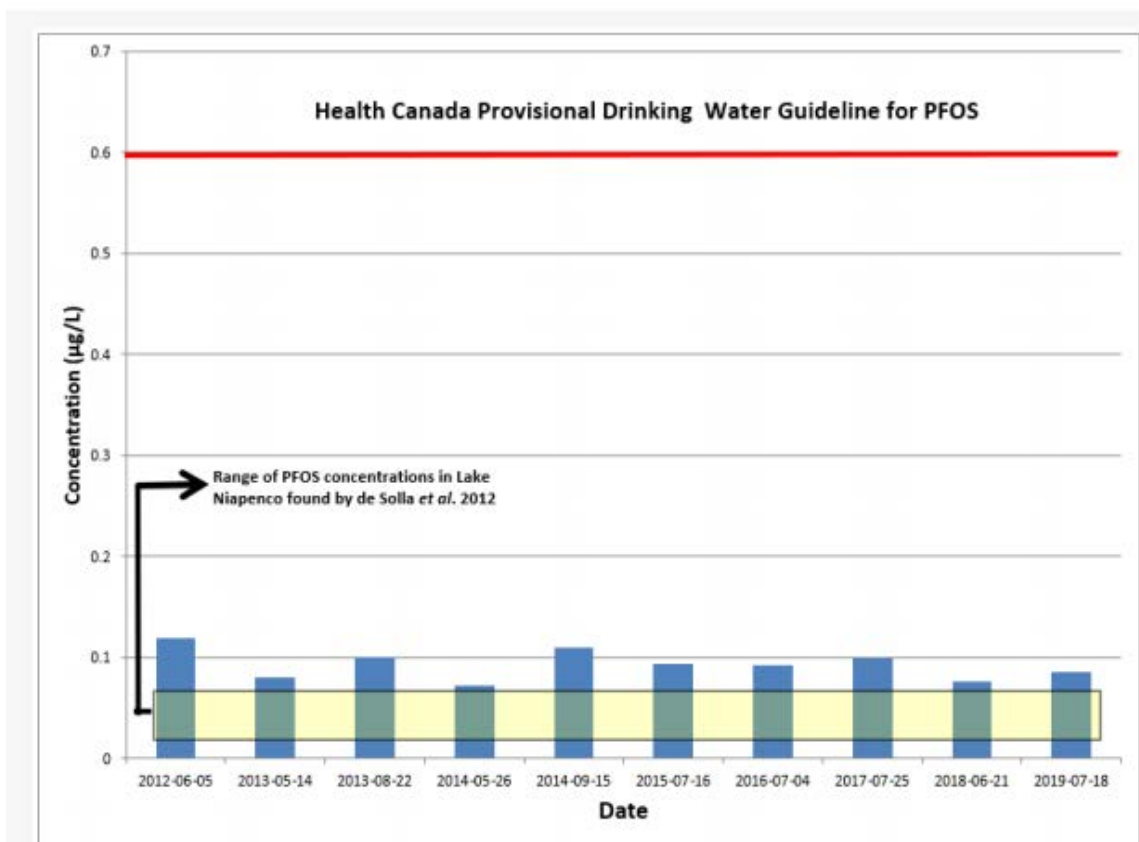
Figure 15. PFOS concentrations found in Lake Niapenco by NPCA monitoring 2012-2019

Lake Niapenco was contaminated by historic PFC usage from John C. Munro International Airport in Hamilton (de Solla 2012 and Fowler 2011). The NPCA's monitoring at Binbrook Conservation Area continues to support the evidence that PFCs and specifically PFOS are present in Lake Niapenco but not at concentrations above Health Canada drinking water guidelines. It is expected that PFCs will continue to be present in Lake Niapenco due the persistence of PFCs in the environment and due to the delay to contain upstream sources. It should be noted that Hamilton Public Health has evaluated previous PFC water quality data at Binbrook Conservation Authority and determined that the PFC concentrations detected would not adversely affect the park users.

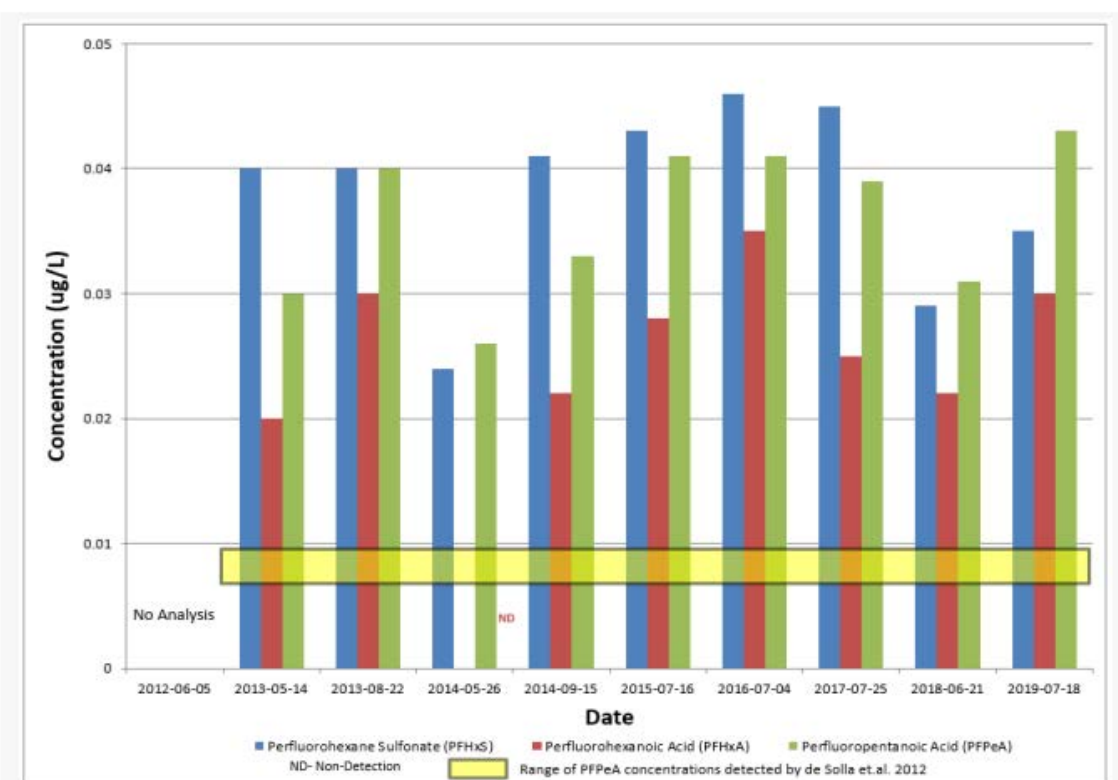
Figure 16: PFHxS, PFHxA and PFPeA concentrations found in Lake Niapenco by NPCA monitoring 2012-2019.
