Haldimand County Lake Erie Hazard Mapping and Risk Assessment

Technical Report

March 19, 2020 | 12969.101.R2.Rev3

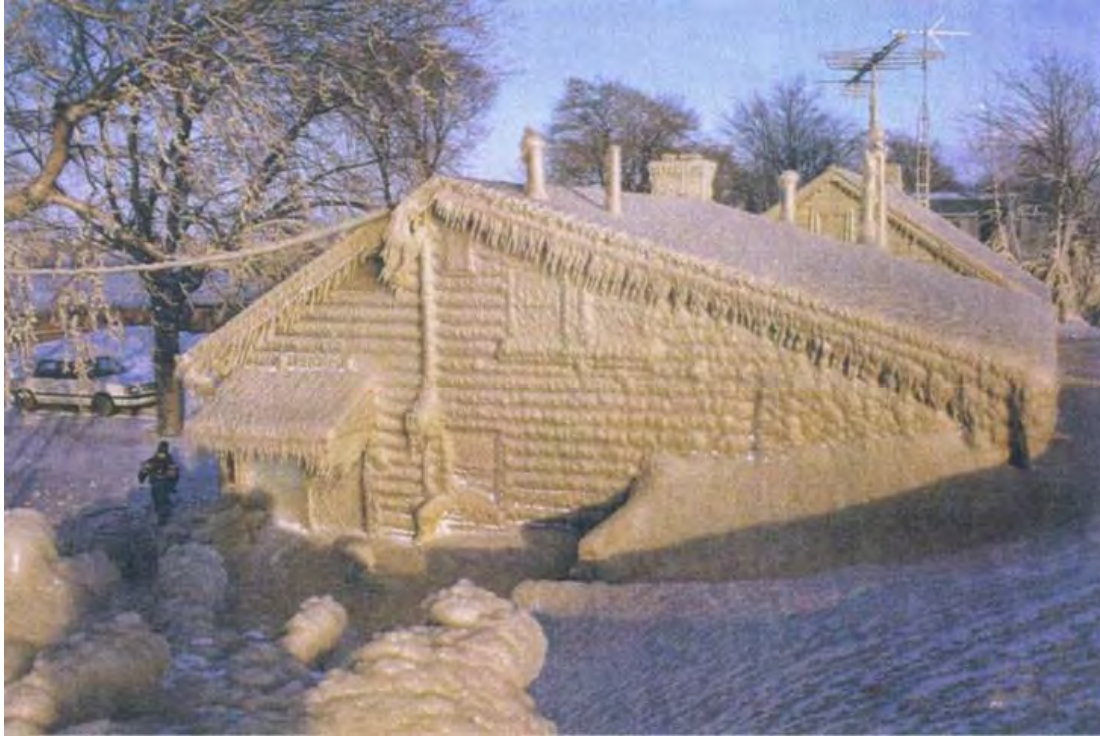
In terms of less severe ice effects along the Haldimand County shoreline, anecdotal reports were obtained from the GRCA and various residents. From the information obtained, it is evident that ice spray can occur during winter months when the lake is not completely frozen, or ice has been broken up by wave action. This combined with winds, results in the spray of waves icing structures along the shoreline. Specifically, this was noted to have occurred in December 1985 and February 2019 but may occur more frequently.

Figure 6.12: Example of Lake Erie ice spray on Erie Shore Drive (from LTVCA, date unknown)

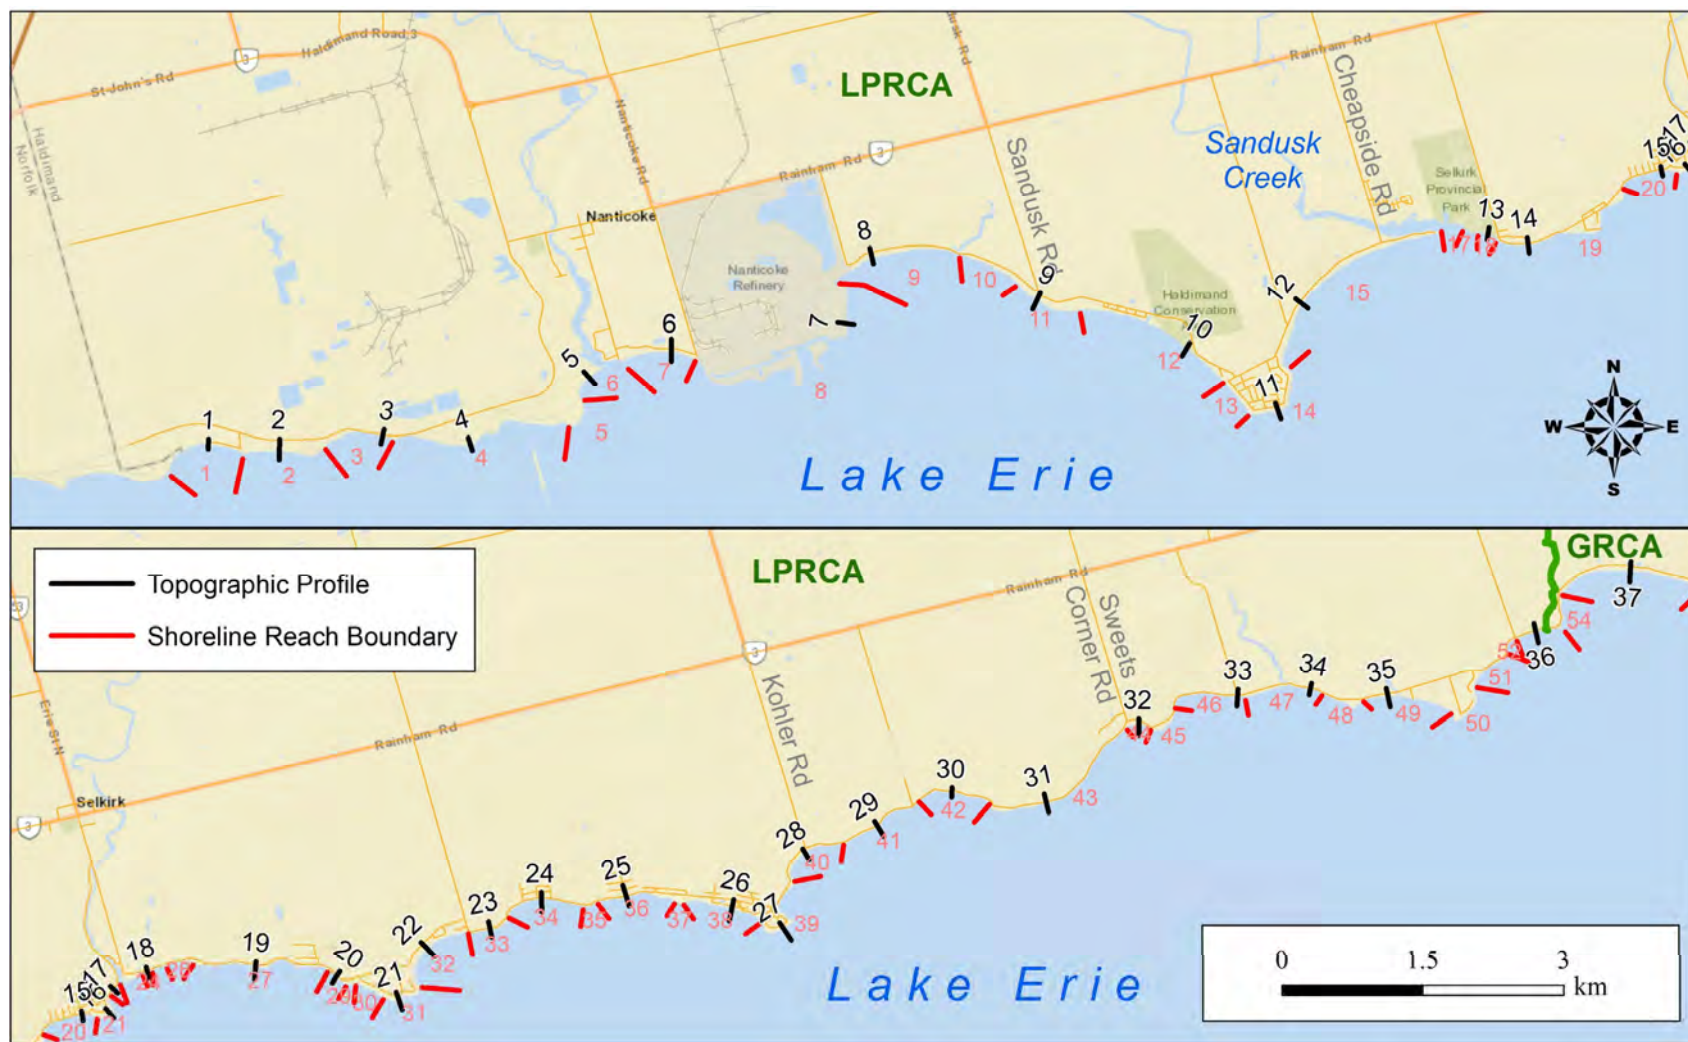
The computed minimum Factors of Safety for the sections analyzed was as low as 1.0 and the minimum Factors of Safety obtained for existing conditions in 10 of 52 section locations are considered inadequate and unacceptable for long-term planning purposes.

Figure 6.14: Map showing reaches and locations where a stable slope analysis was completed (west end of Haldimand County)

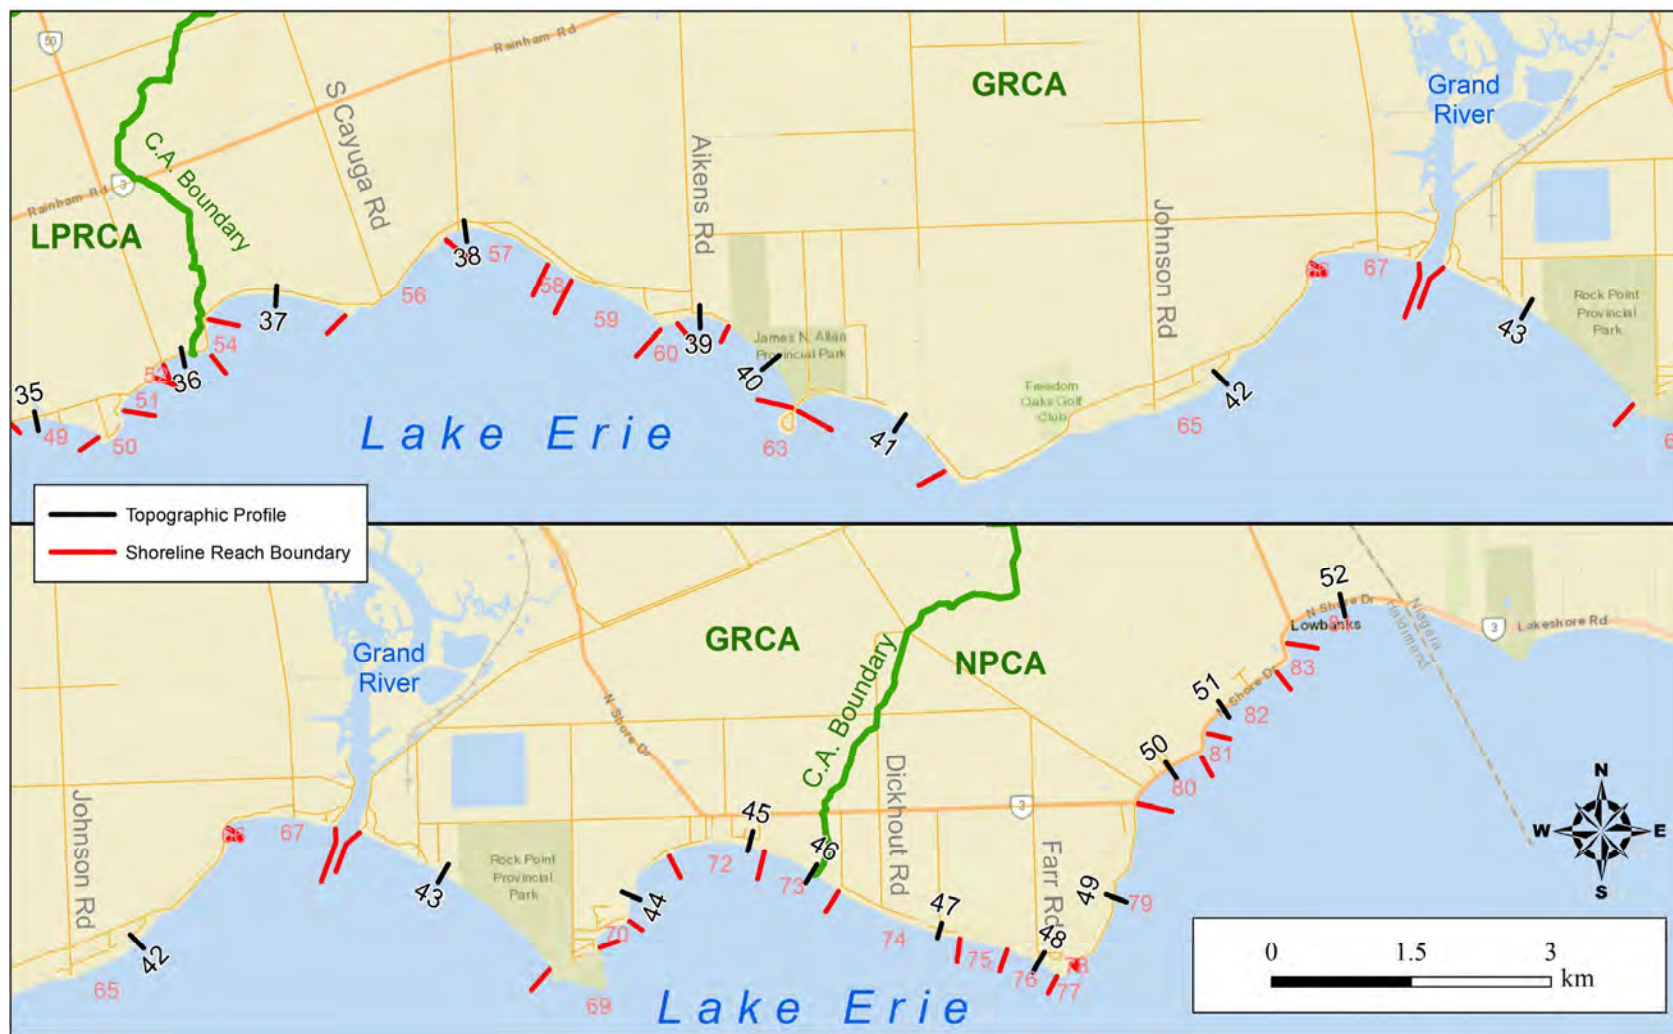
Figure 6.15: Map showing reaches and locations where a stable slope analysis was completed (east end of Haldimand County)

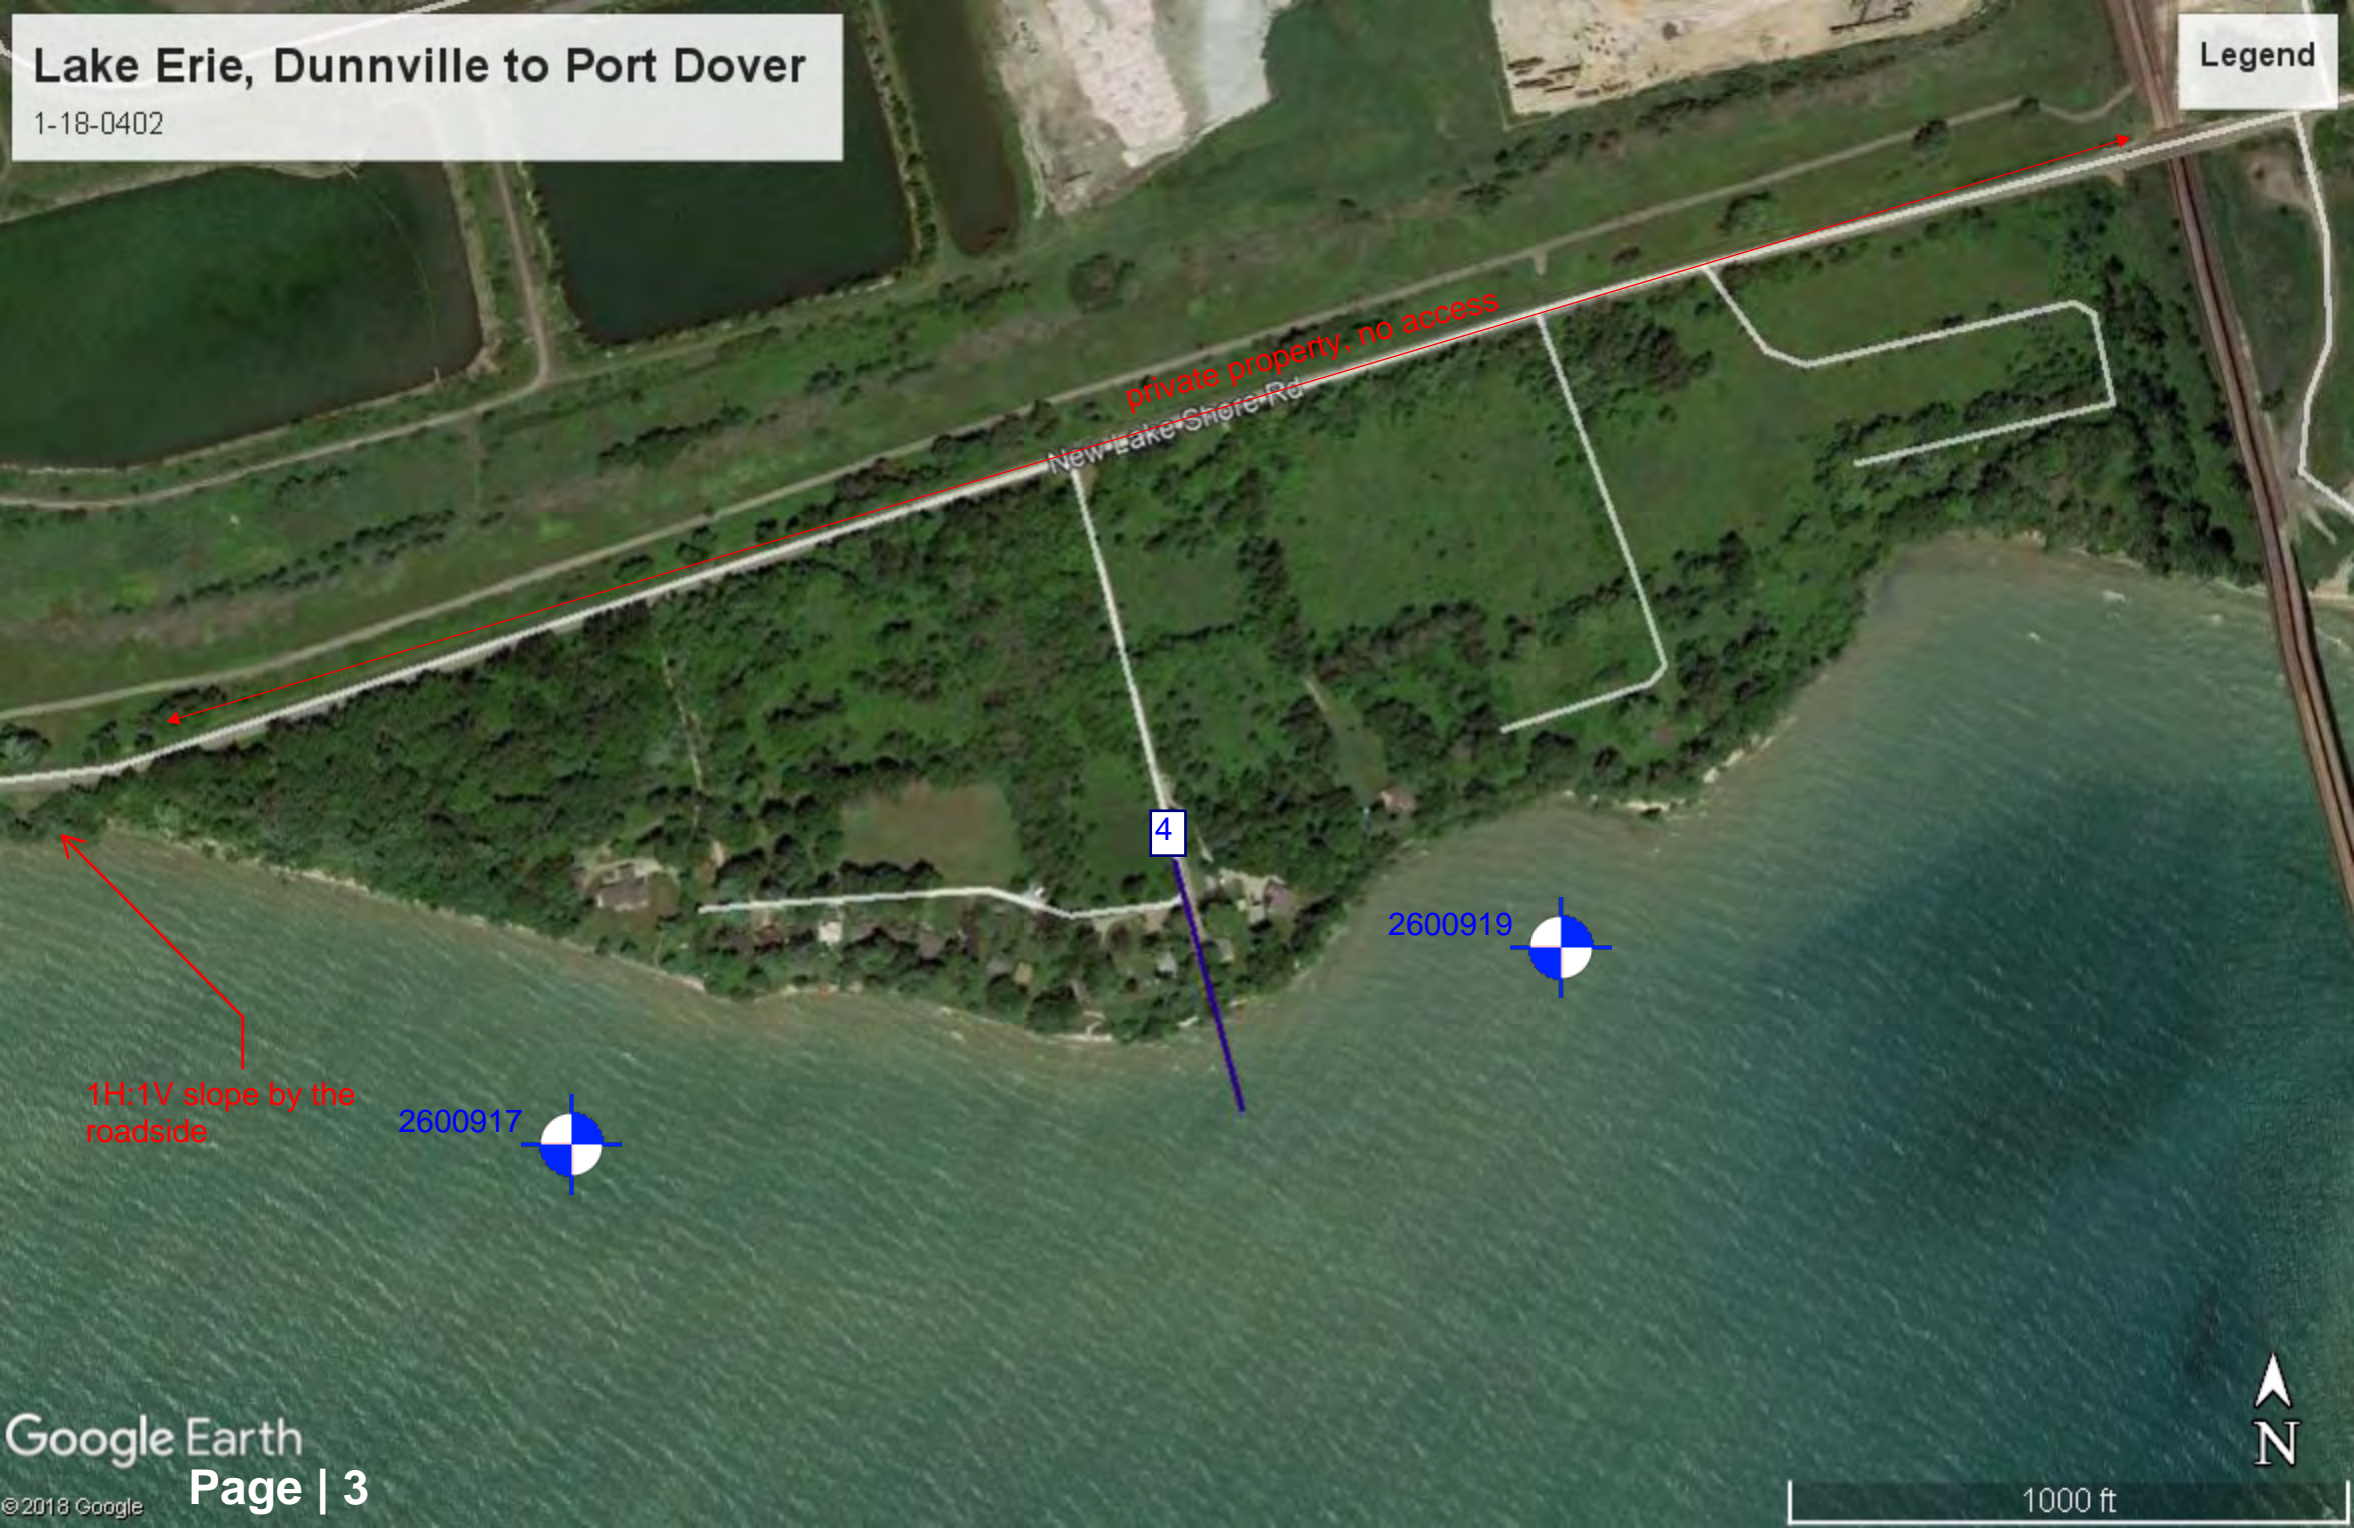
1H:1V slope by the roadside

private property, no access

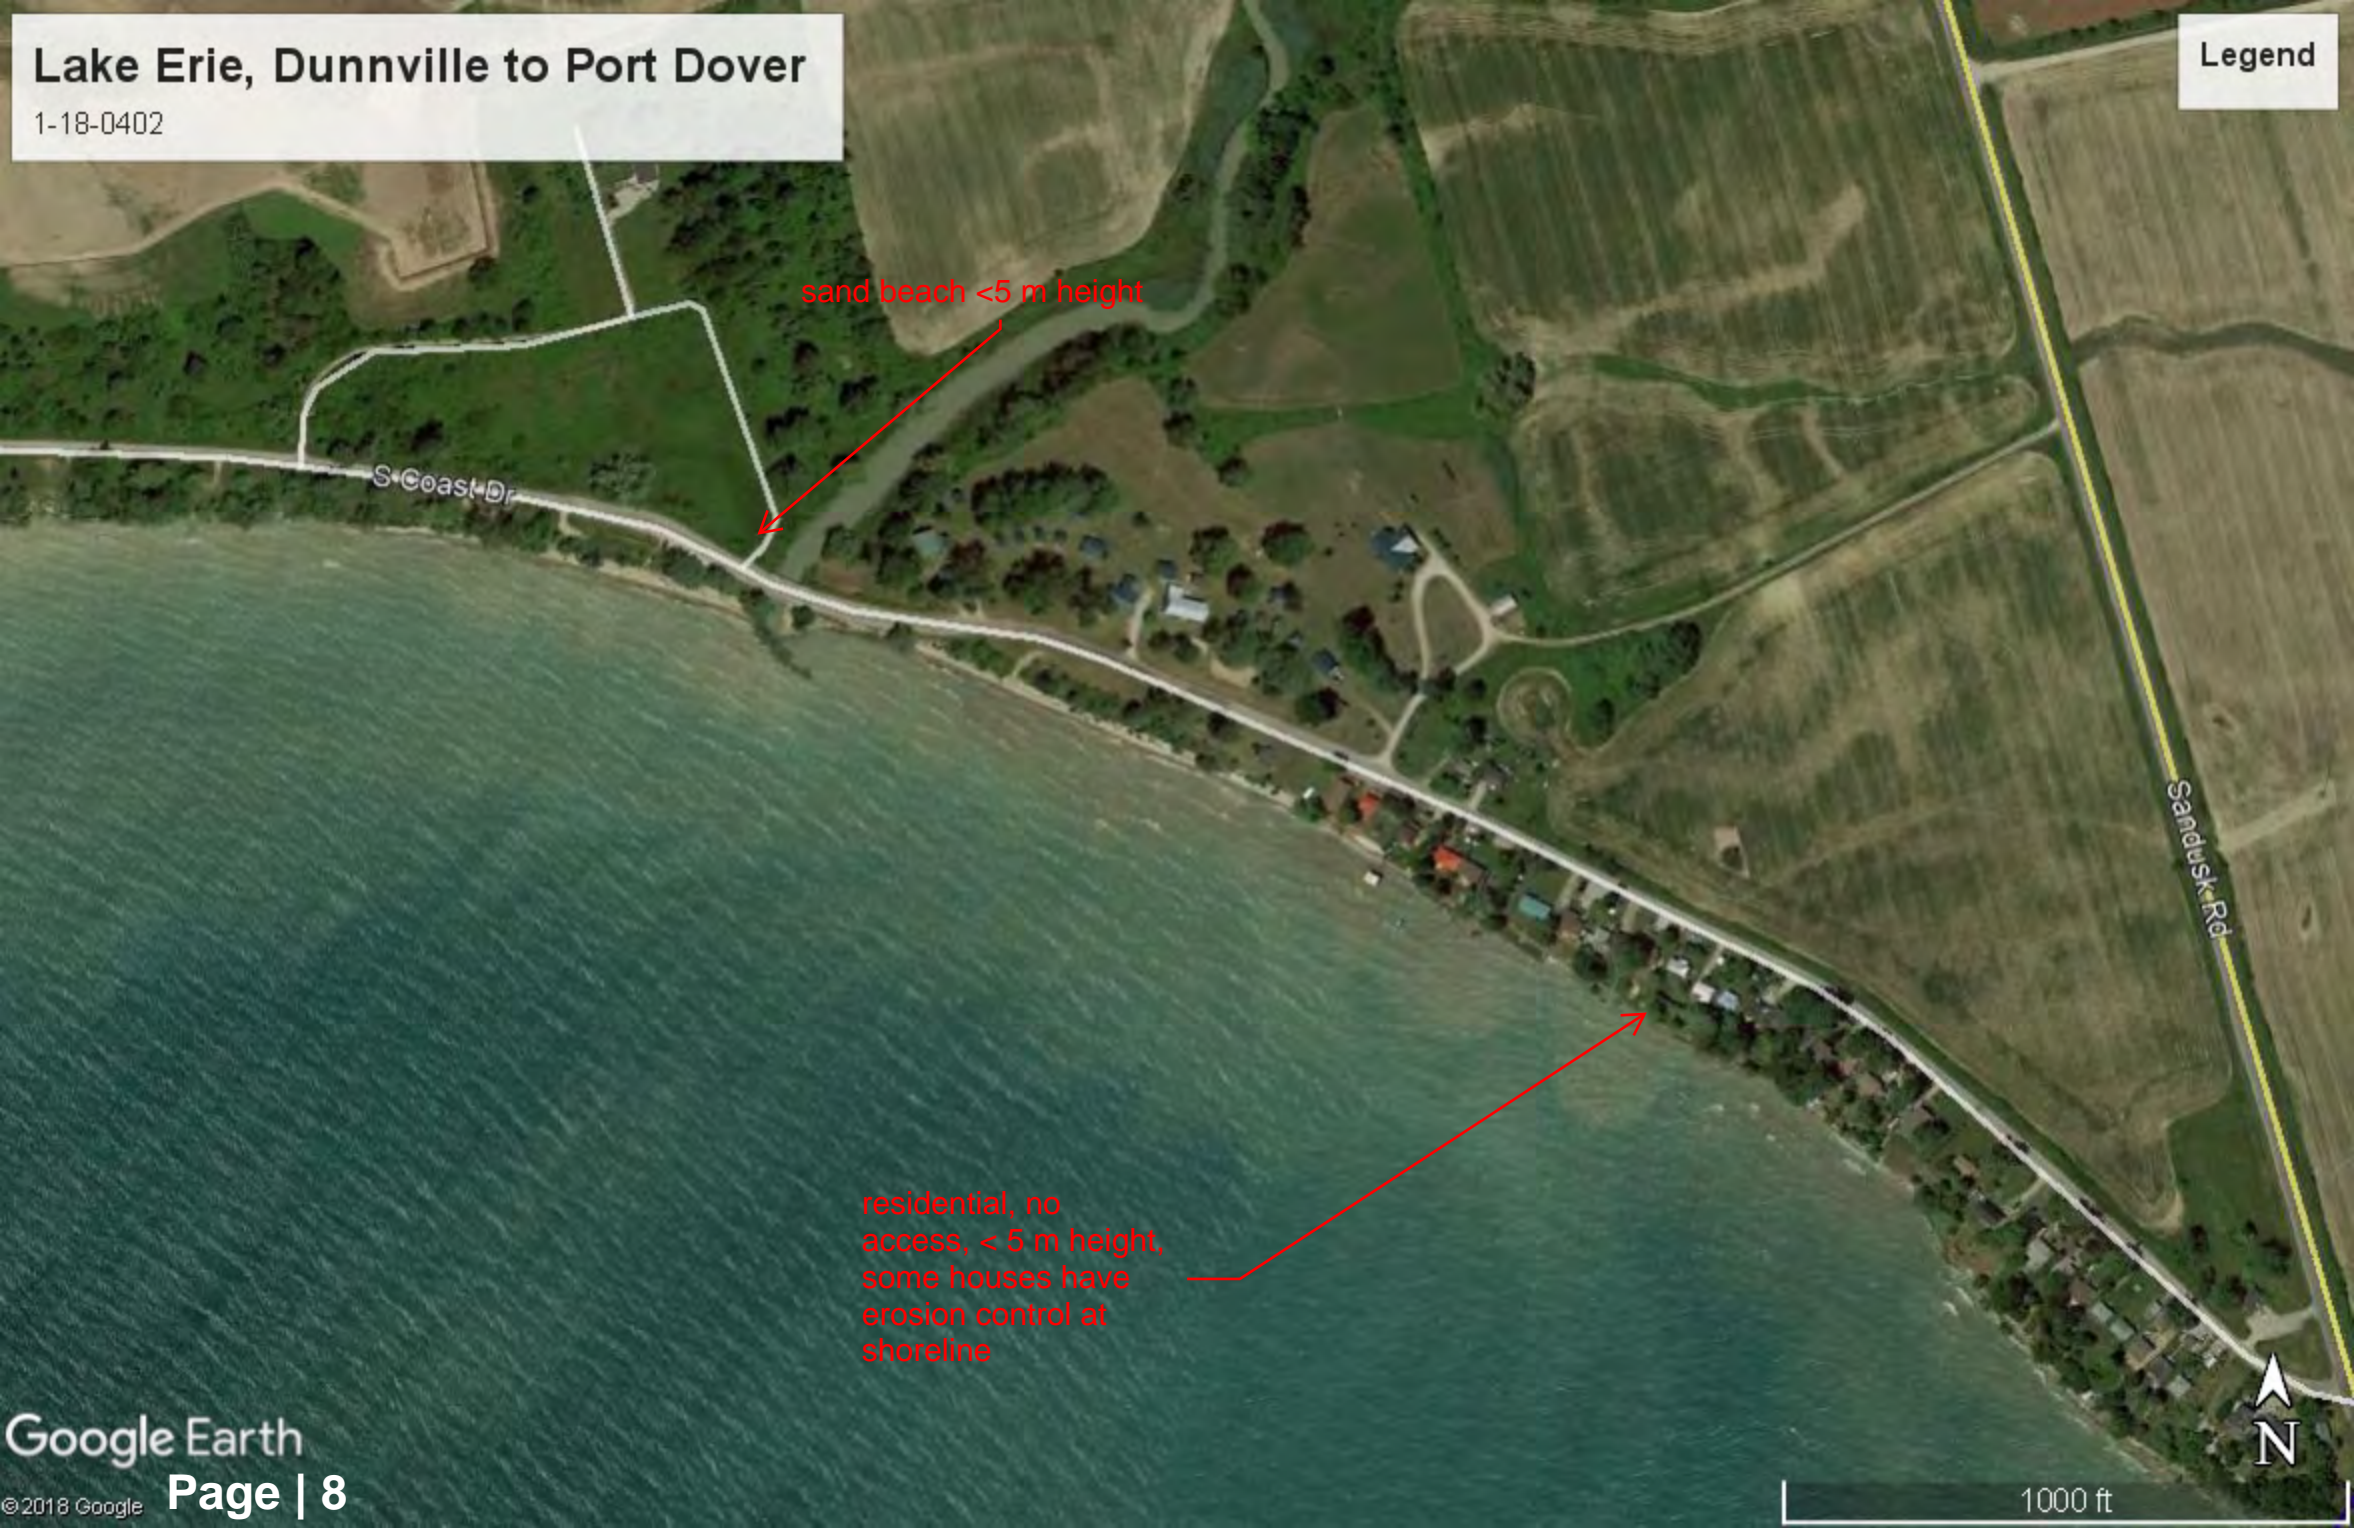
sand beach <5 m height

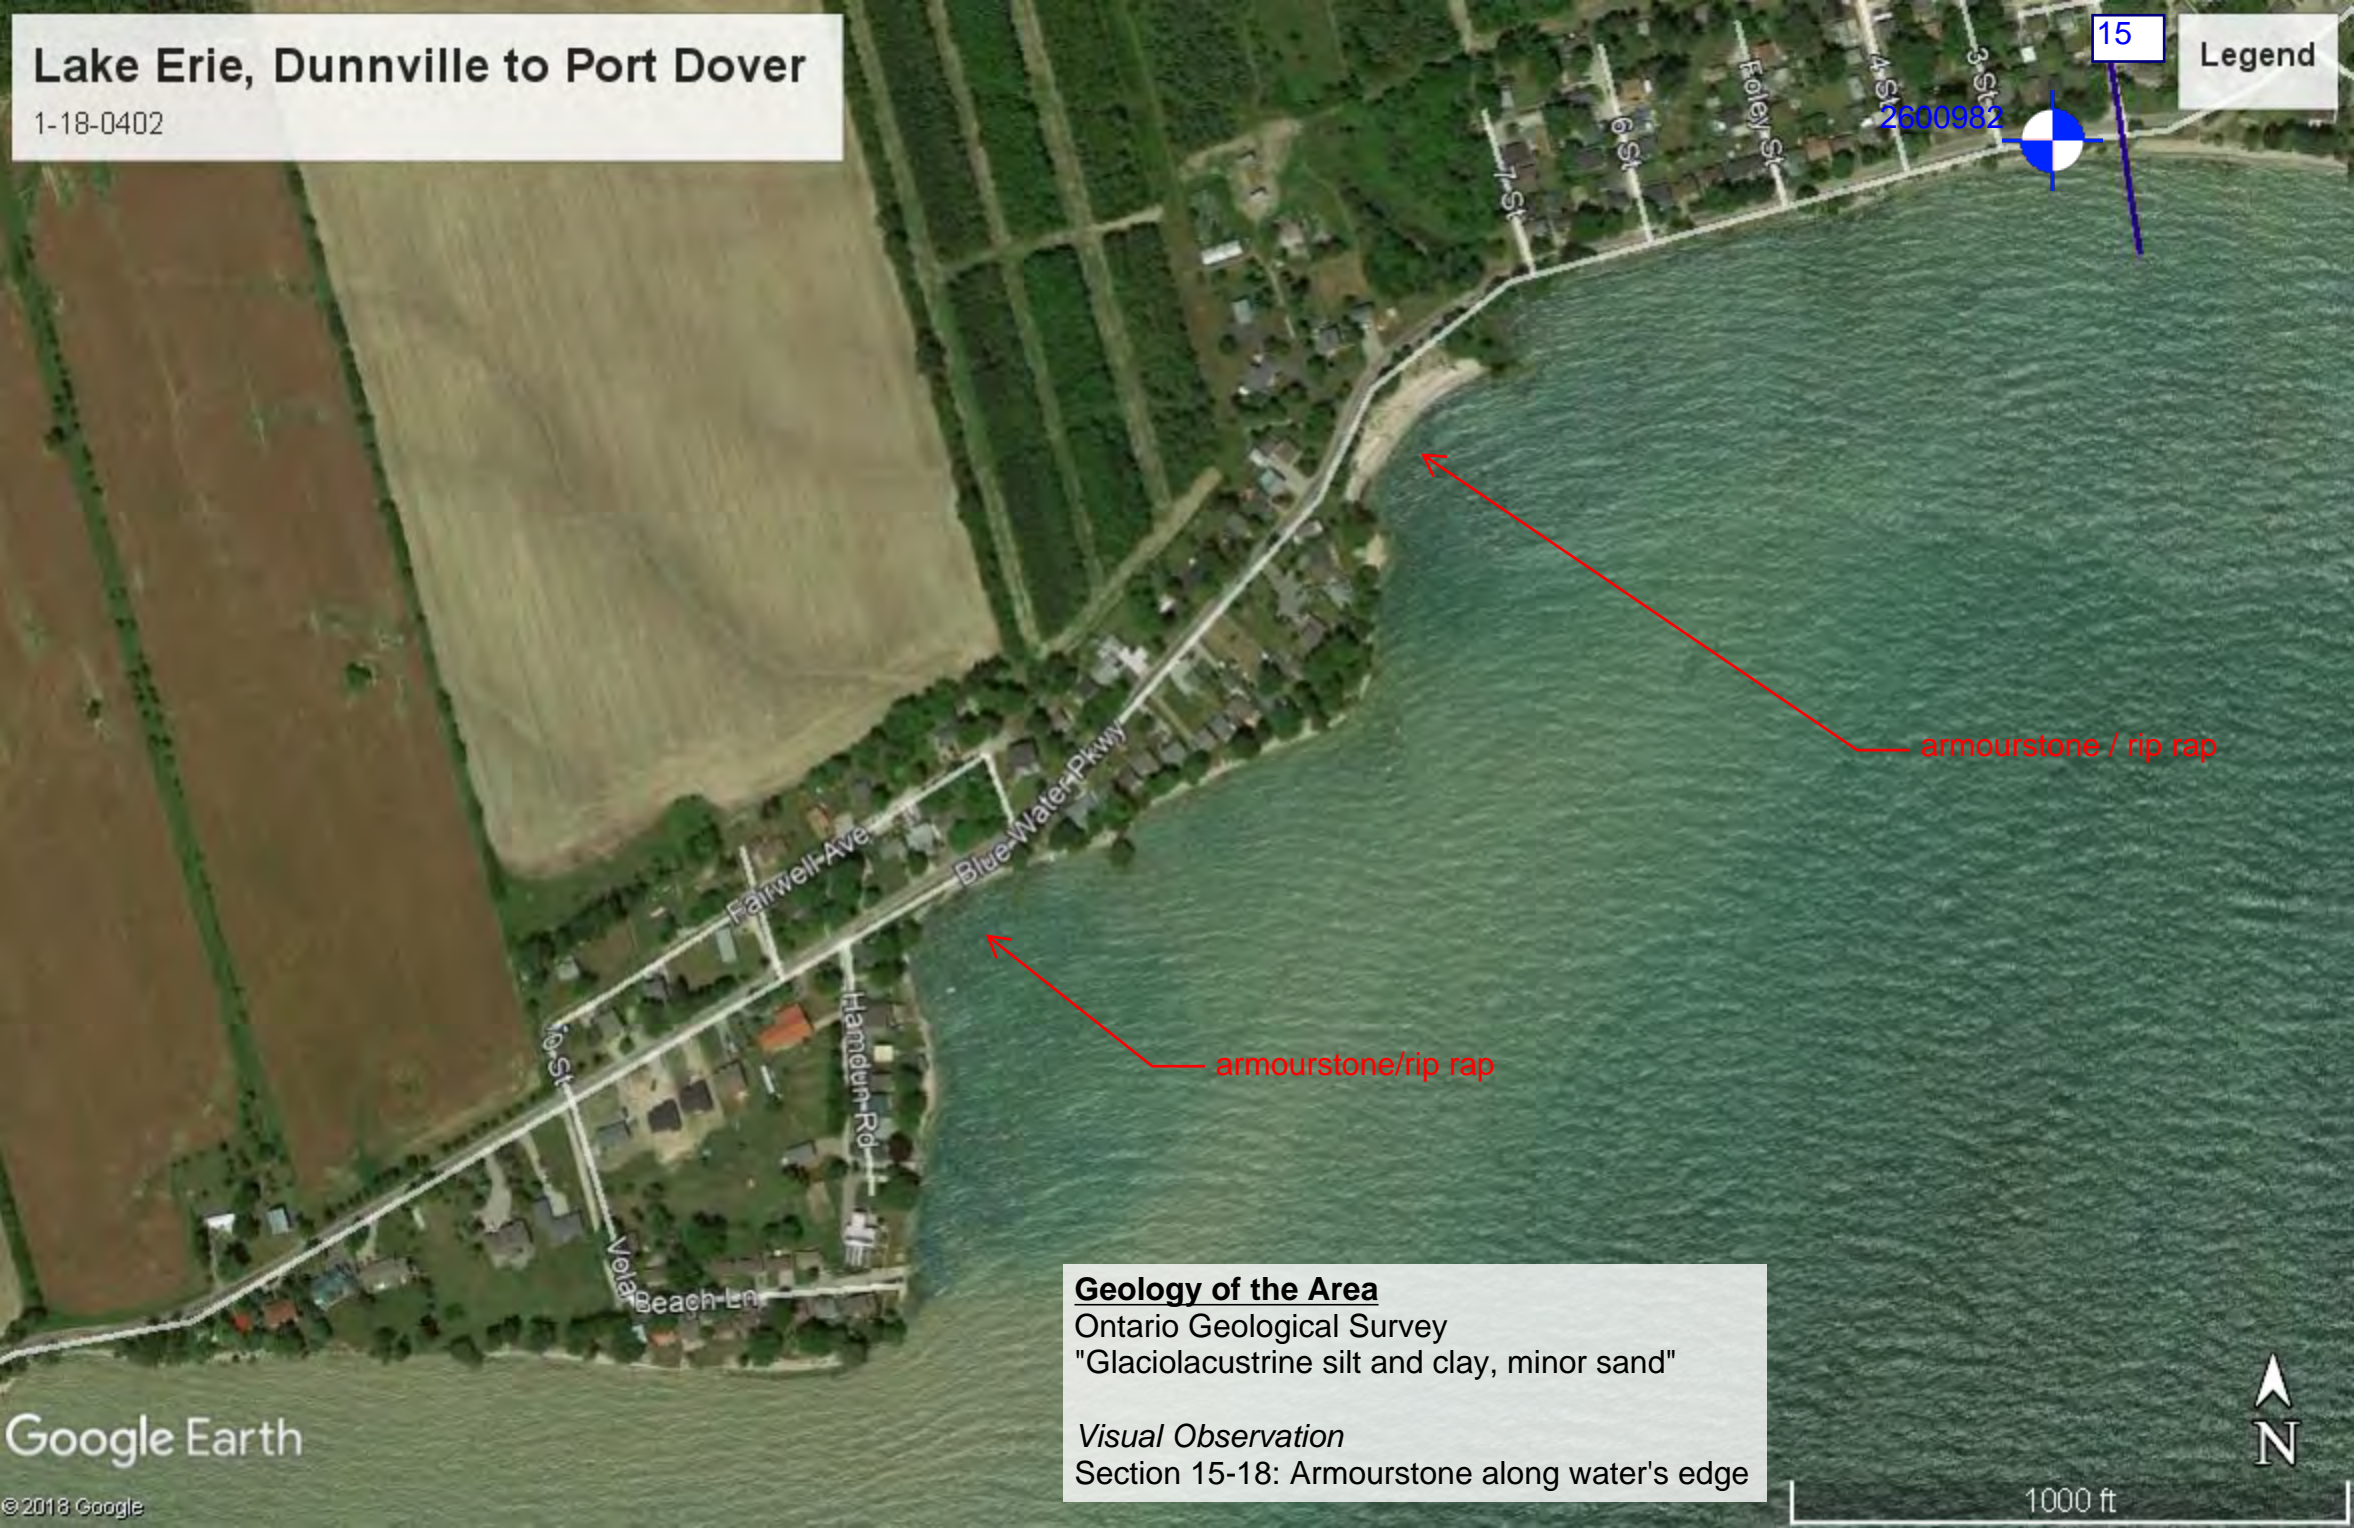
Geology of the Area
Ontario Geological Survey
"Glaciolacustrine silt and clay, minor sand"

Visual Observation
Section 15-18: Armourstone along water's edge

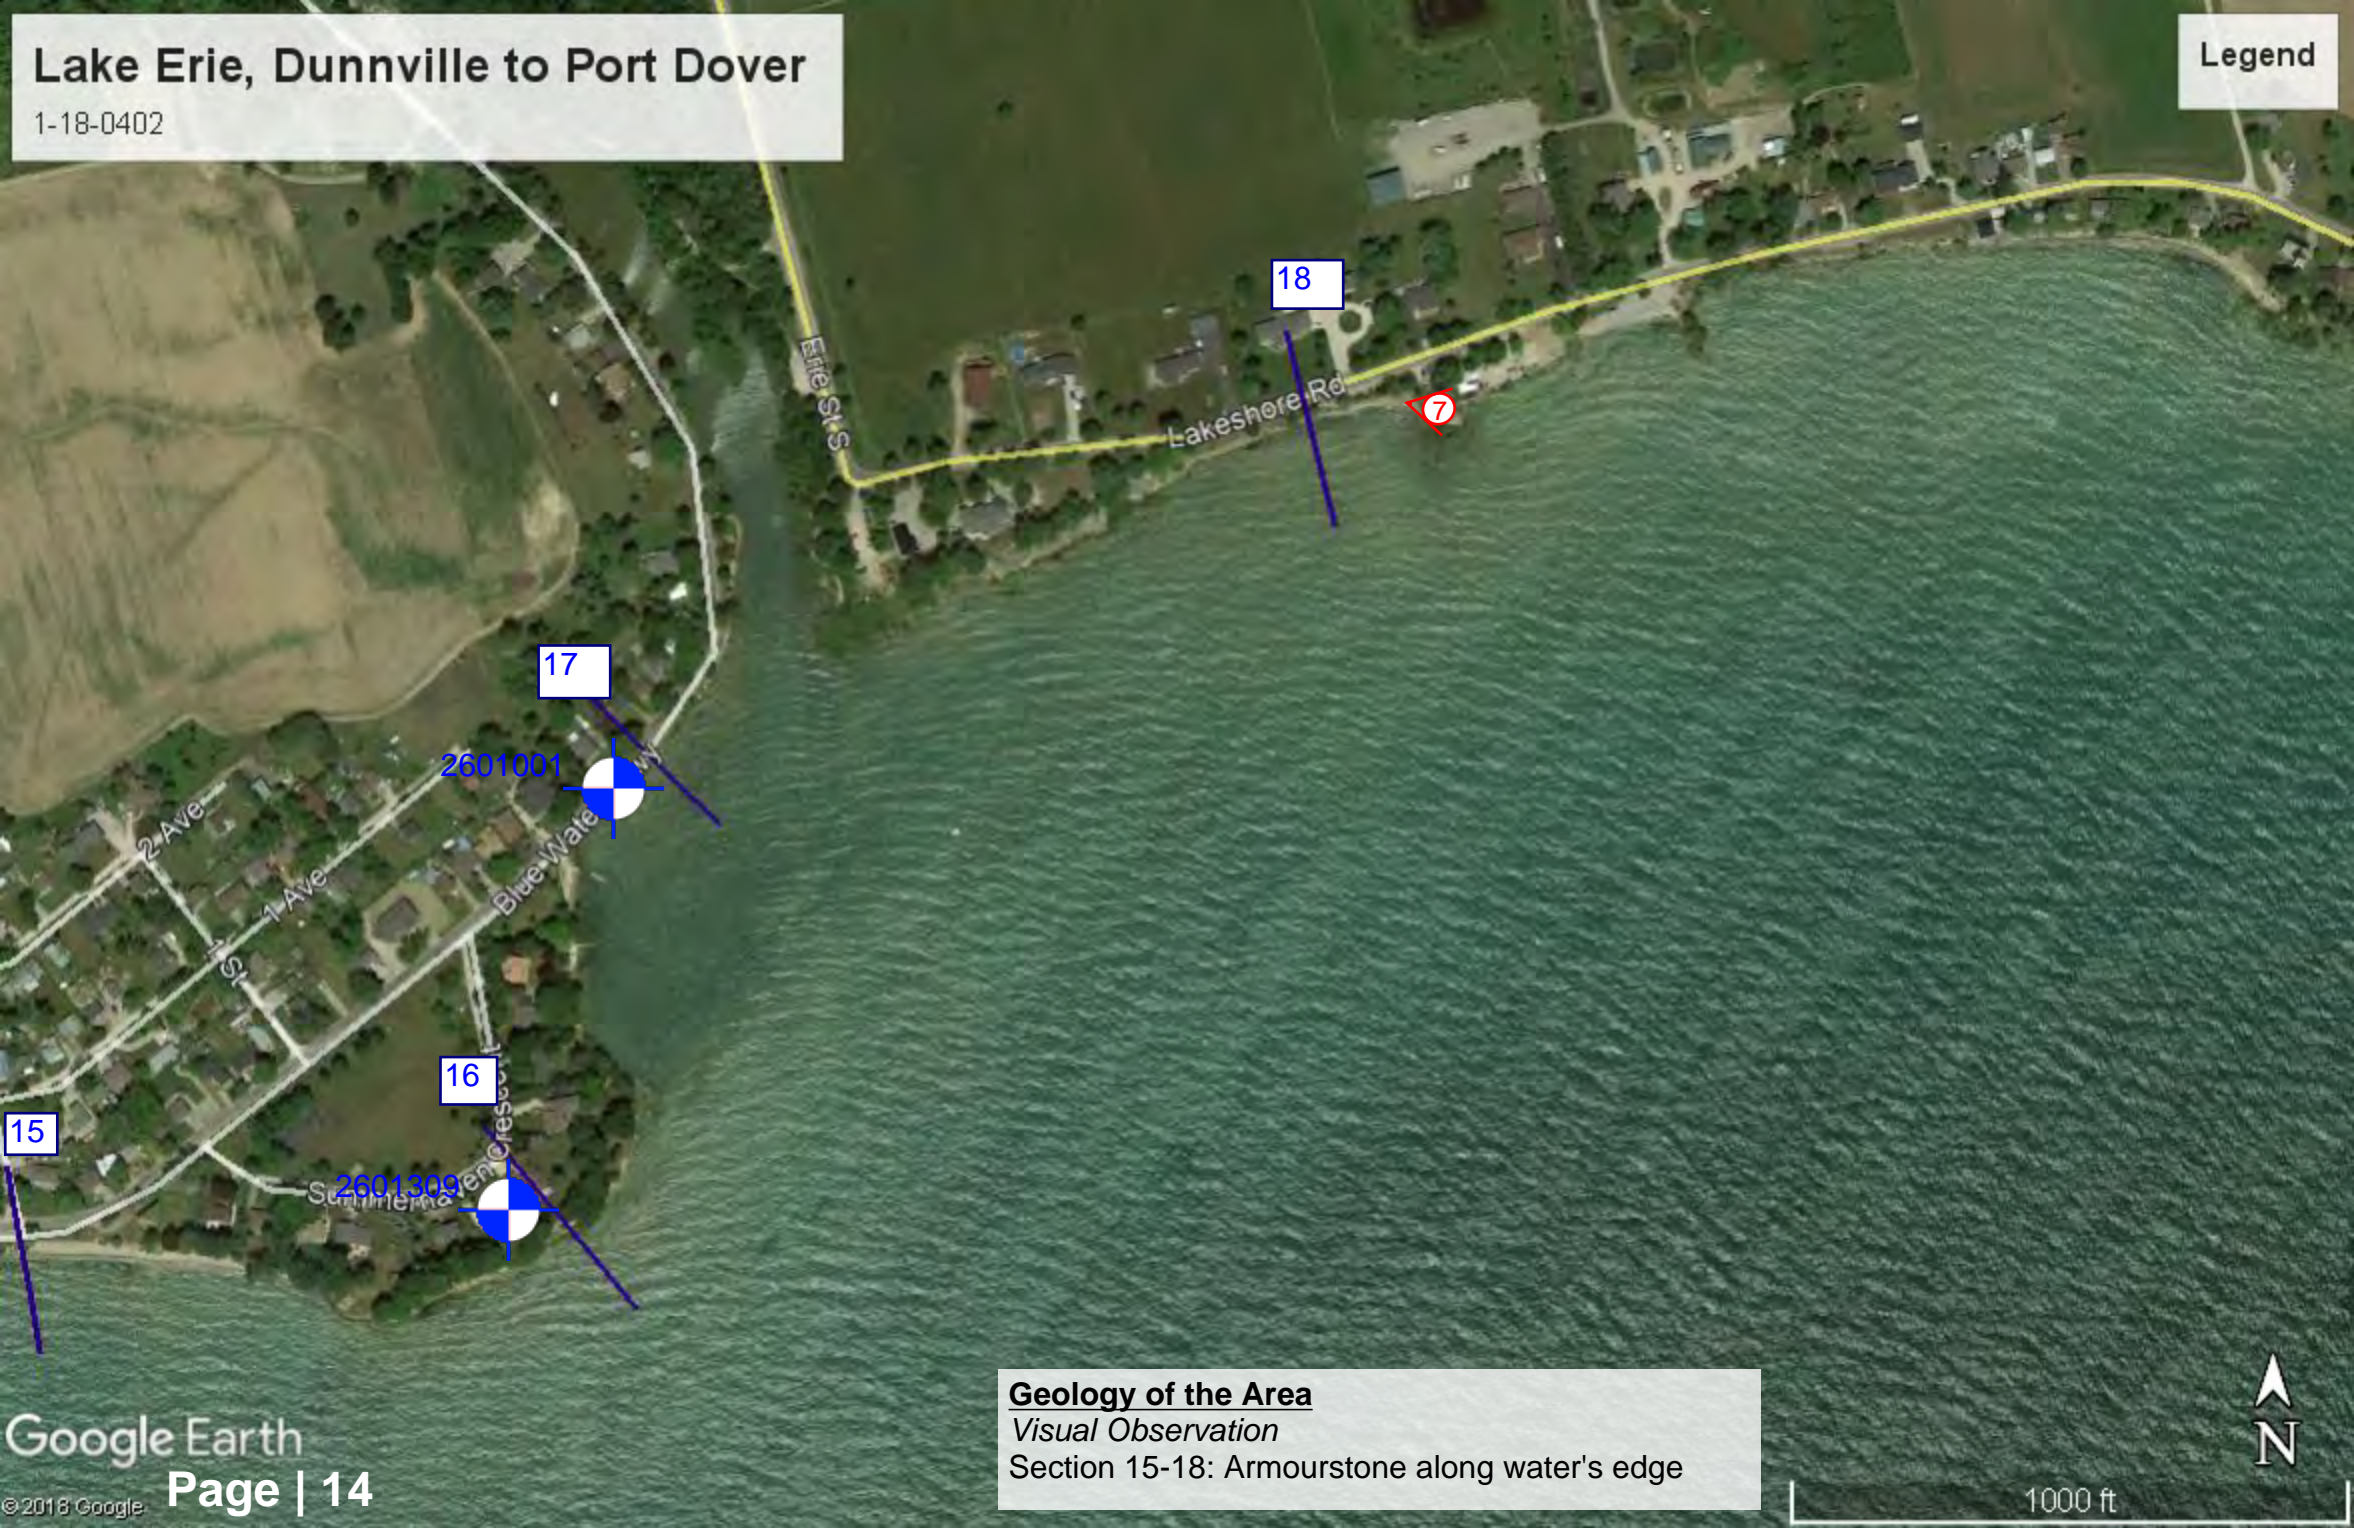
Geology of the Area
Visual Observation
Section 15-18: Armourstone along water's edge

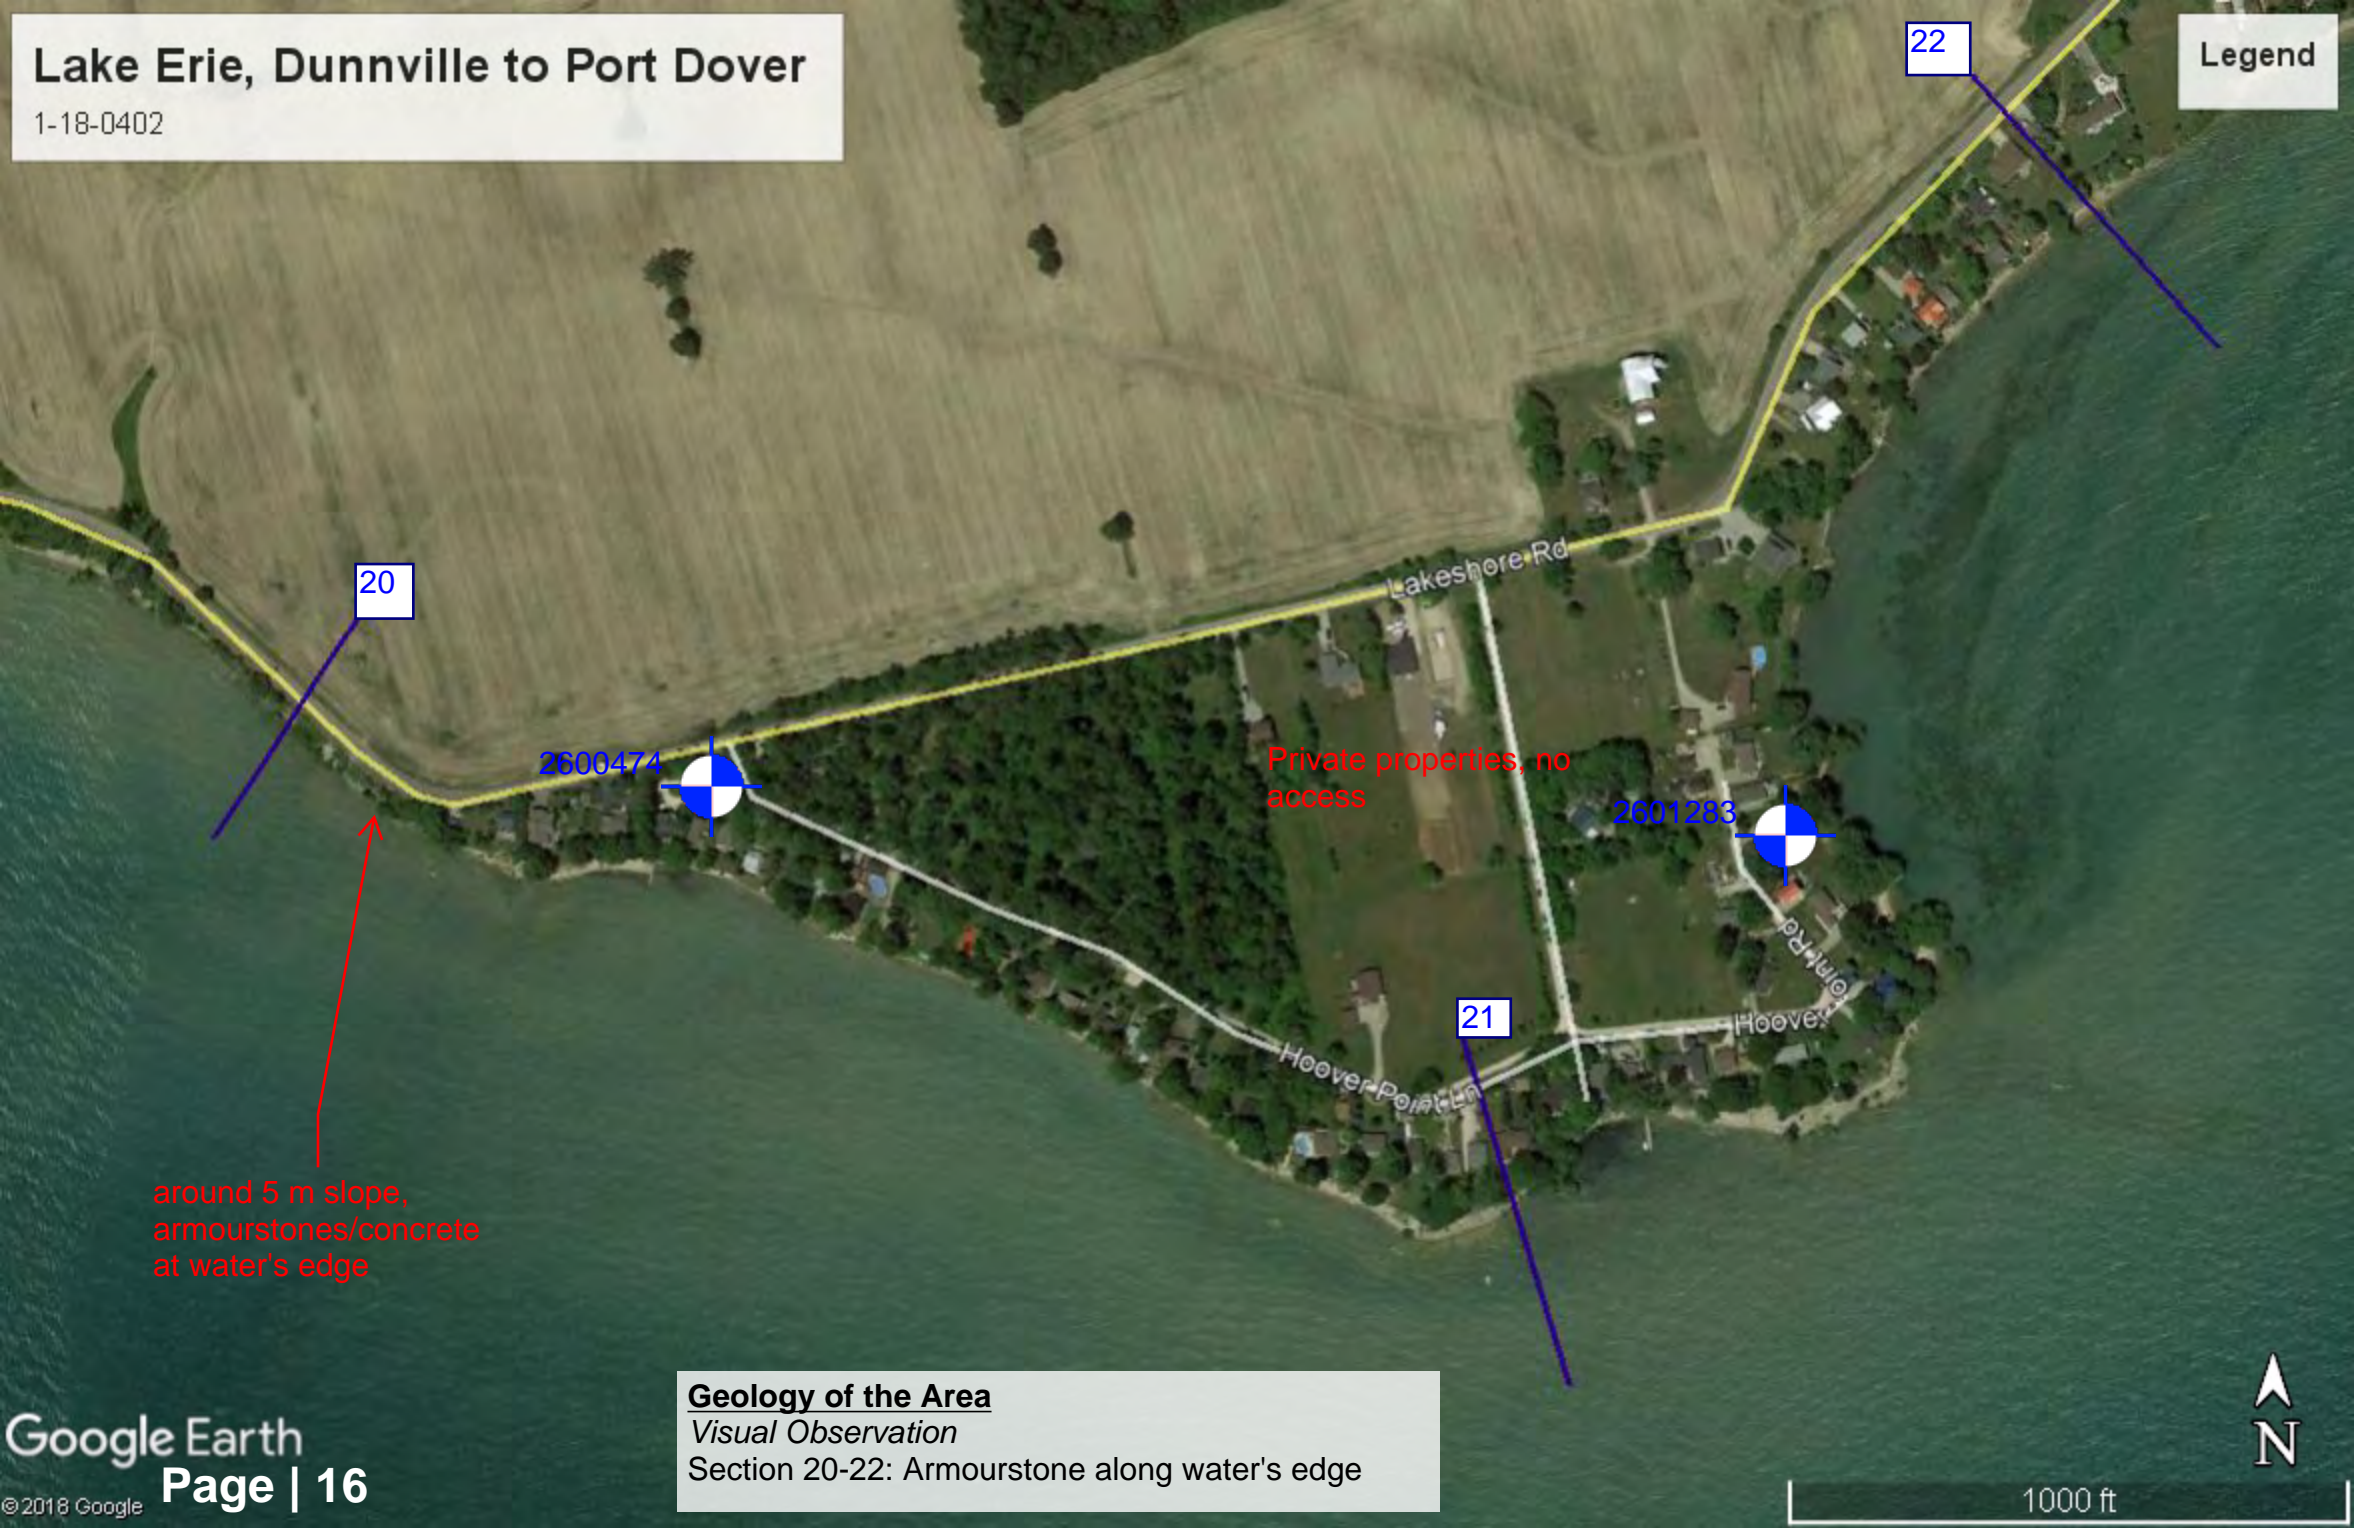
around 5 m slope,
armourstones/concrete
at water's edge

Private properties, no
access
