Haldimand County Lake Erie Hazard Mapping and Risk Assessment

Technical Report

March 19, 2020 | 12969.101.R2.Rev3

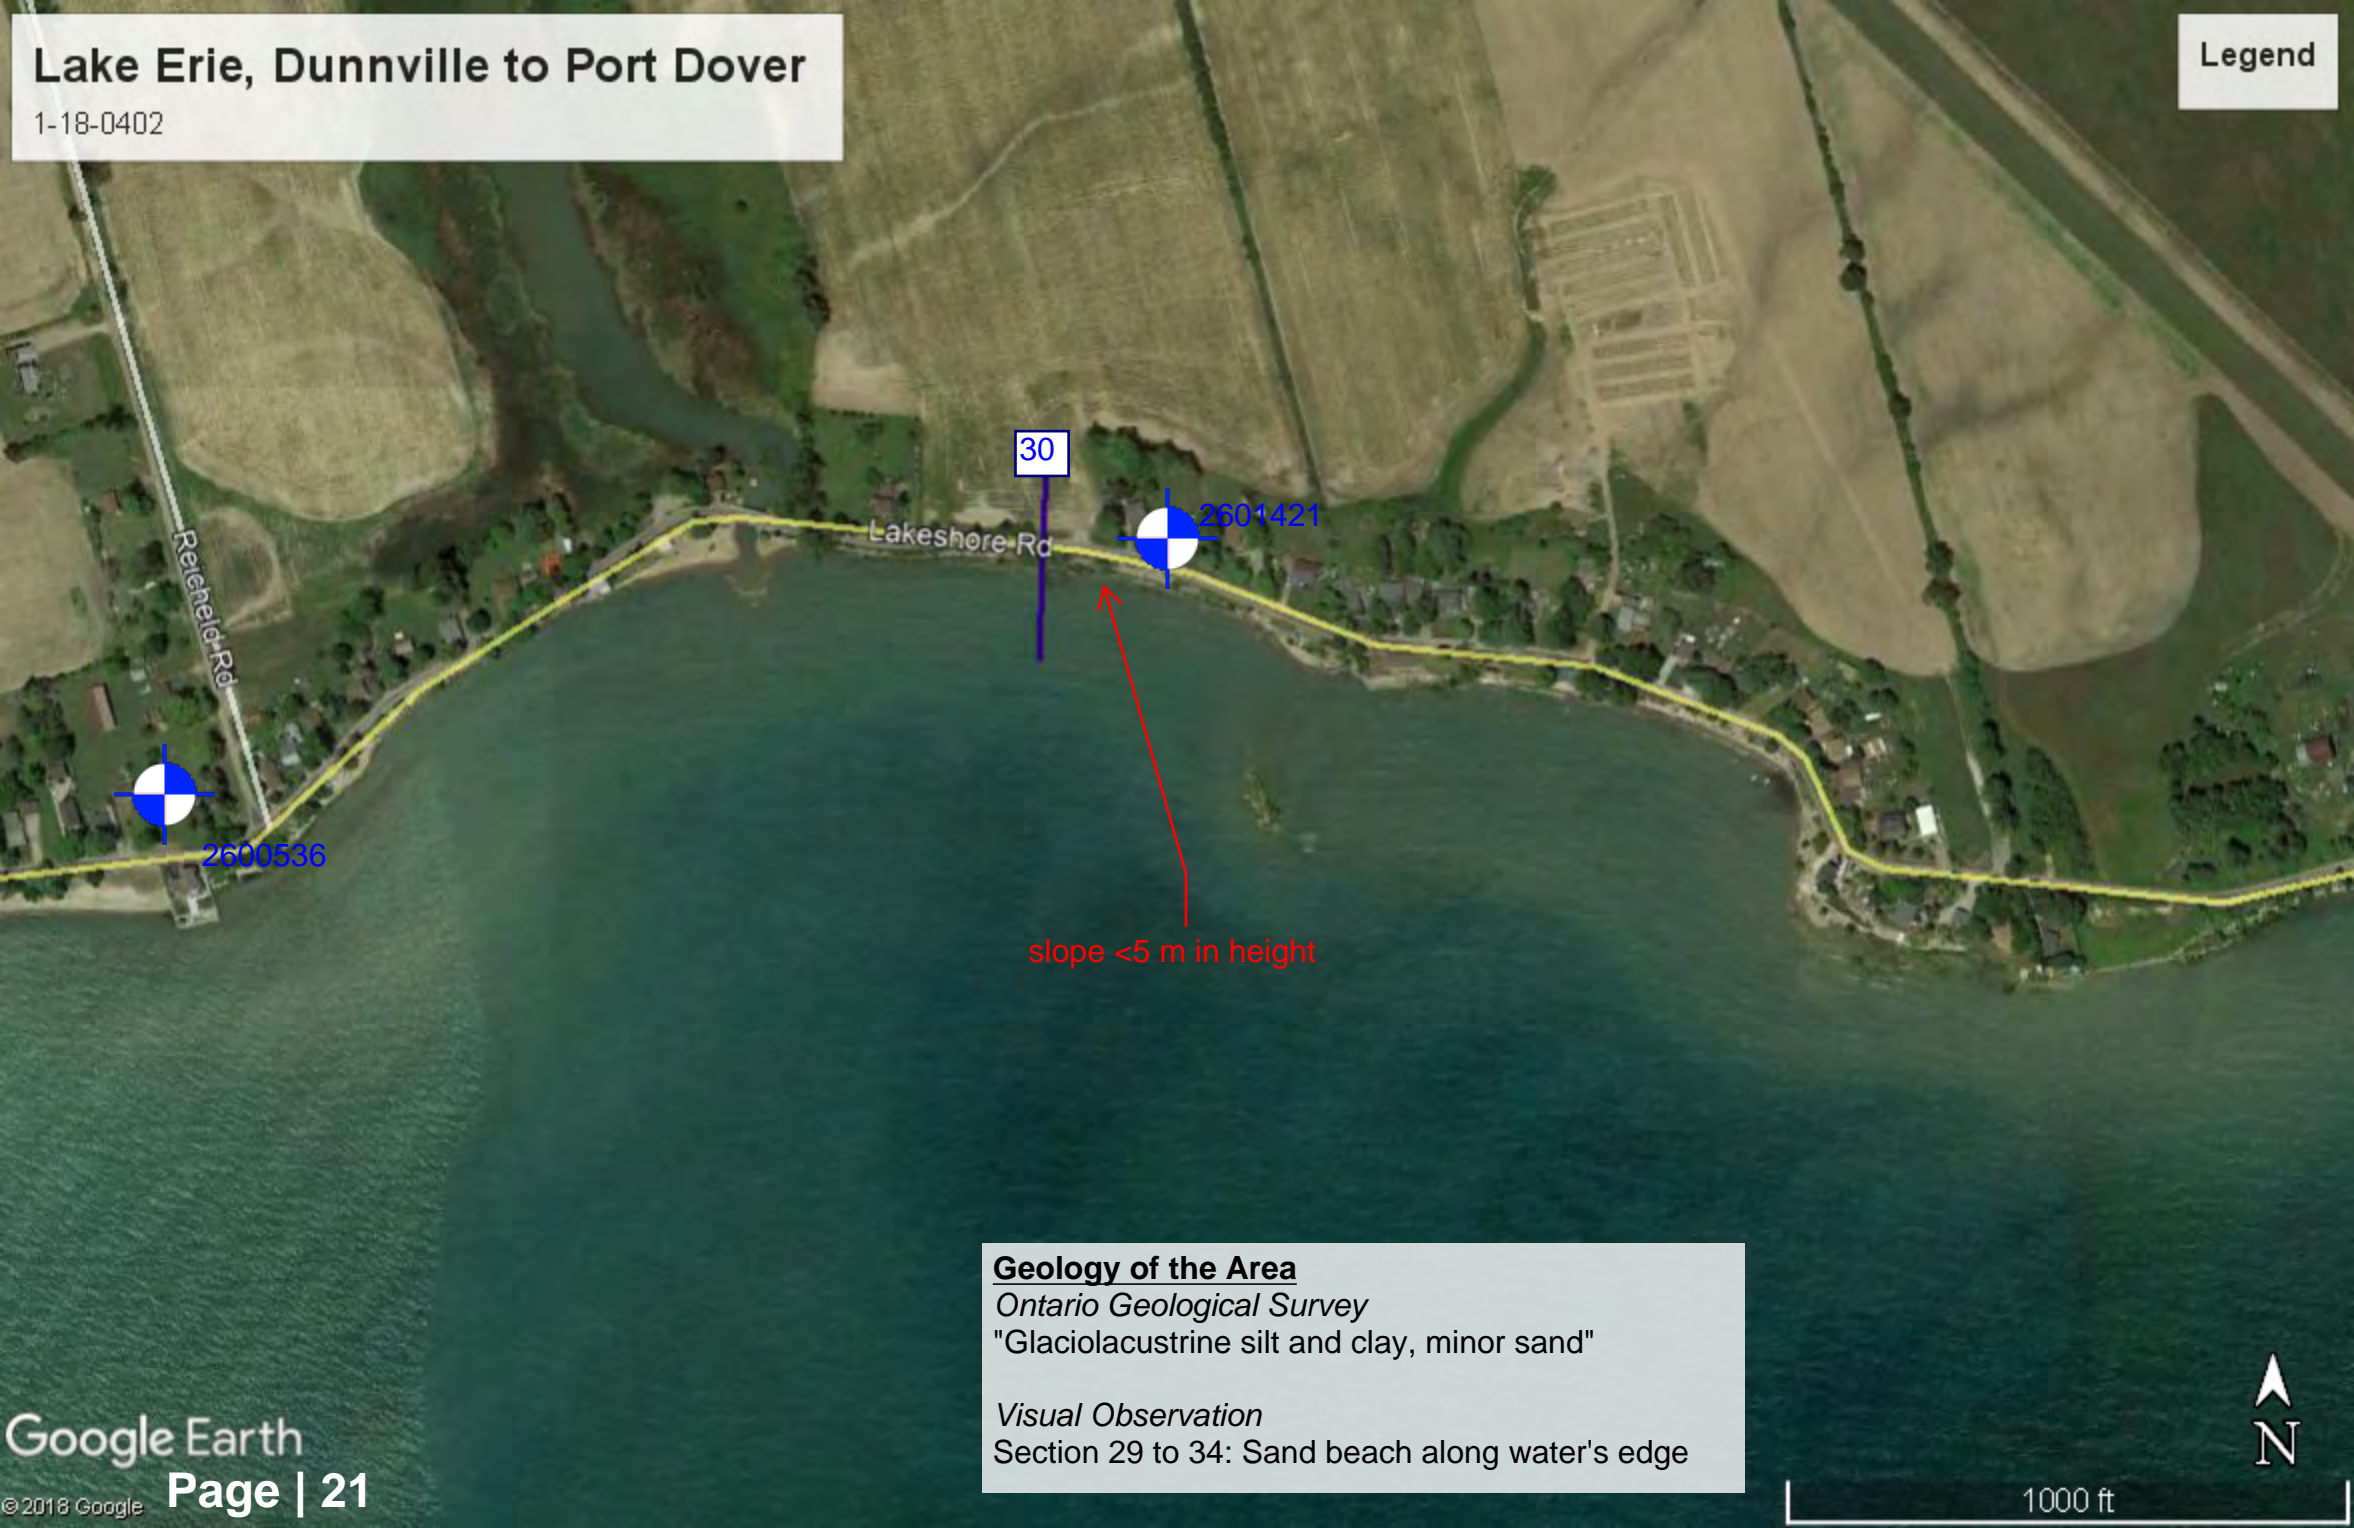
Geology of the Area
Ontario Geological Survey
"Glaciolacustrine silt and clay, minor sand"

Visual Observation
Section 29 to 34: Sand beach along water's edge

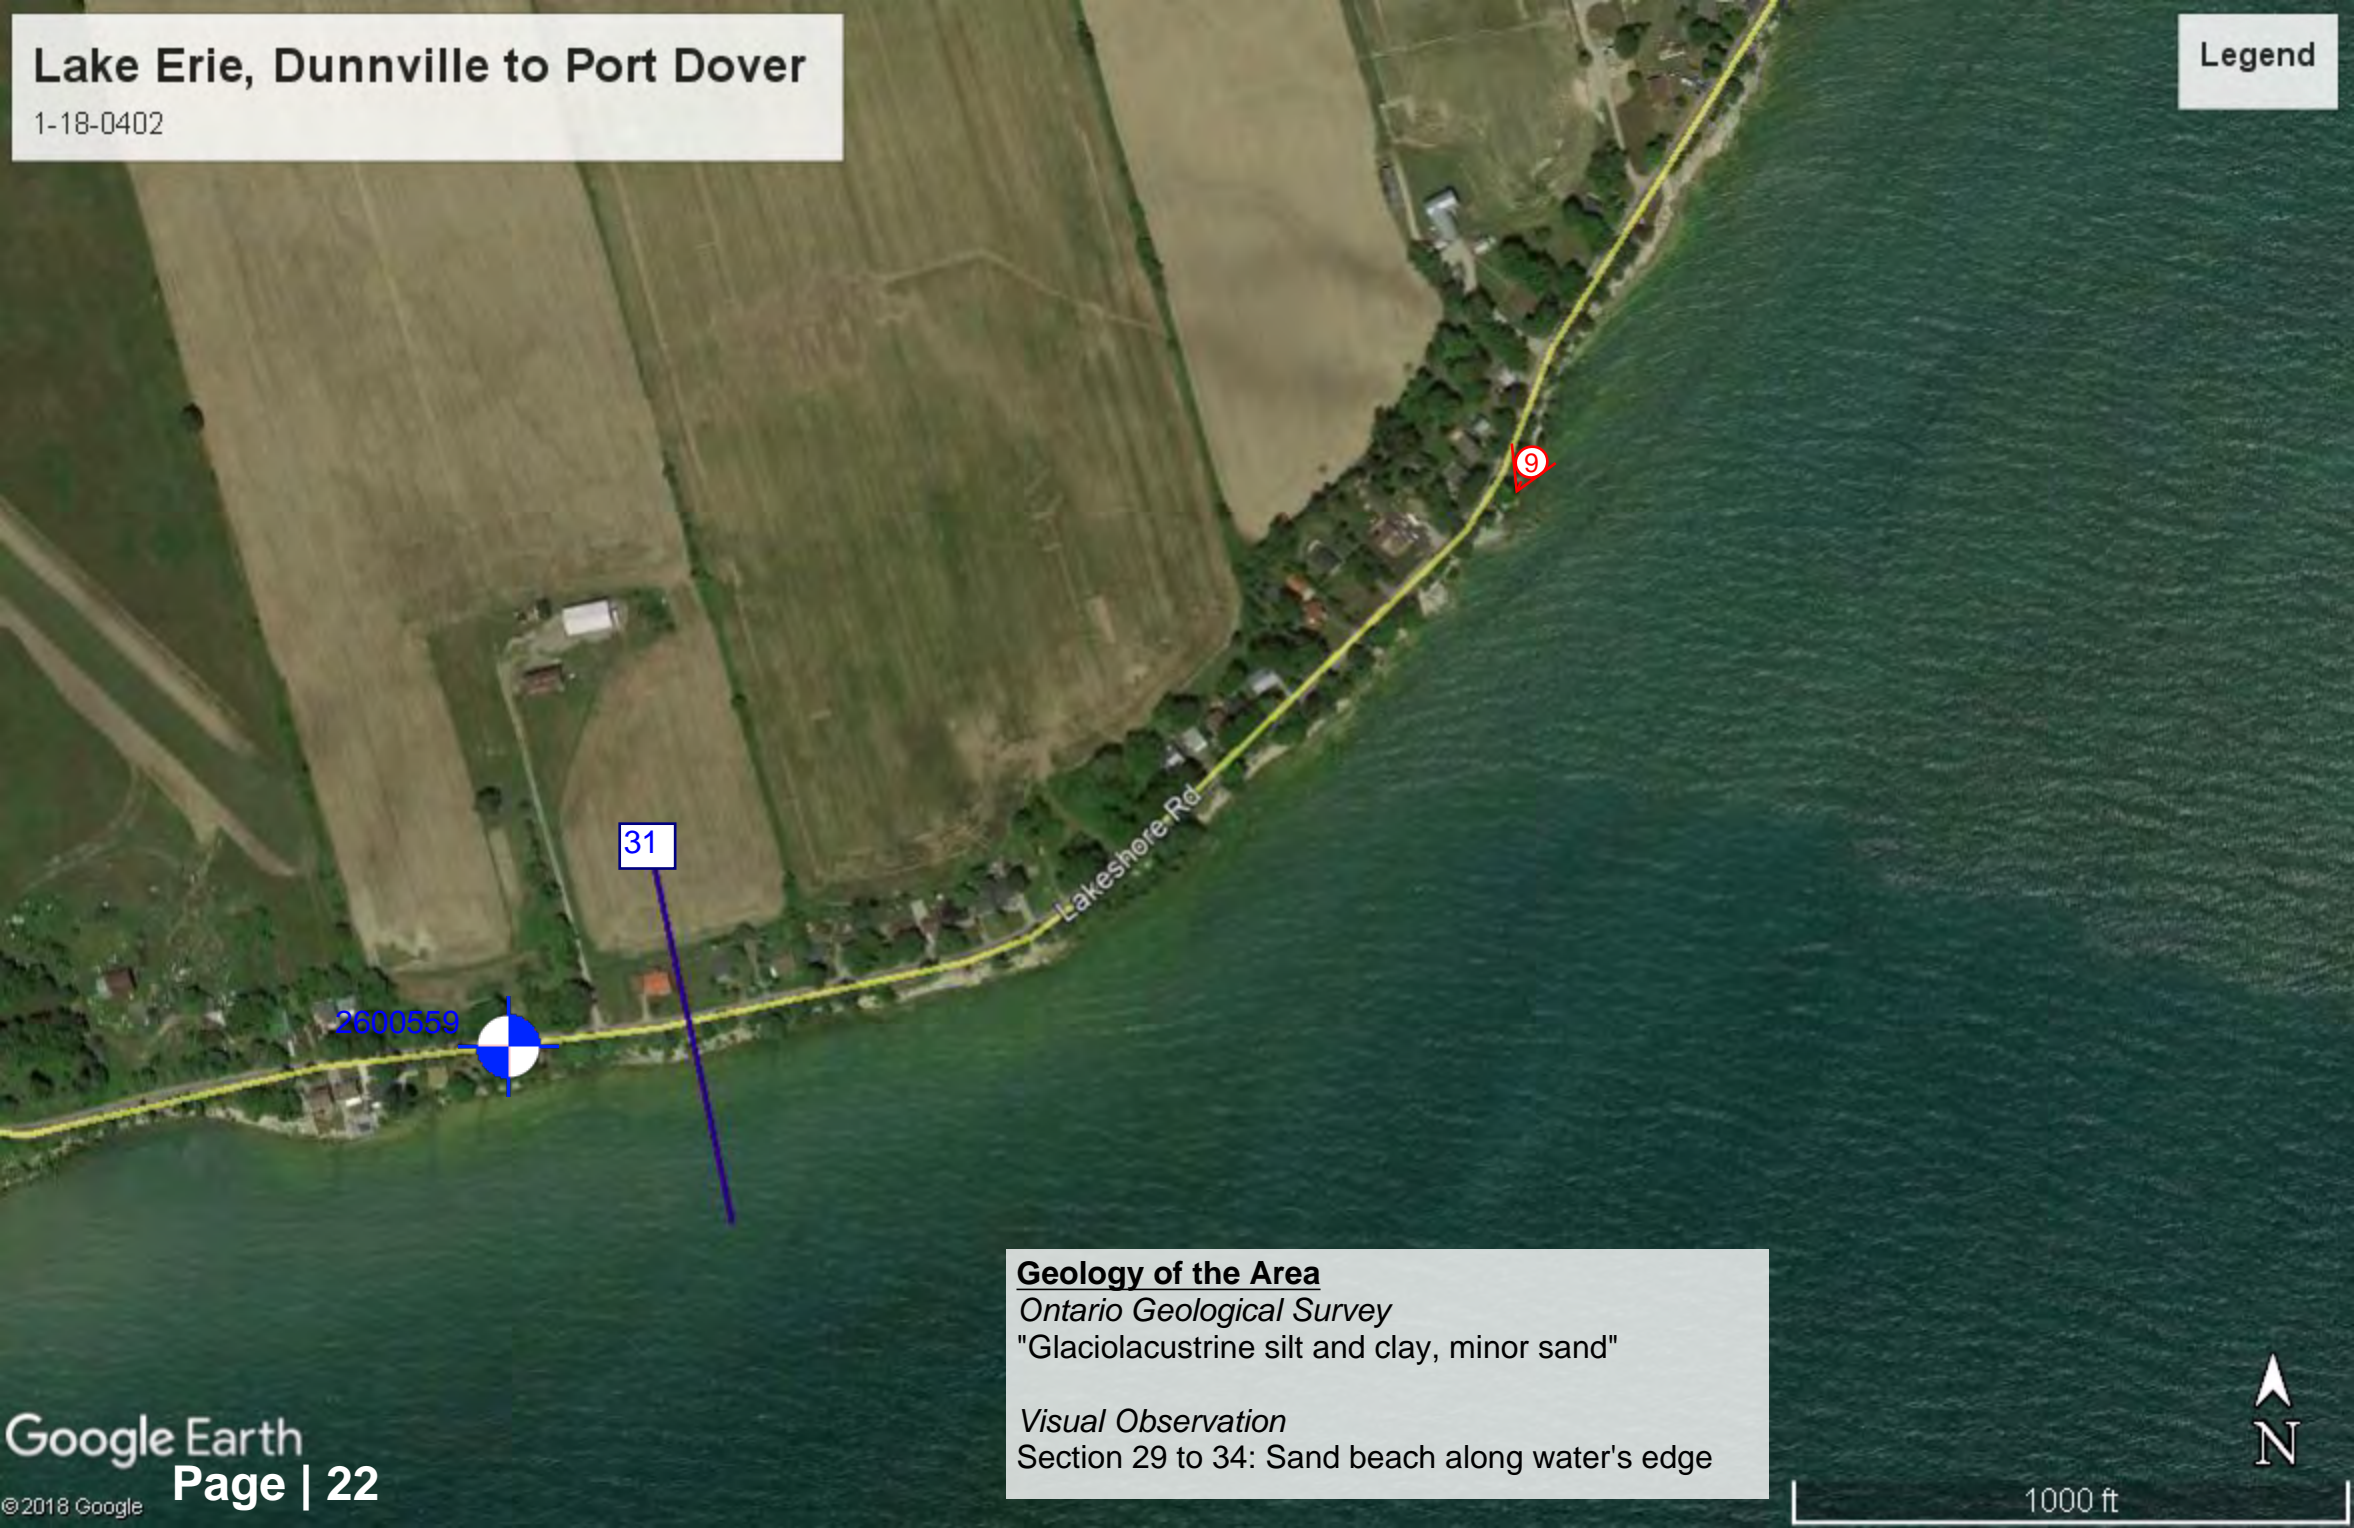
Geology of the Area
Ontario Geological Survey
"Glaciolacustrine silt and clay, minor sand"

Visual Observation
Section 29 to 34: Sand beach along water's edge

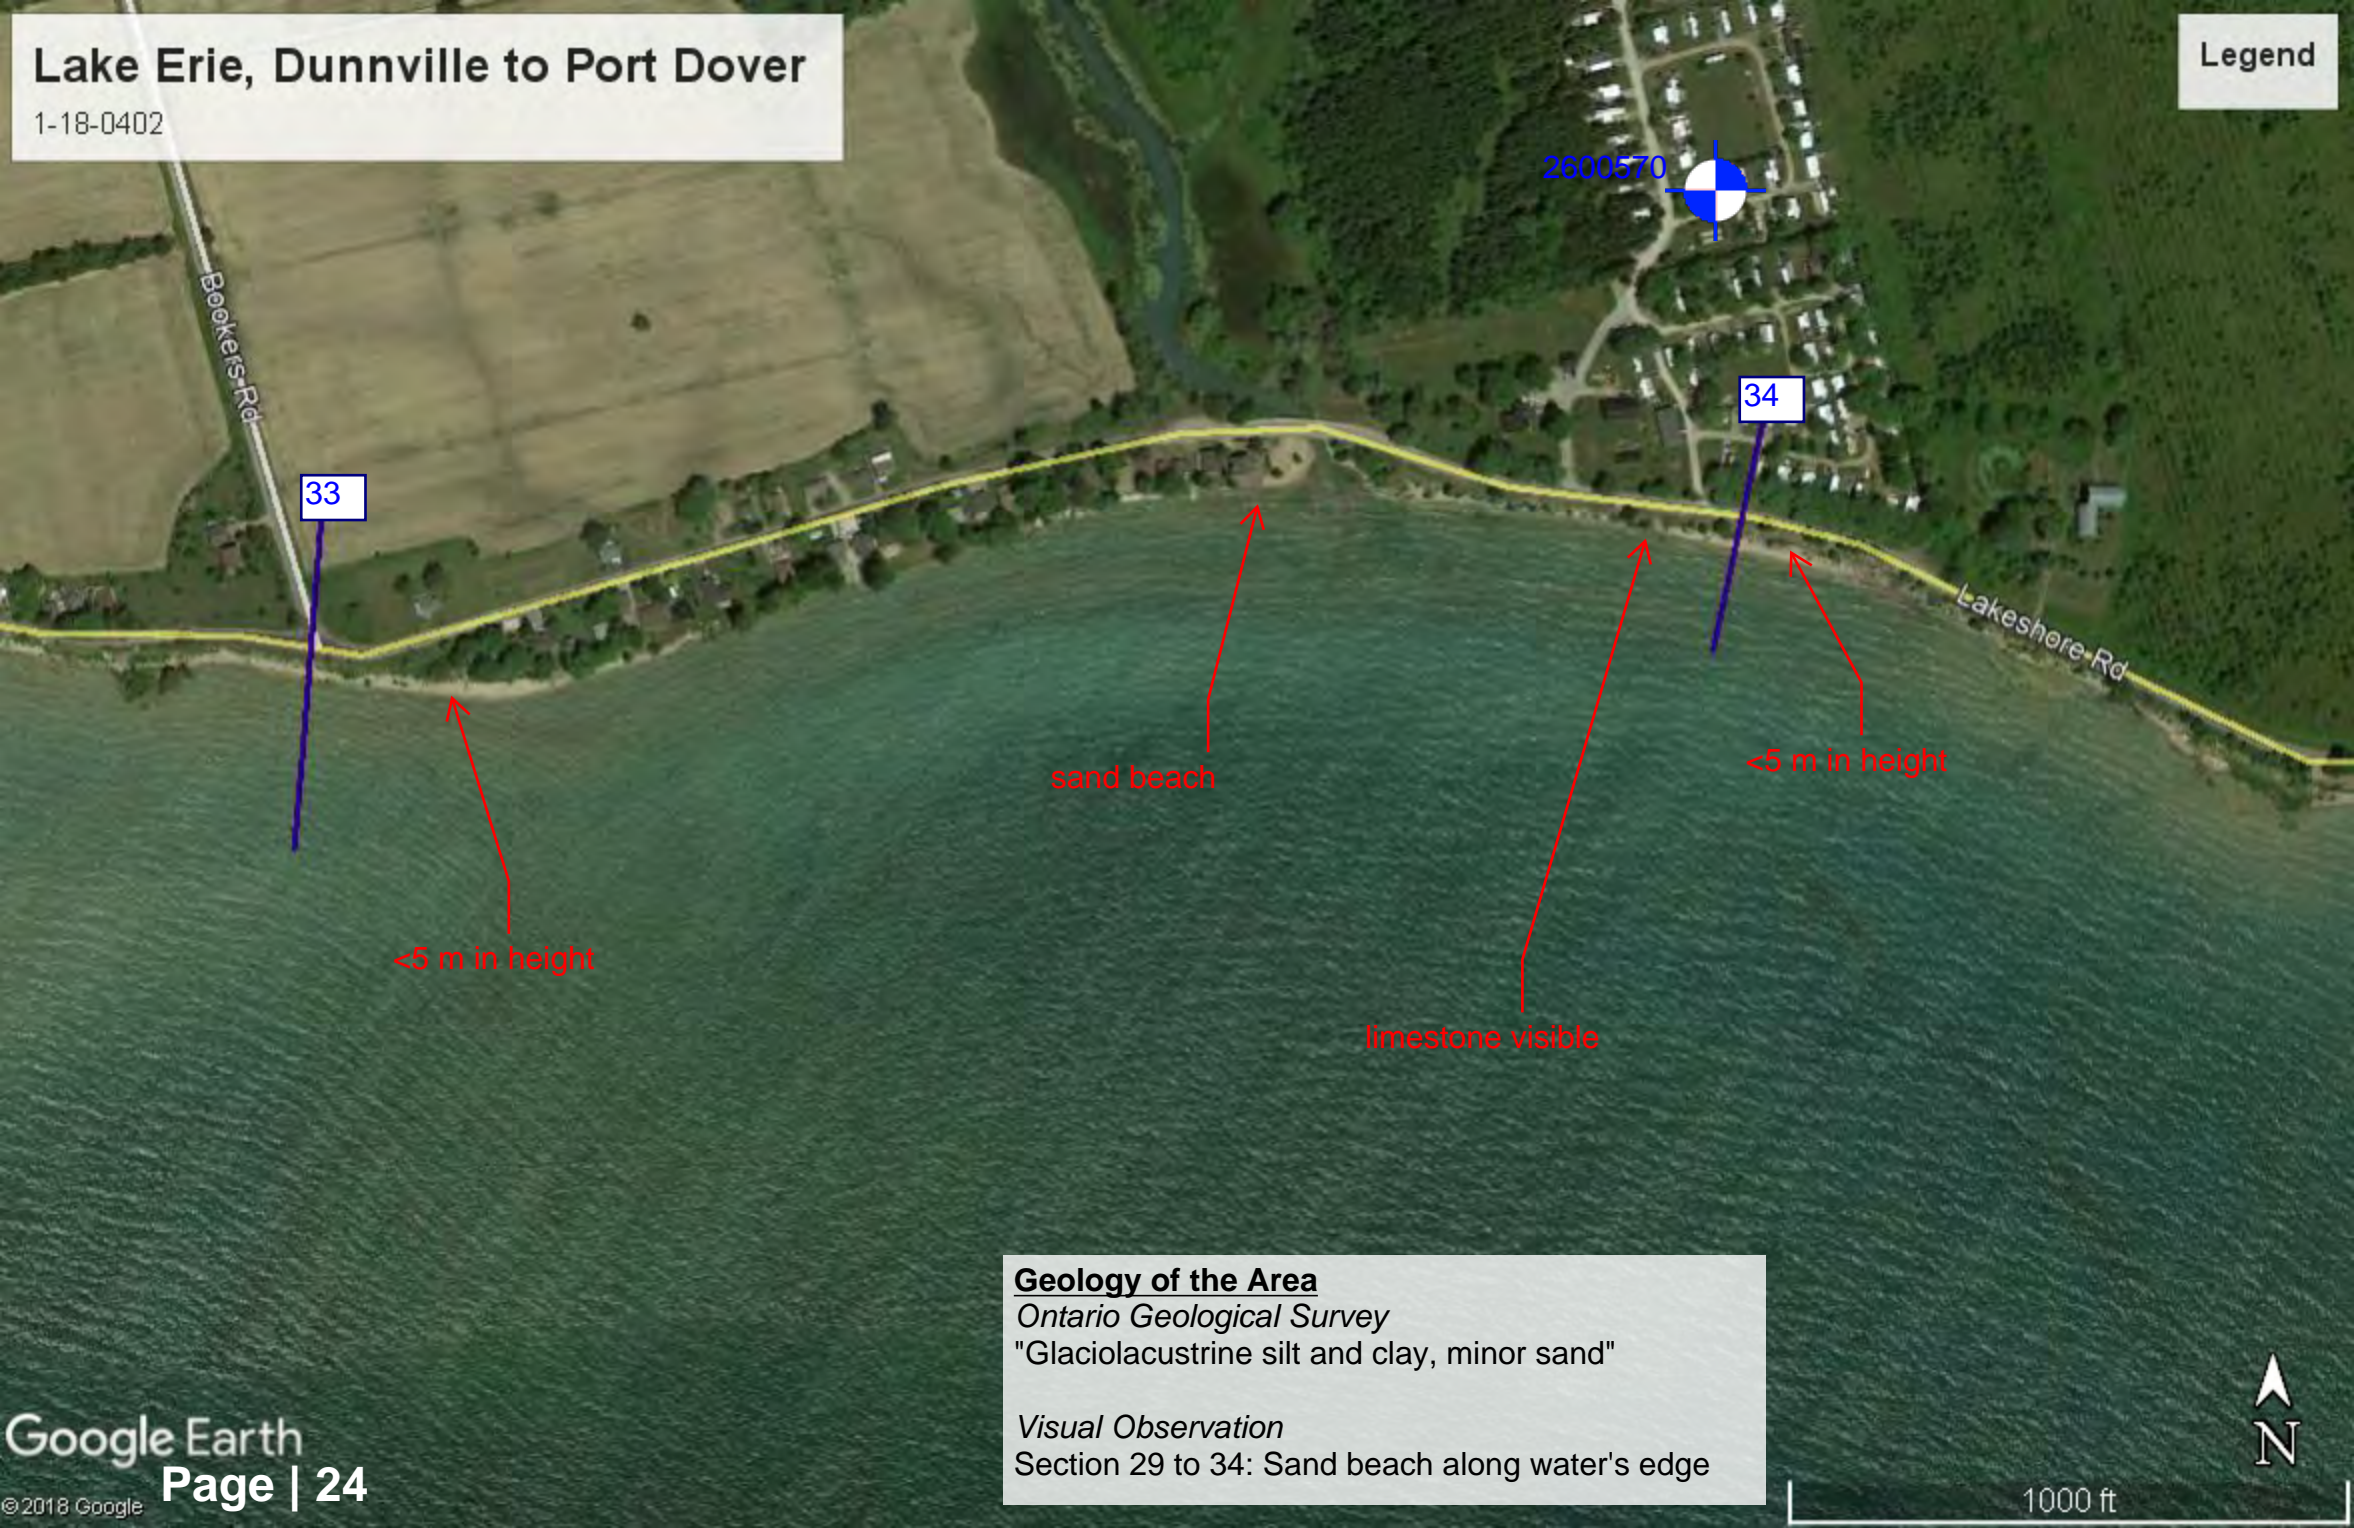
Geology of the Area
Ontario Geological Survey
"Glaciolacustrine silt and clay, minor sand"

Visual Observation
Section 29 to 34: Sand beach along water's edge

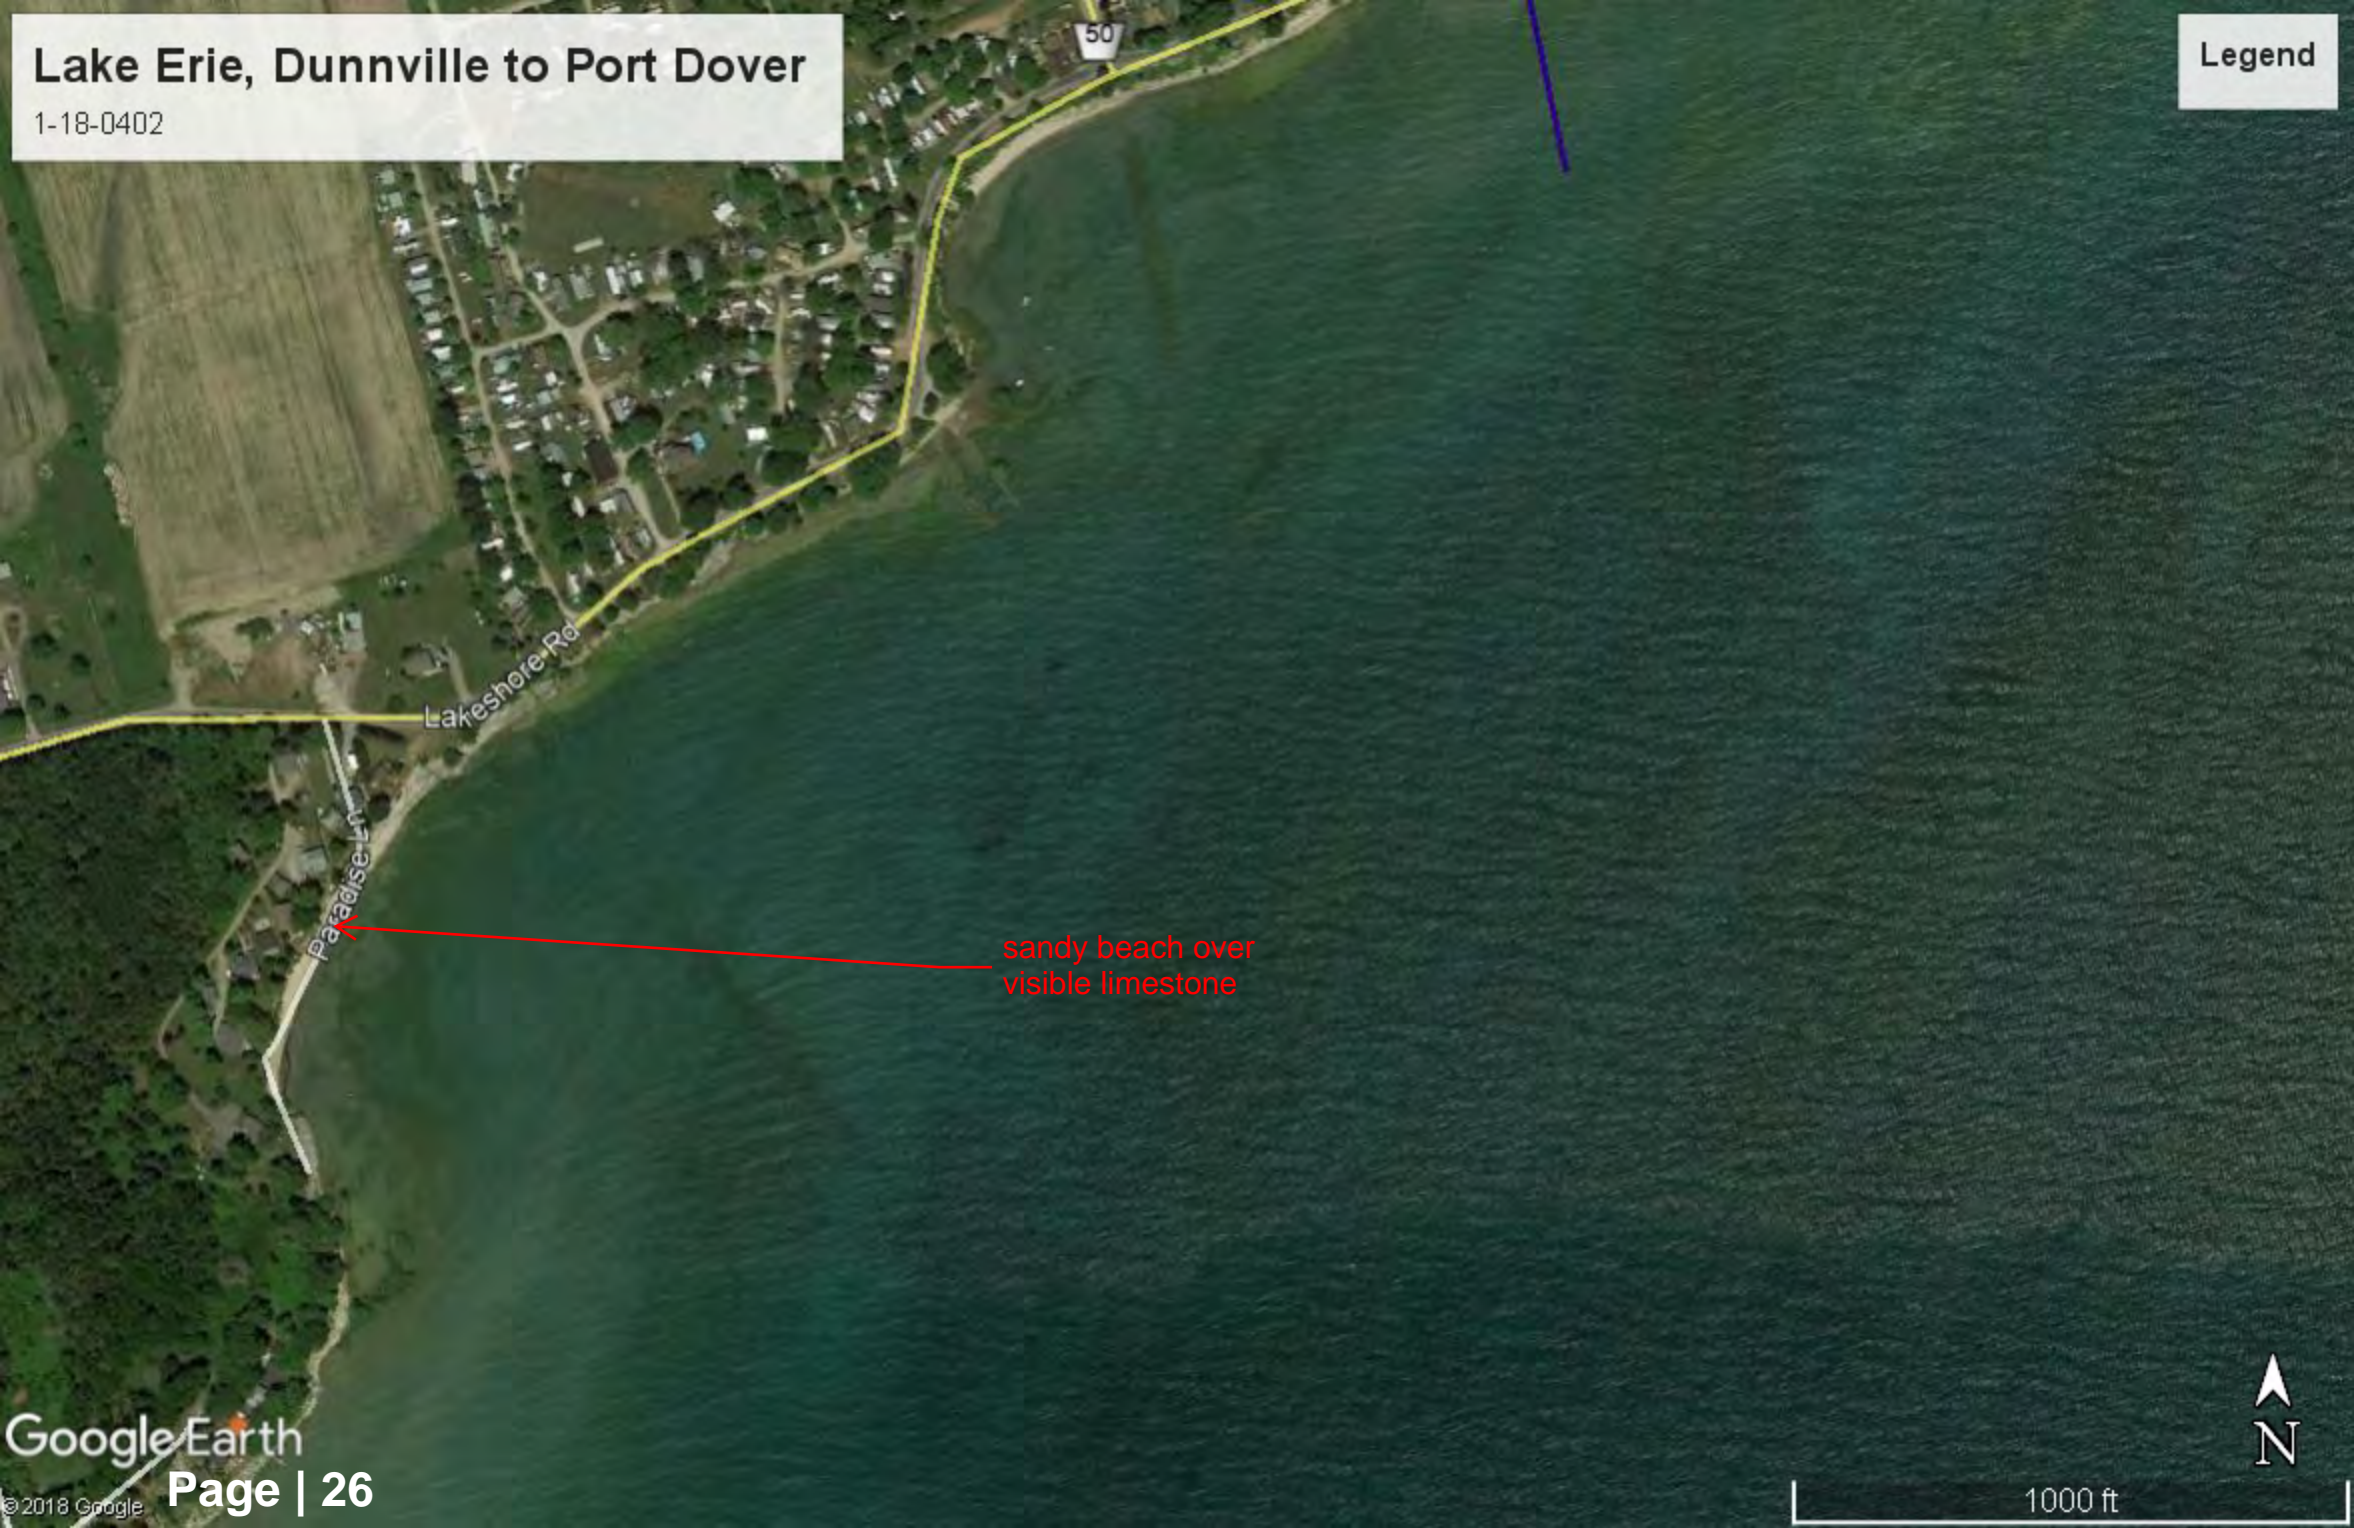
sandy beach over
visible limestone

Visual Observation
Section 36: Sand beach along water's edge

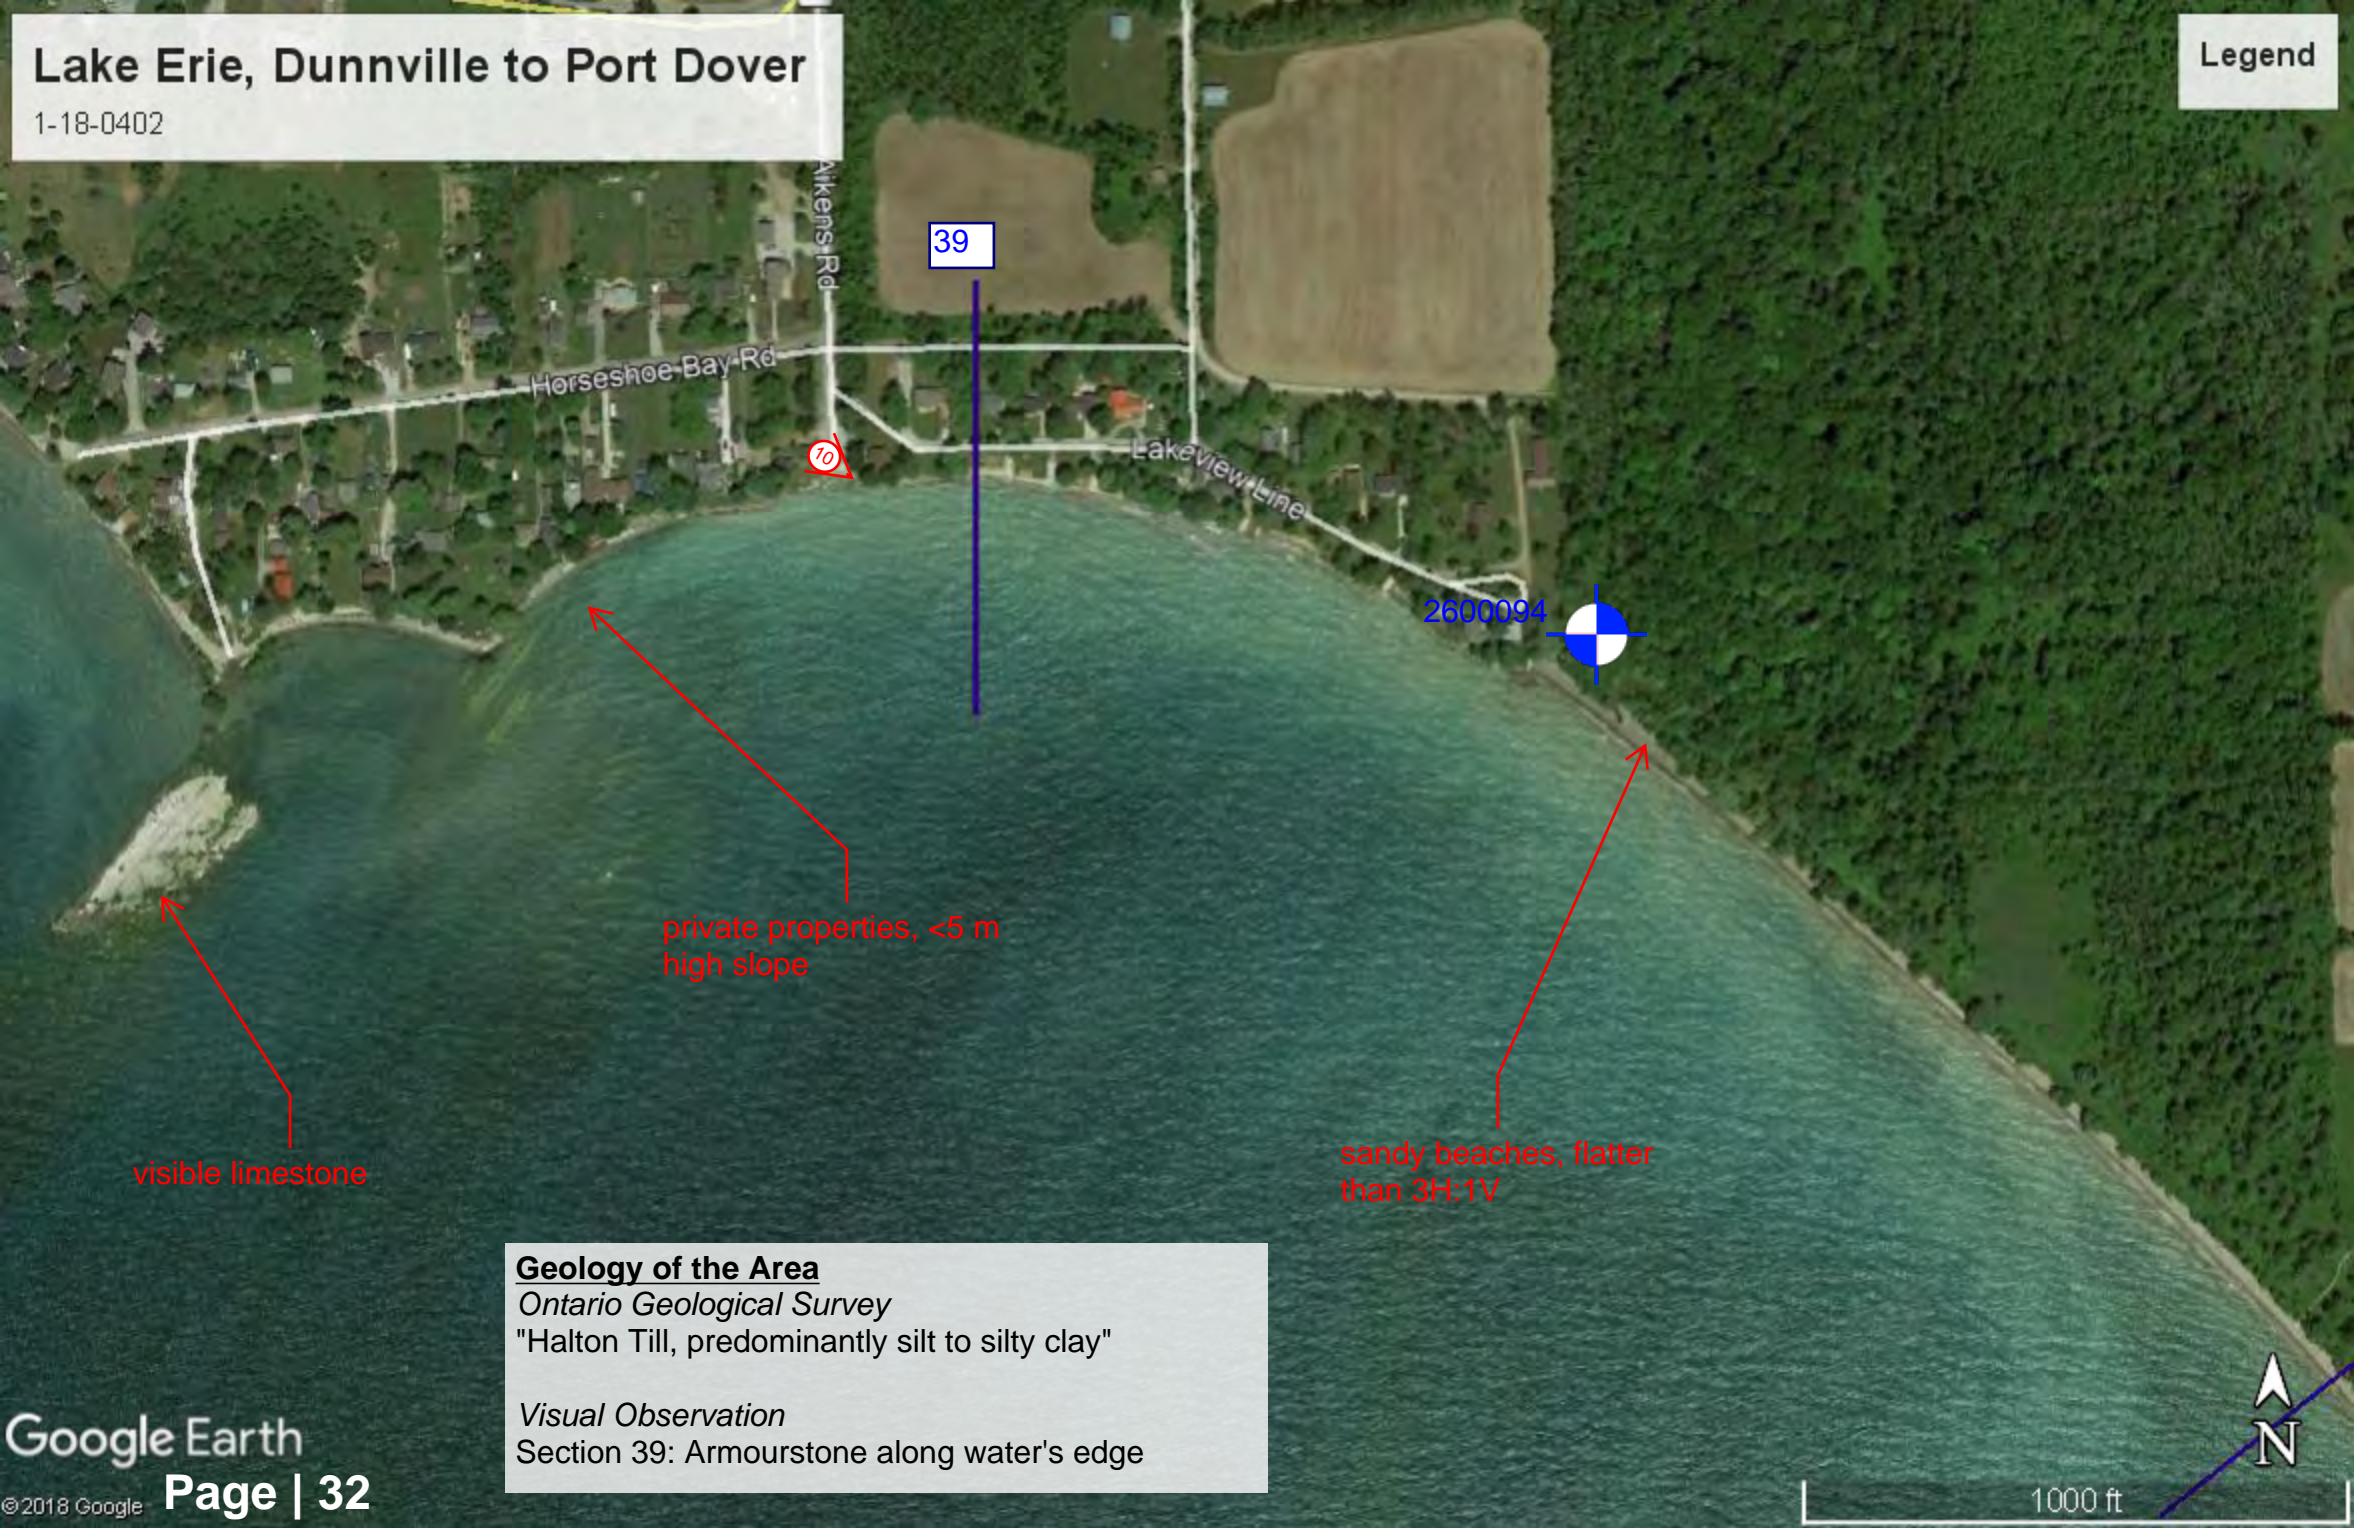
Visual Observation
Section 39: Armourstone along water's edge

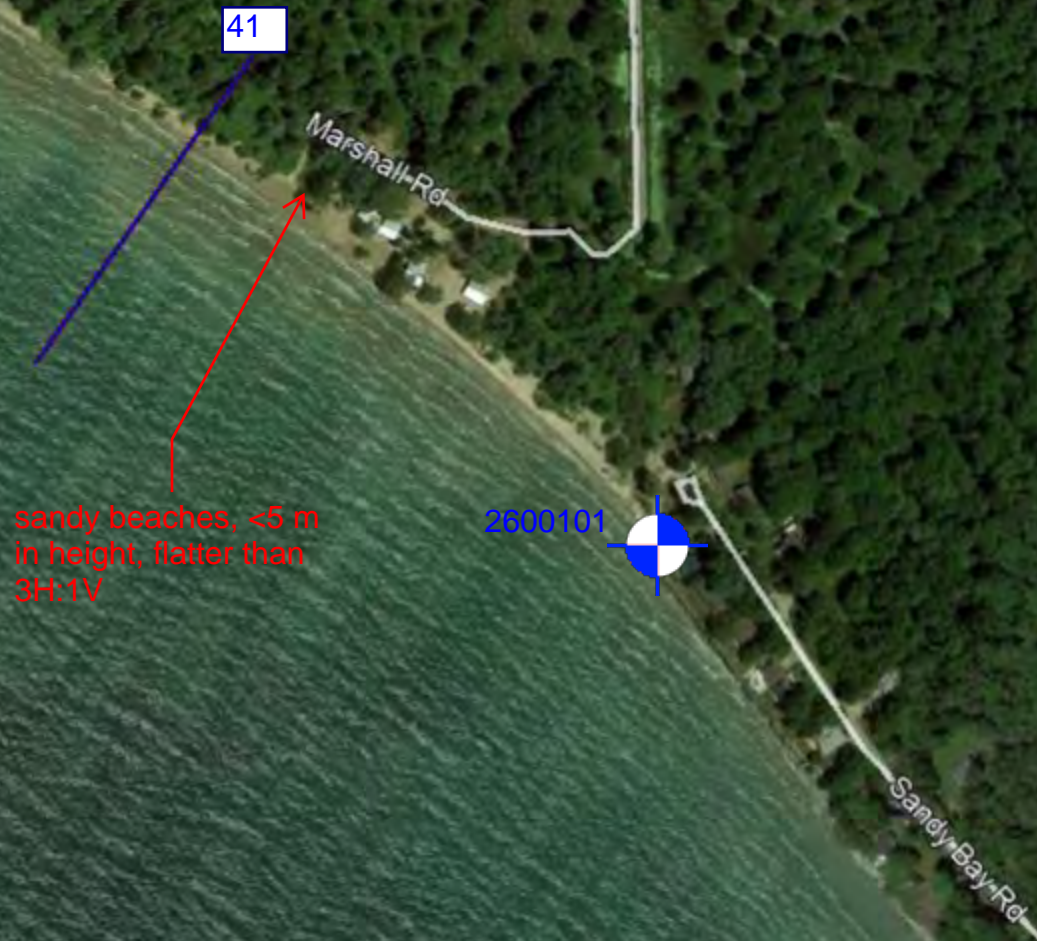
Visual Observation
Section 41: Sand beach along water's edge

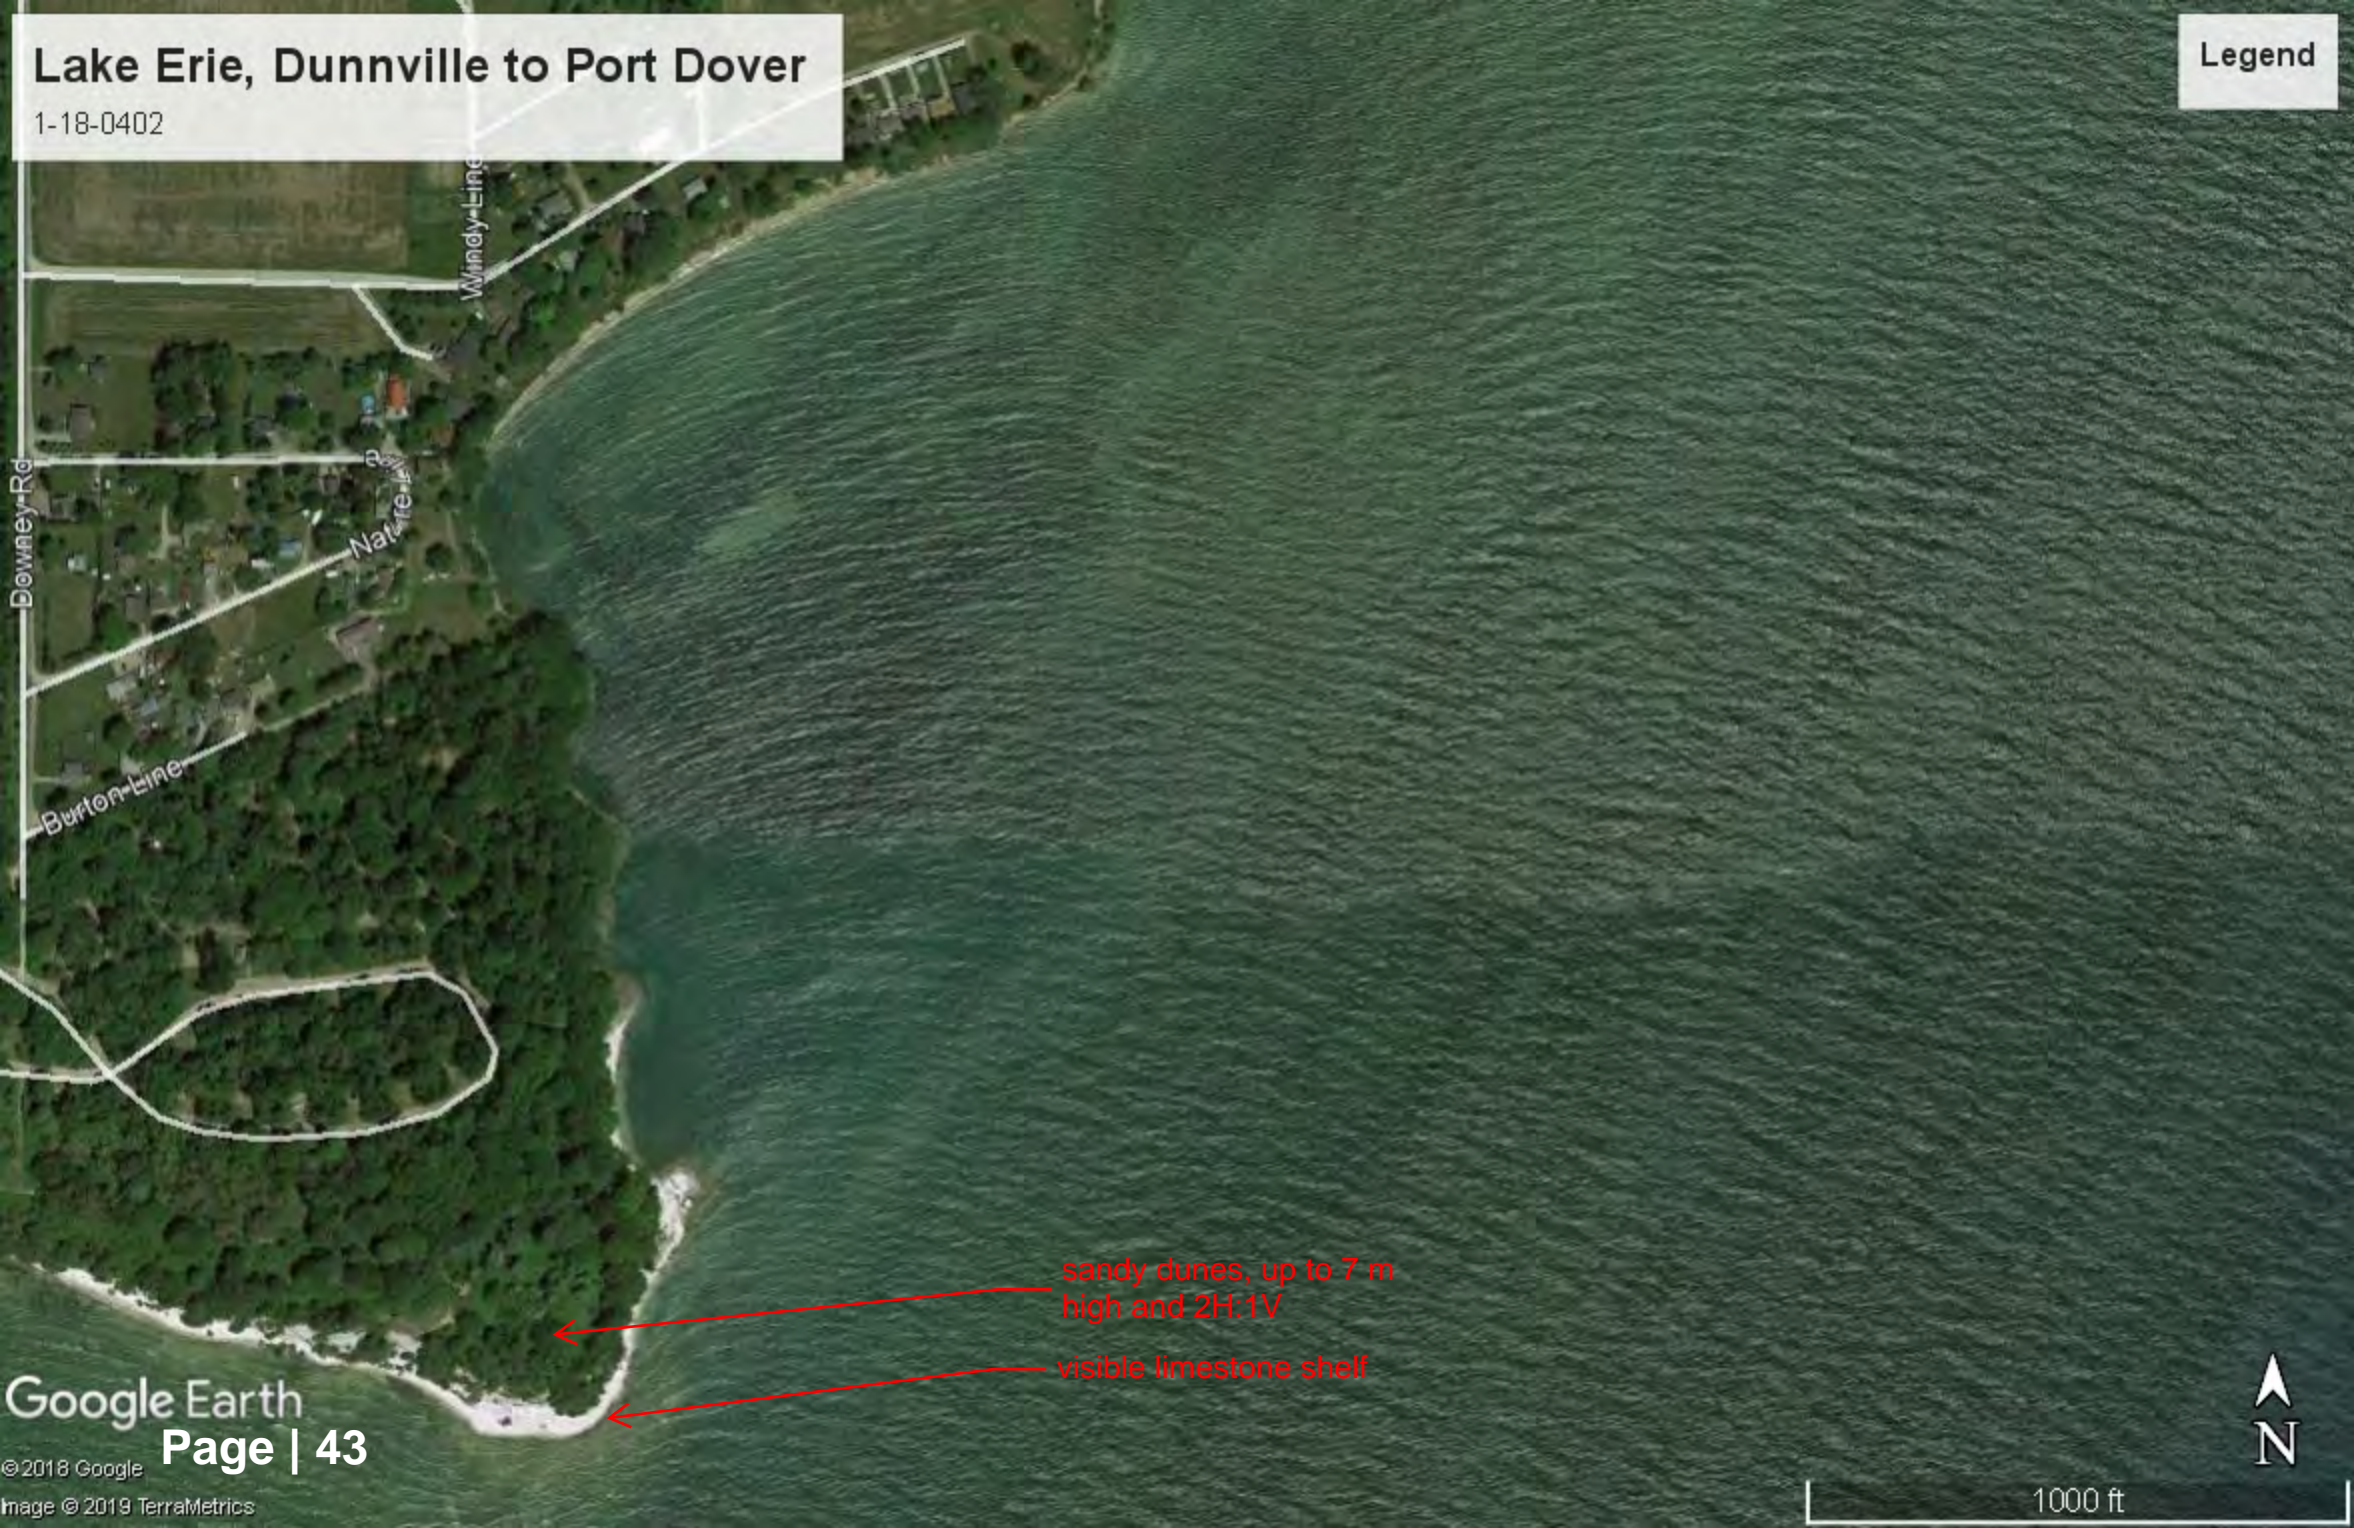
sandy dunes, up to 7 m high and 2H:1V

visible limestone shelf
