Haldimand County Lake Erie Hazard Mapping and Risk Assessment

Technical Report

March 19, 2020 | 12969.101.R2.Rev3

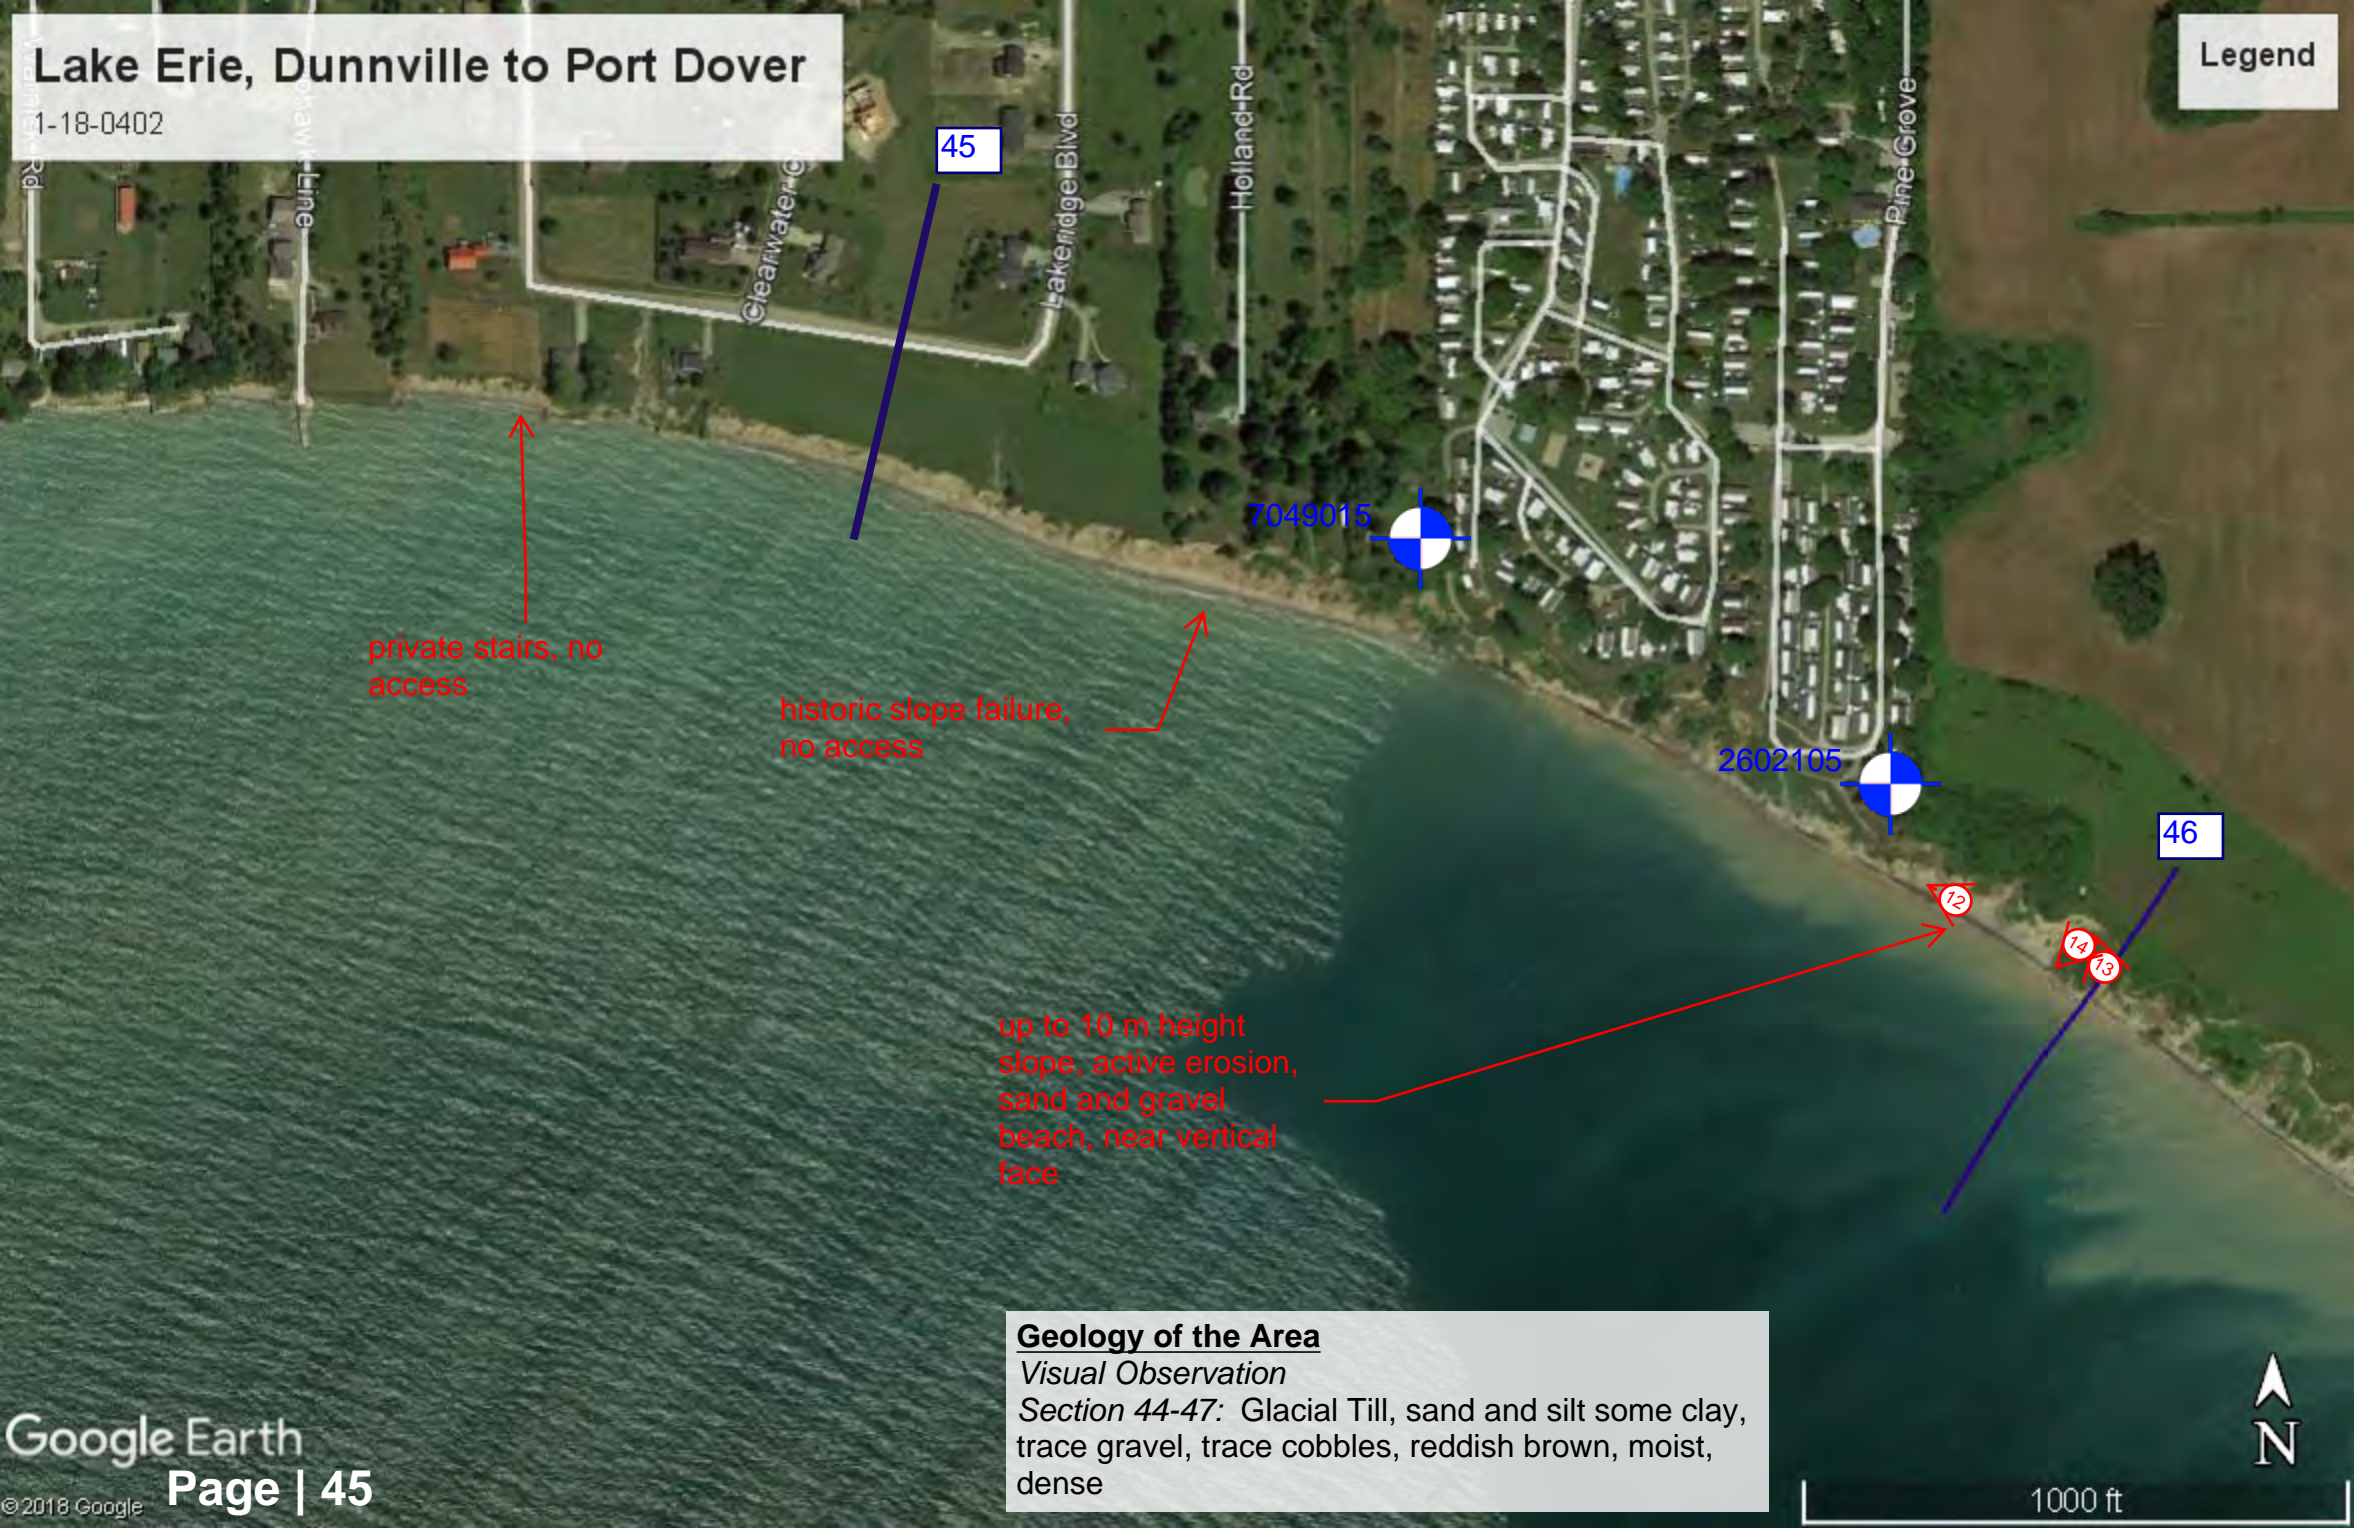
private stairs, no access

historic slope failure, no access

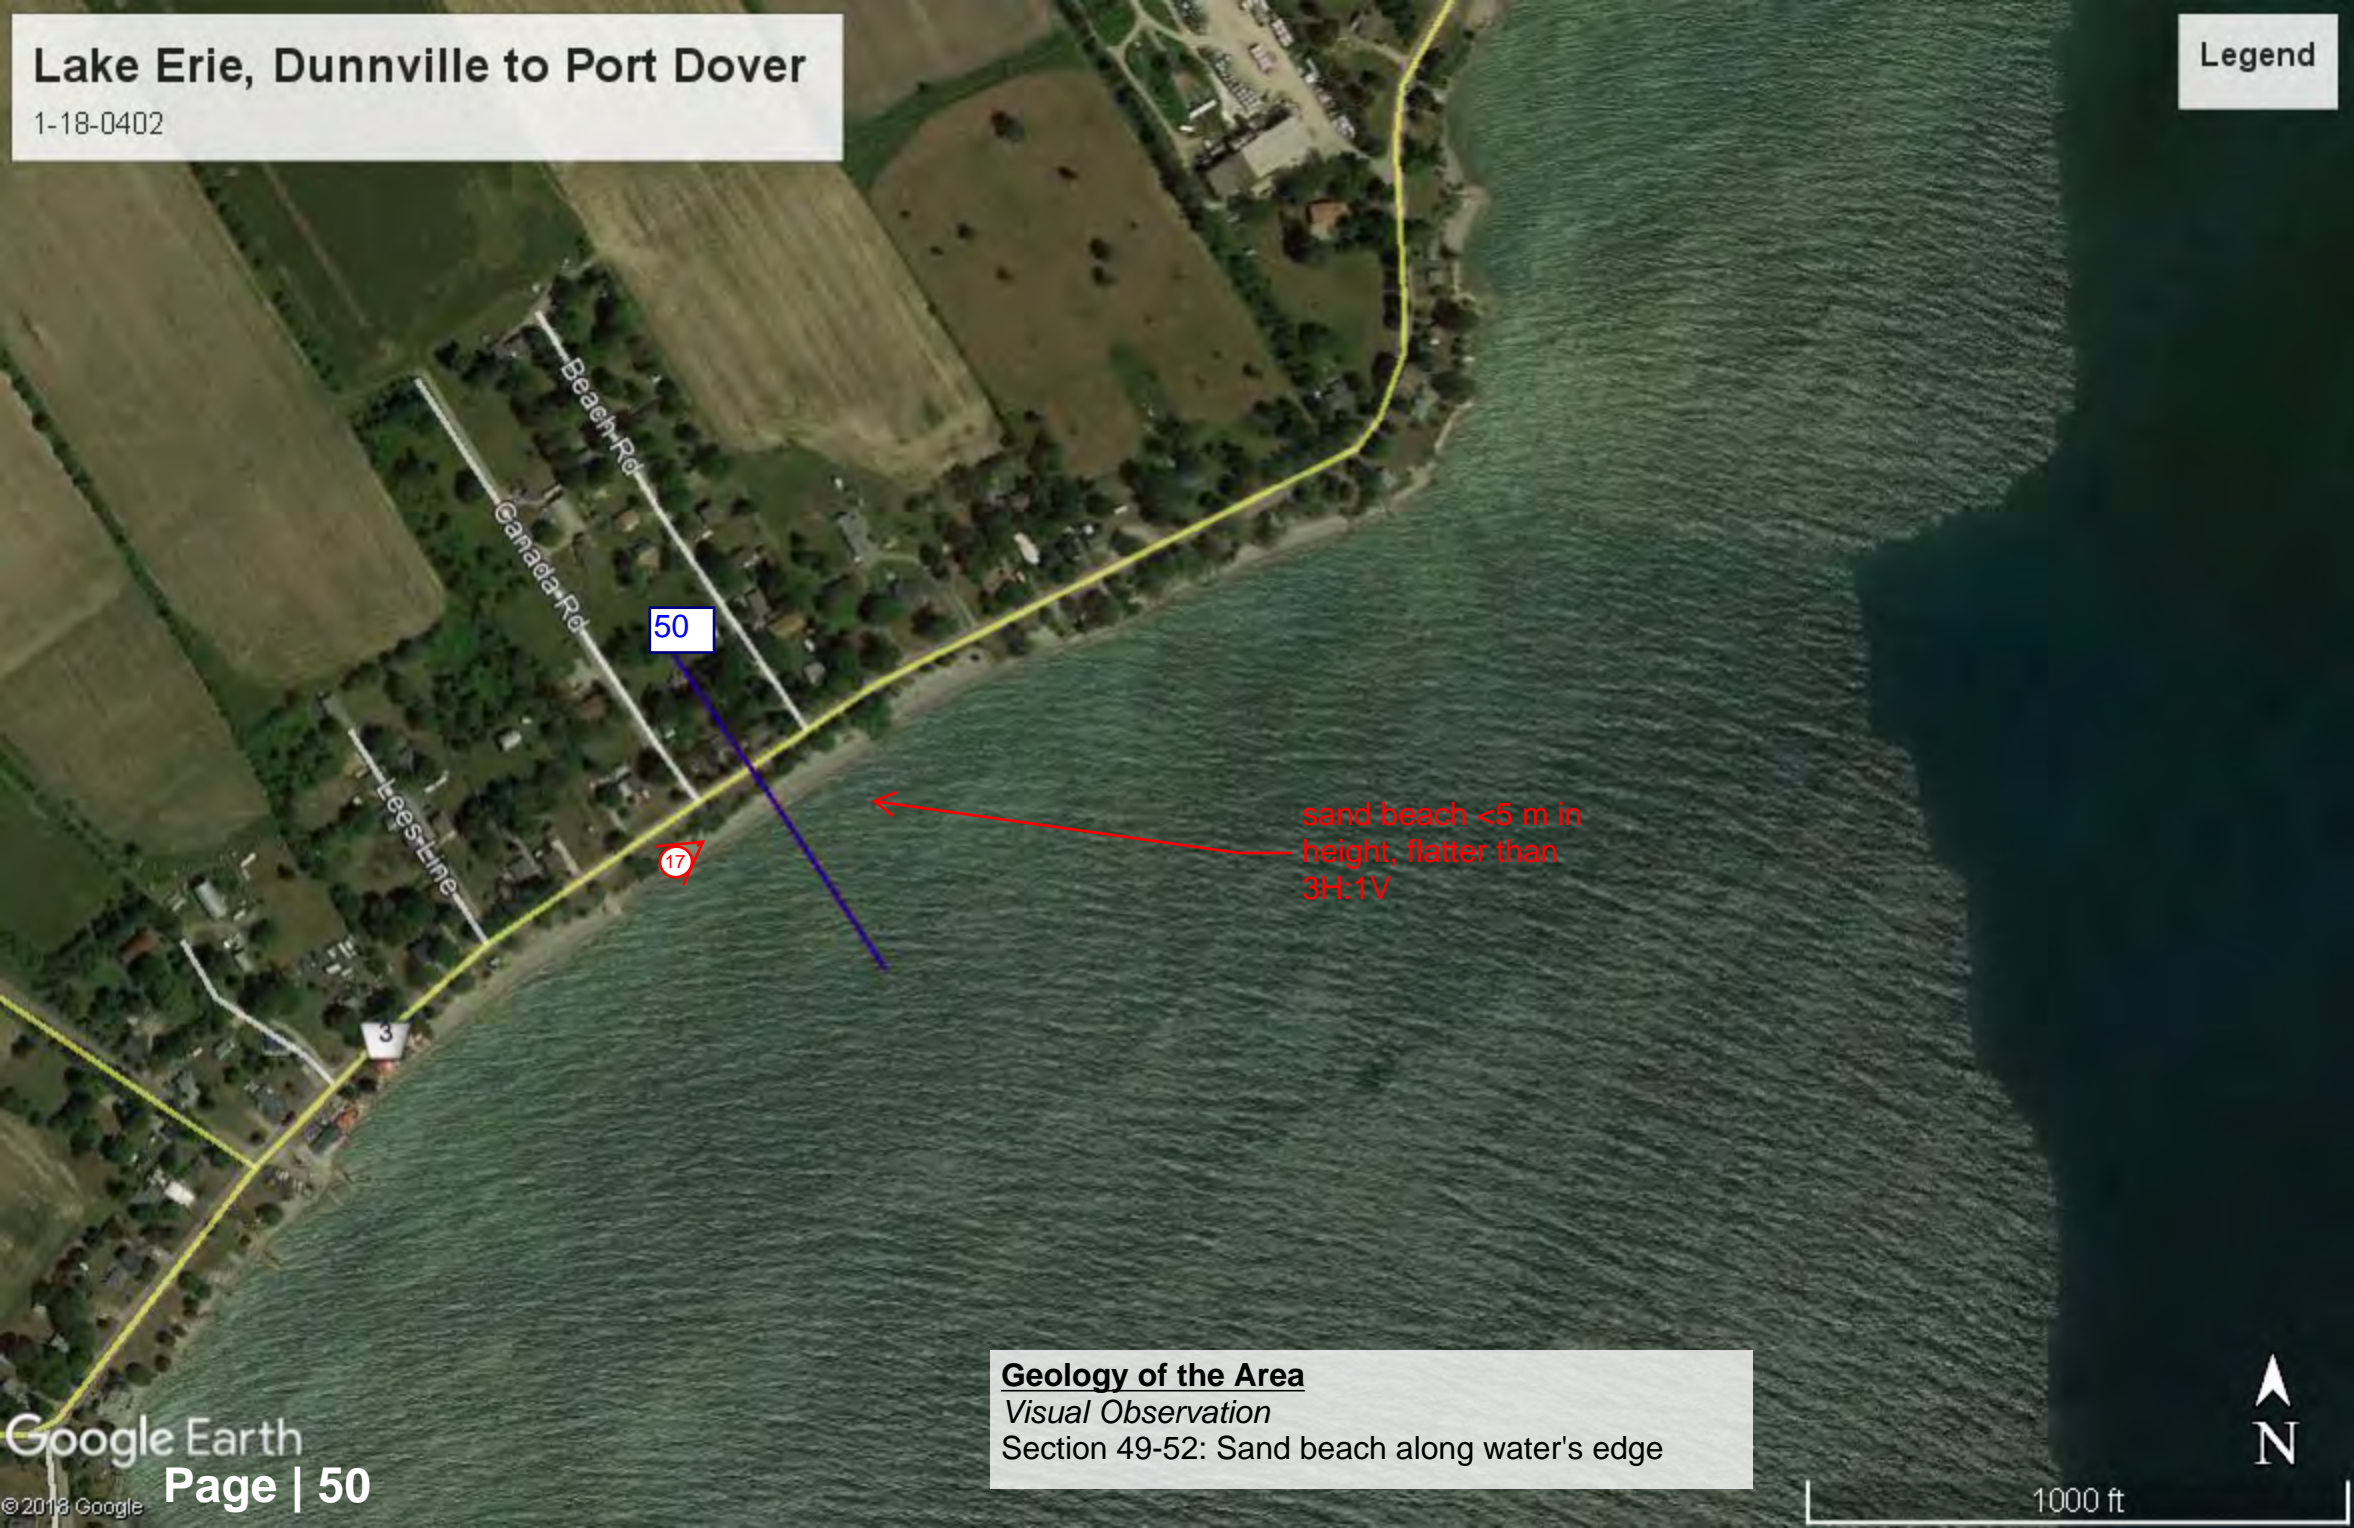
sand beach <5 m in height, flatter than 3H:1V

Geology of the Area
Visual Observation
Section 49-52: Sand beach along water's edge

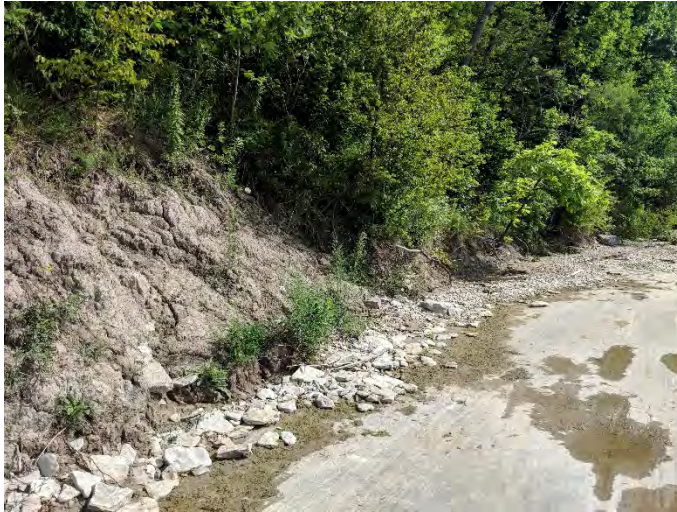
Photograph 1

Location: Toe of slope around Section 1
Viewing: East
Description: The slope face is forested, the toe of slope is bare. Clayey silt soil is visible. There is a limestone shelf at the toe.

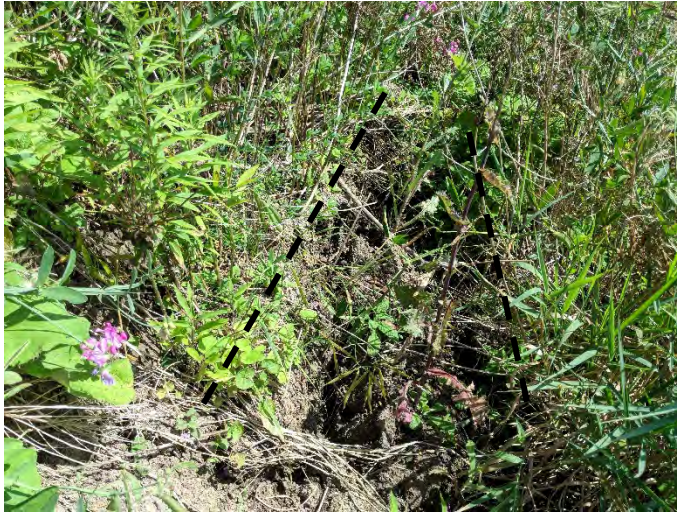
Photograph 4

Location: Top of slope around Section 8
Viewing: East
Description: There are tension cracks visible in the upper slope face of the slope around Section 8.

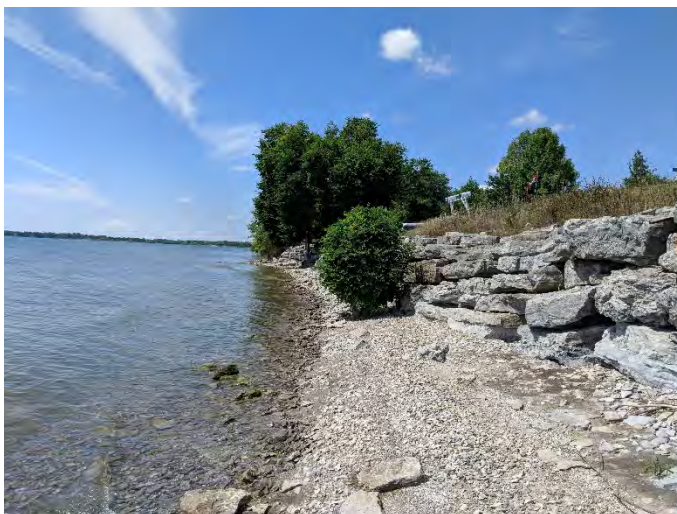
Photograph 6

Location: Toe of slope around Section 14
Viewing: West
Description: There is an armoured stone wall along the toe of slope. The tableland is relatively flat.

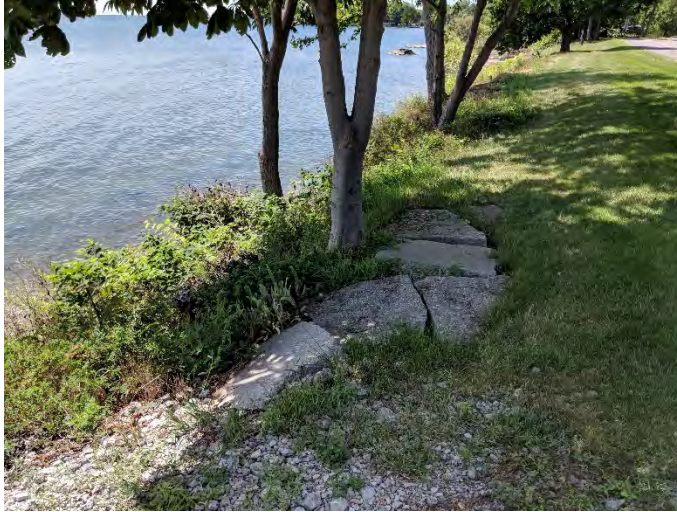
Photograph 7

Location: Toe of slope around Section 18
Viewing: West
Description: There is rip rap along the toe of slope. The tableland appears to be relatively flat, and vegetated with grass and young trees.

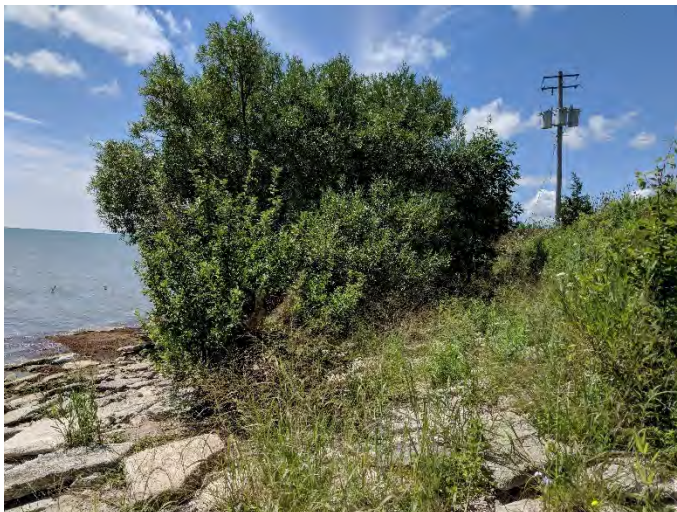
Photograph 8

Location: Slope around Section 23
Viewing: West
Description: There is sand at the toe of slope. The shoreline is vegetated with grass and shrubs.

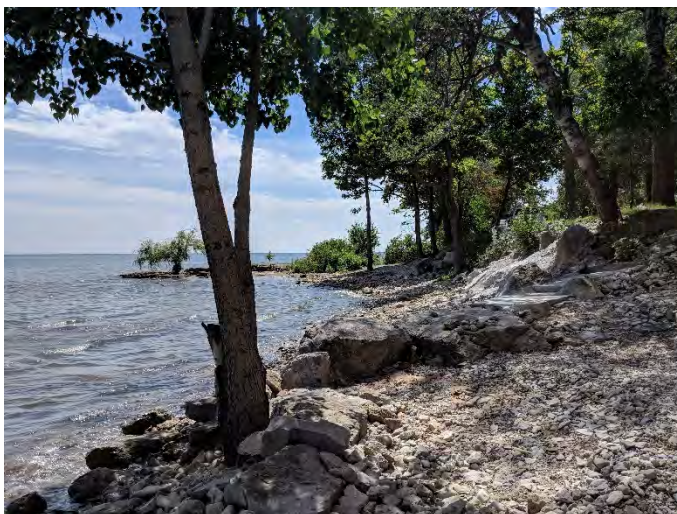
Photograph 9

Location: Between Section 31 and 32
Viewing: West
Description: There is a sand and pebble beach along the shoreline. The tableland is vegetated with grass, and mature to young trees.

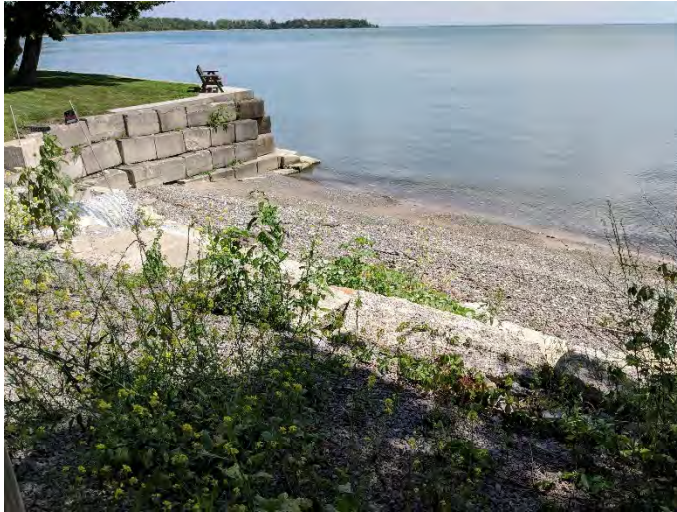
Photograph 10

Location: Slope around Section 39
Viewing: East
Description: There is an approximately a 5 m high slope at the shoreline with erosion protection. The tableland is vegetated with grass.

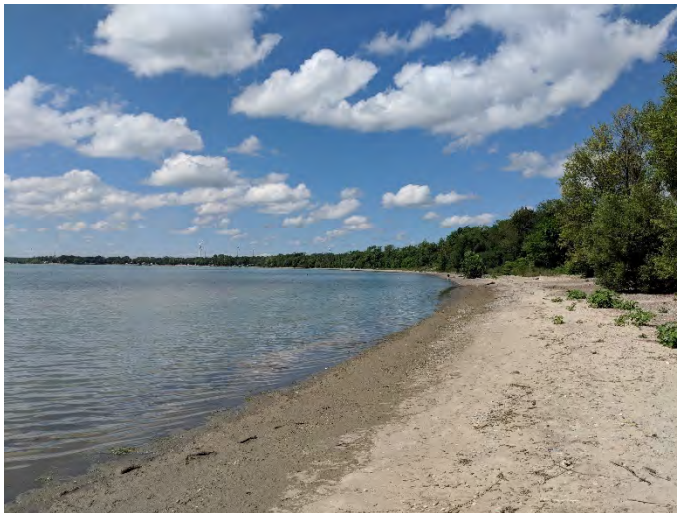
Photograph 11

Location: Slope around Section 40
Viewing: West
Description: There is a sand beach around Section 40.

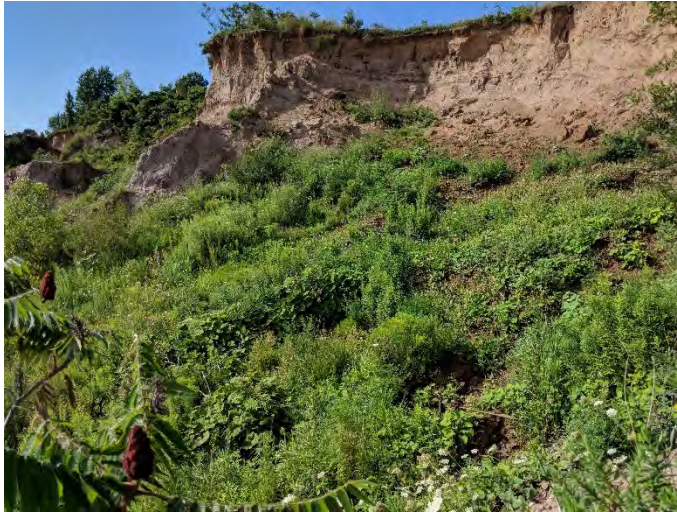
Photograph 13

Location: Slope at Section 46
Viewing: North
Description: There is a near vertical scarp in the upper slope face, with talus accumulation on the mid to lower slope face. The talus is vegetated with grass and shrubs.

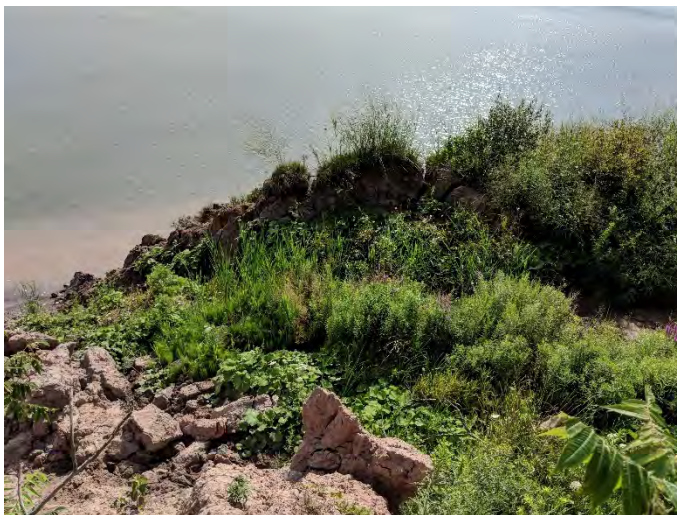
Photograph 14

Location: Slope at Section 46
Viewing: Slope
Description: Talus accumulation at the toe of slope along the shoreline at Section 46.

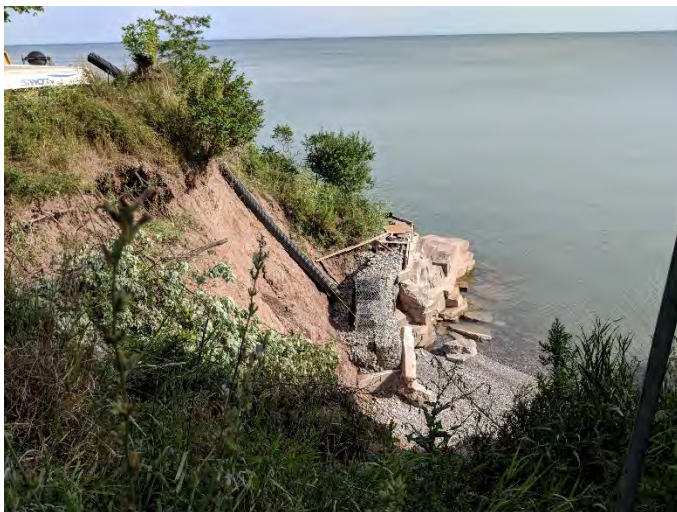
Photograph 15

Location: Slope at Dickout Road
Viewing: Gabion and Limestone retaining walls
Description: At the end of Dickout Road there is construction of retaining walls at the toe of slope, with a drainage pipe down the slope face. The retaining walls are up to 6-7 m in height.

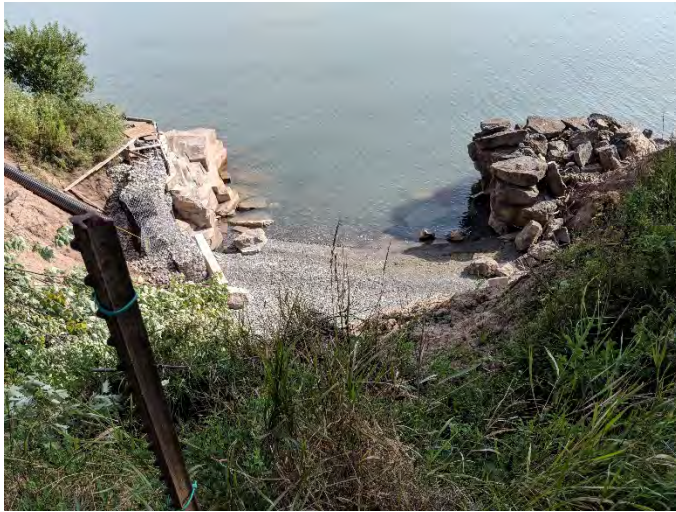
Photograph 16

Location: Slope at Dickout Road
Viewing: Retaining walls
Description: There is a limestone toe wall across from the gabion stone wall up to approximately 5 m in height. There is a gravel beach in between the two walls.

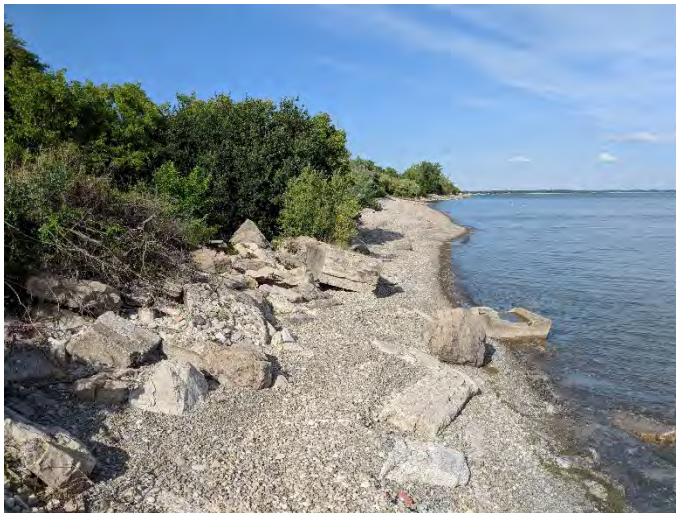
Photograph 17

Location: Slope around Section 50
Viewing: West
Description: Shoreline is composed of a sand and gravel beach with some rip rap.
